CATEGORY 2.

IMPROVED SEALING OF THE SCINTILLA CHOKE

THERMAL DELAY SWITCH

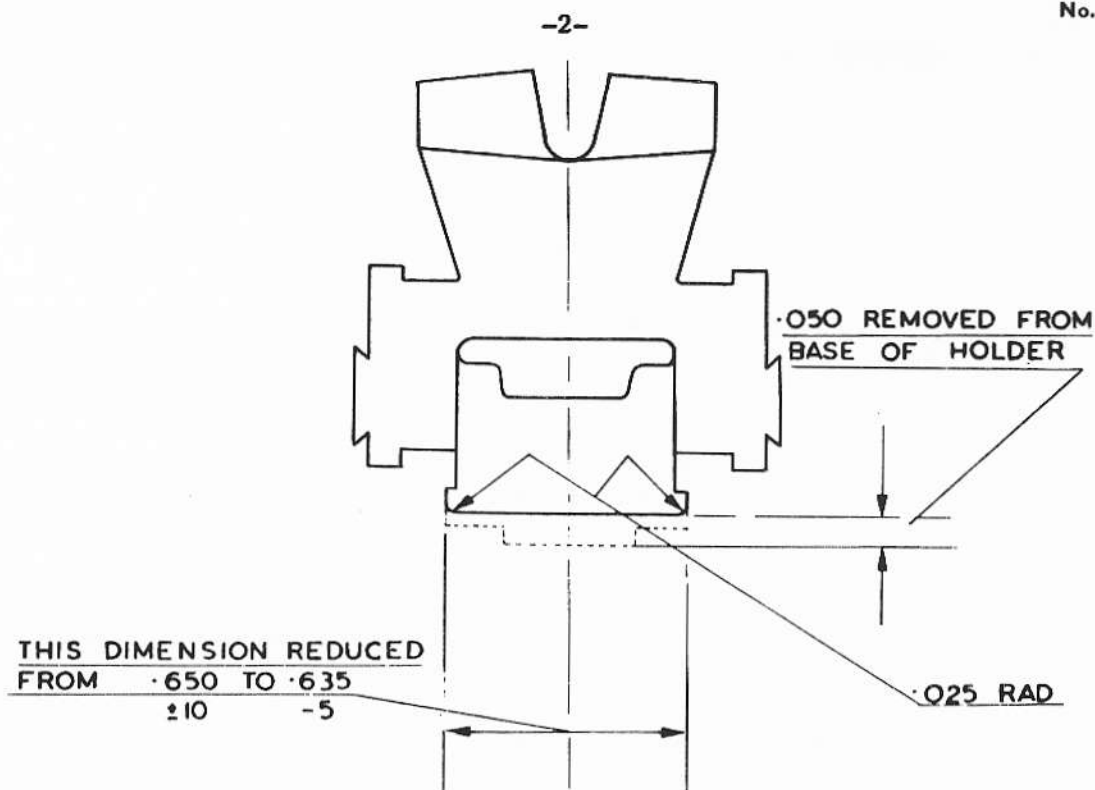
Fig.1. Method of Modifying the Fuse Holder

On late S1 cars and certain S2 cars, failure of the fuses to make good contact may be due to the fuse wires being located too high in the fuse clips. This fault can be attributed to one of the following causes.

- (a) Dimensional differences which produce a foul between the base of the fuse holder and the fuse clips, thereby preventing the holder from being pushed fully down into the clips.
- (b) The copper contact strips being incorrectly fitted, do not locate correctly on the moulding, which means that unless the fuse is carefully assembled the wire makes poor contact.

This allows the position of the fuse wire to be lowered from .425 in. to .375 in. and enables the fuse holder to fit fully down between the clips.

Remove .050 in. from the bottom of the fuse holder and reduce the width of the bottom to between .630 and .635 as shown in Figure 1.

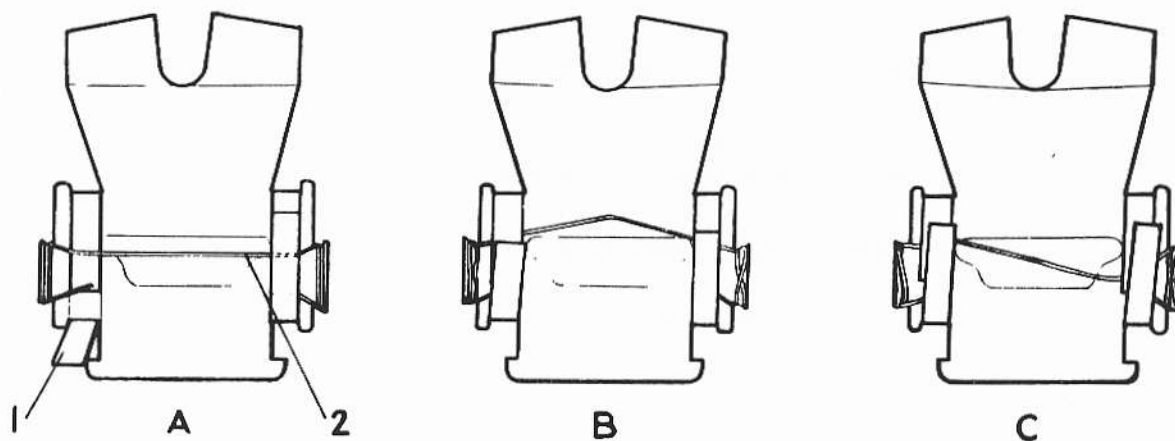
Fig.2. 'A' Correct Method of Fitting the Fuse Wire,
'B' and 'C' Incorrect Method

The correct method of fitting the wire is shown, in comparison with incorrect methods, in Figure 2.

Ensure that the wire is wrapped around the bollard on the fuse holder one and a half times, and passed across the air space along the ledge, parallel with the bottom of the holder, then wrapped around the other bollard one and a half times. The ends of the wire must be positioned so that they are securely trapped by the copper strips when they are fitted.

Fit the copper strips to the fuse holder so that the fuse wire is firmly trapped and that each end of the copper strip overlaps the wire by an equal amount. The correct method of fitting the fuse wire and the contact strips is shown in 'A' of Figure 2.

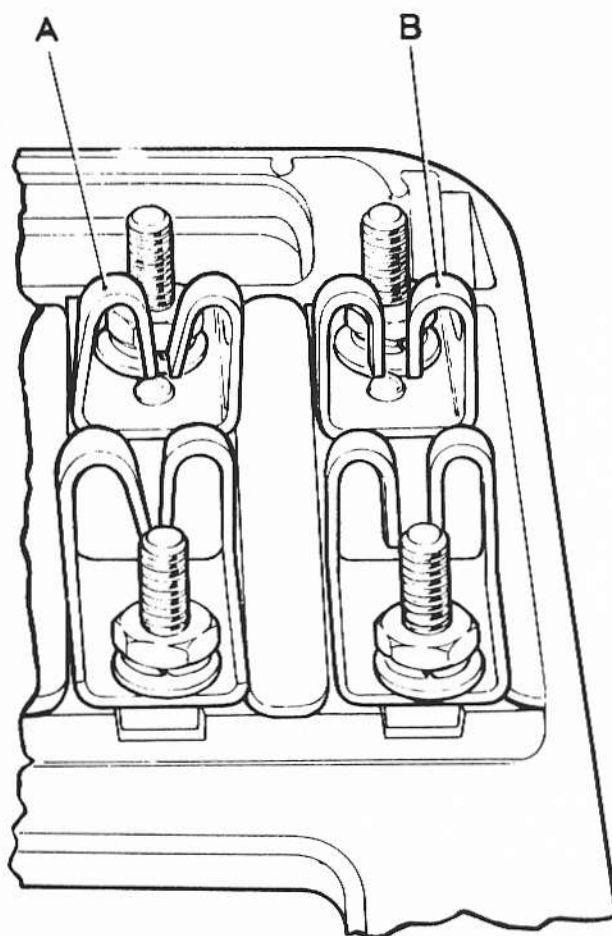
Fig.3. 'A' Fuse Clips set Incorrectly.
'B' Correctly.

Figure 3 shows a comparison between the fuse clips set correctly and incorrectly.

Ensure that the fuse clips are not distorted. They should be set square and parallel in order to maintain the holder firmly in position.

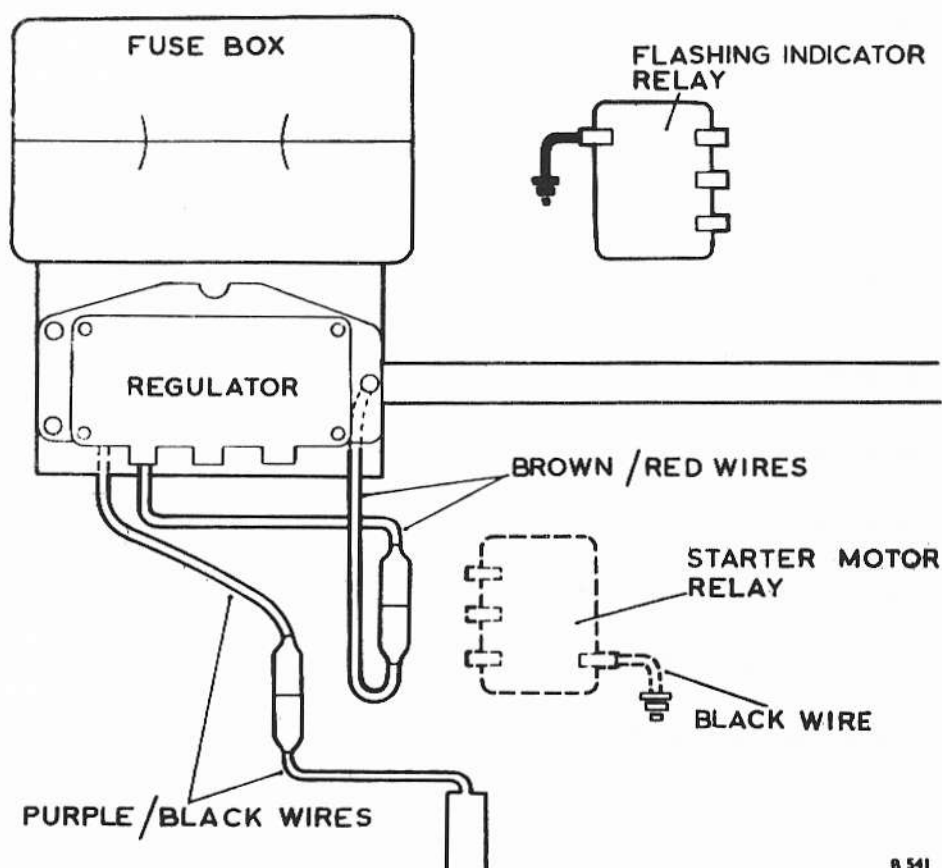
Fig.1. Positioning of Starter Motor Relay and Re-wiring of Connections

A protective device, in the form of a relay switch, was fitted to S2 cars to prevent drivers from engaging the starter motor pinion when the engine was running. Recent Service experience has shown that this relay does not function correctly and Retailers and Service Personnel should remove these relays when affected cars next come in for Service or in the case of customer's complaint.

If the engine cannot be started with the ignition key but will start when the rubber button on the solenoid is depressed then the relay is not working.

Remove the two Brown/Red wires from the connection W.1 on the relay and connect them together using a double-ended 'Lucar Blade'

connector (UD.6074), (See Fig.1).

Remove the two Purple/Black wires from the connections C.2 and C.3 on the relay and connect them together using another double-ended connector (UD.6074).

Remove the Black earthing wire from the connection W.2 on the relay and from the bulkhead.

Remove the relay. The two cheese-headed screws and washers should be refitted to the bulkhead.

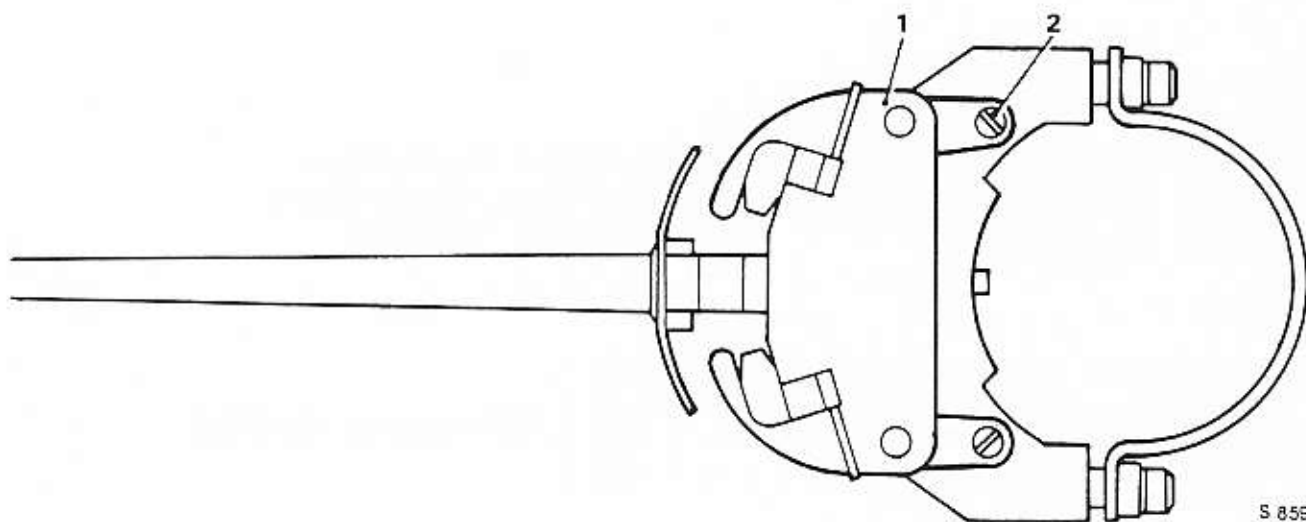
Figure 1. Direction indicator switch (UR 16530)

The direction indicator switch UR 5273 is no longer available. For replacement purposes, the switch used on Silver Shadow cars (UR 16530) will be fitted. When it is fitted, the terminal connectors must be changed.

1. The removal and replacement procedure for the new switch remains the same as for the old. However, there is a small modification to be carried out on the new switch as follows:
2. Remove the two screws and discard the brown insulation board (see Fig. 1). Replace the screws with a washer (X 4401) behind each screw head (see Fig 2).
3. Cut the 7 pin plug off and withdraw the insulation board along with the green/yellow and green/blue wires.
4. Fit 'Lucar' connectors to all the wires except the black one to which a bullet connector is fixed. Connect the wires as follows.
