SERVICE INSTRUCTION LEAFLET

ISSUED BY
BENTLEY MOTORS (1931) LTD.

Engine - Tappet Clearances
3½ and 4¼ Litre Bentley.

Subject : ENGINE
MAIN AND CONNECTING ROD BEARINGS
BENTLEY 3½ AND 4¼ LITRE.

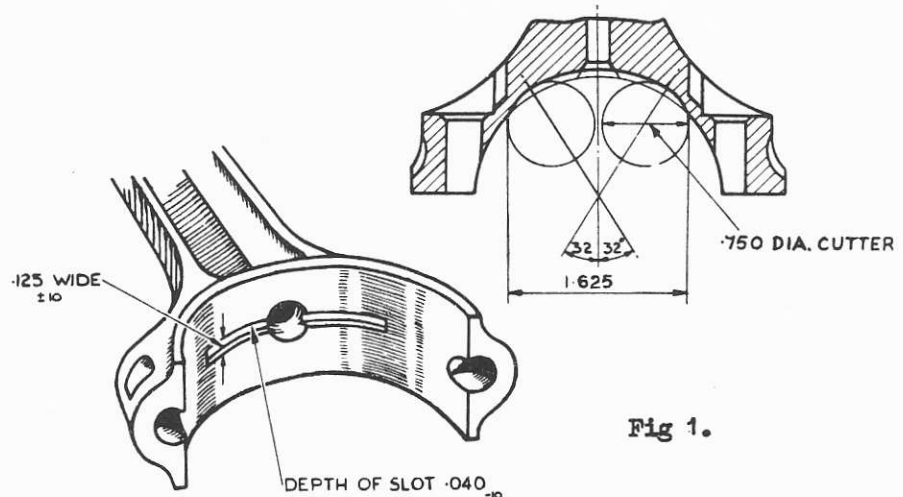
The original 2.000" bore connecting rod big end bearing shells (Part No.E.55613) carried an external oil groove in the upper half which conveyed oil through the shells to the connecting rod for the feed to the gudgeon pin.

In order to avoid cracking of the white metal which might occur due to local distortion in the vicinity of the groove, the original type shells will be no longer manufactured, and for replacement purposes, shell EB.3463* will be used.

This shell has no external groove and it is most important to machine the connecting rod so as to incorporate the necessary oilway as shown in Fig 1.

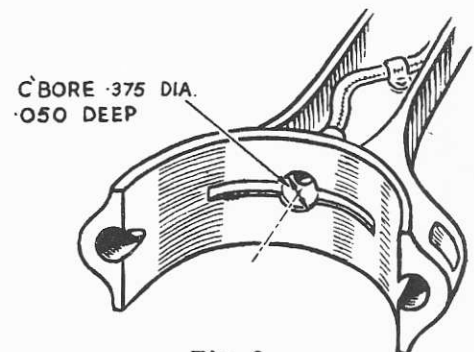
On connecting rods fitted with an external oil pipe, an additional counterboring operation is necessary to connect the groove with the oil hole. This is shown in Fig 2.

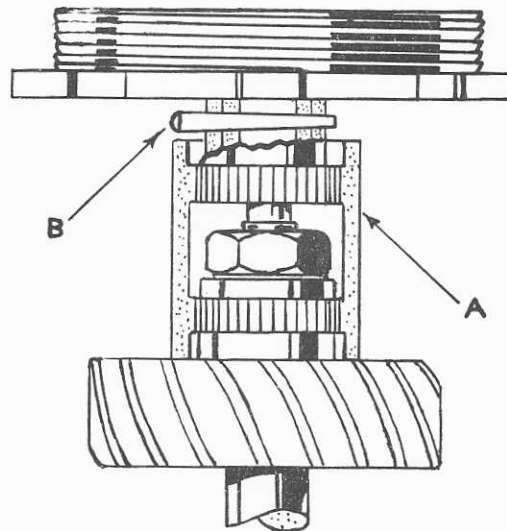
It is necessary to draw attention to the following point in connection with the distributor drive on the above models. The splined sleeve shown at "A" in the sketch is free to move vertically on the splines, but complete dis-engagement is prevented by the taper pin "B" on which the sleeve butts after a limited amount of vertical travel.

If the pin is short, the condition may arise in which the sleeve ceases to engage the splines, and complete ignition failure will occur on the road.

It is therefore essential, when a distributor is removed or dismantled to make sure that the head of the pin projects to an effective extent. A new pin must be used if the existing one does not project sufficiently when driven into position.

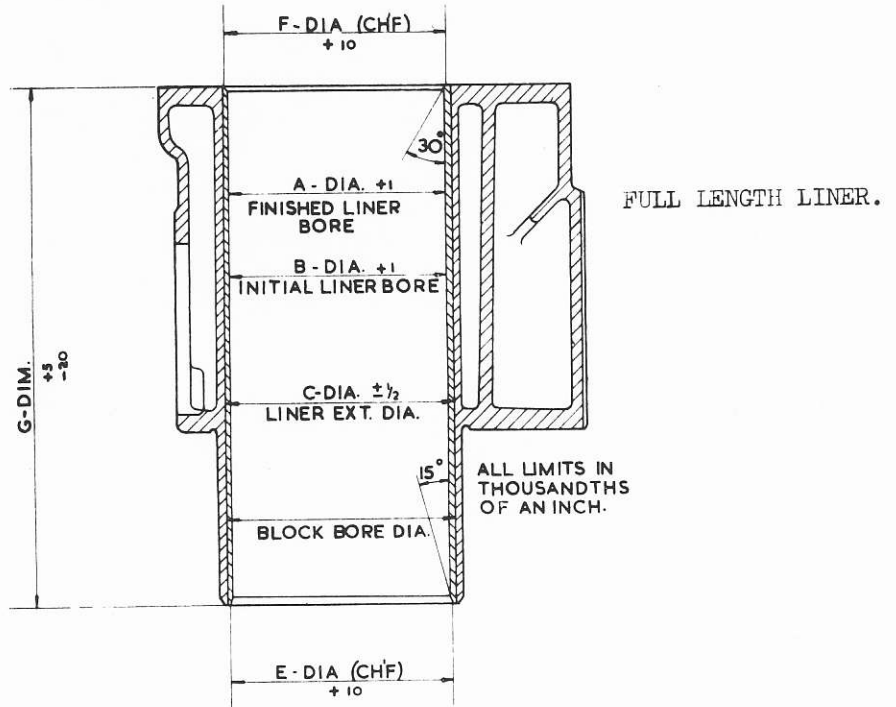
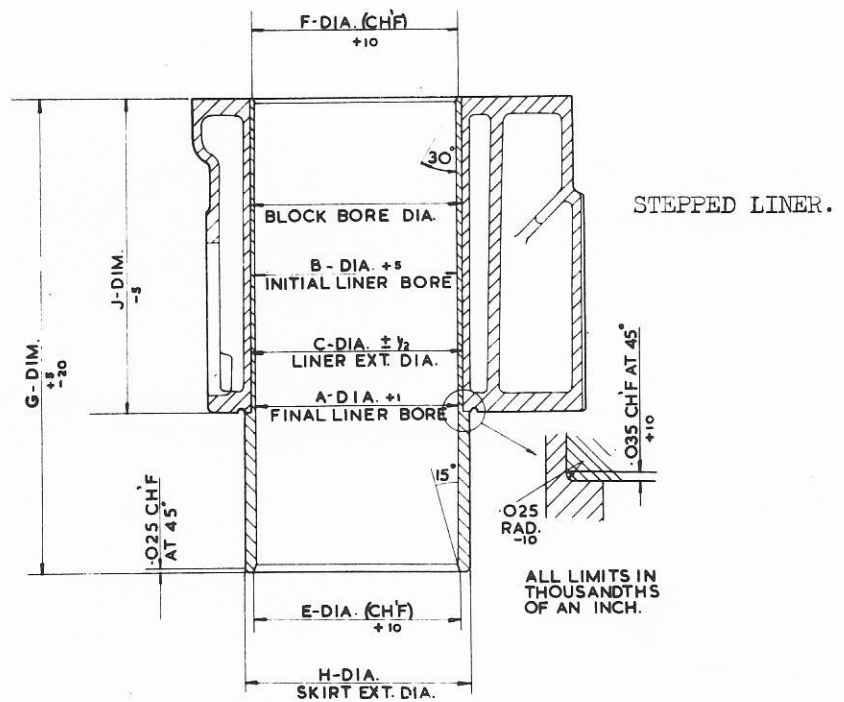
In cases where it is necessary to rebore and fit replacement pistons to an engine which has already been bored to the maximum permissible oversize, a dry liner may be fitted.

- (a) A full-length parallel type to restore the bore diameter to the original size.
- (b) A stepped liner, the lower part of which constitutes a "skirt" or bore extension. This can be used to salvage any block having a broken extension, irrespective of bore size.

STEPPED LINER - Machine off the broken skirt flush with the bore of the cylinder. Measure the liner and bore out as above. Chamfer the inside edge of the cylinder bores as shown in the diagram.

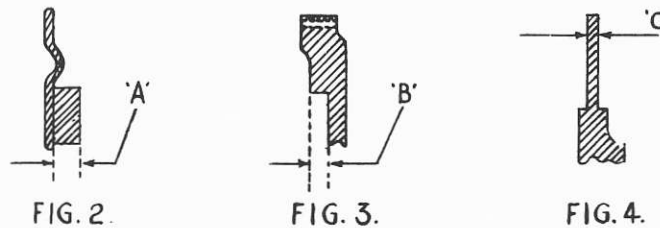
The diagrammatic sketches appended below, illustrate the limits to which the various friction faces may be safely ground:-

Minimum Permissible Working Thickness for Presser Plate. (See Fig. 2 Dimension 'A')	Depth to which the Rear Damper Friction Face may be ground. (See Fig. 3 Dimension 'B')
3 1/2 litre } 4 1/4 litre }	0.107" or 2.72 mm.	0.388" or 9.86 mm.
