BENTLEY MARK VI

MODIFICATIONENGINE OIL FILLER CAP WASHER.

REPLACEMENT OF TAPPETS.

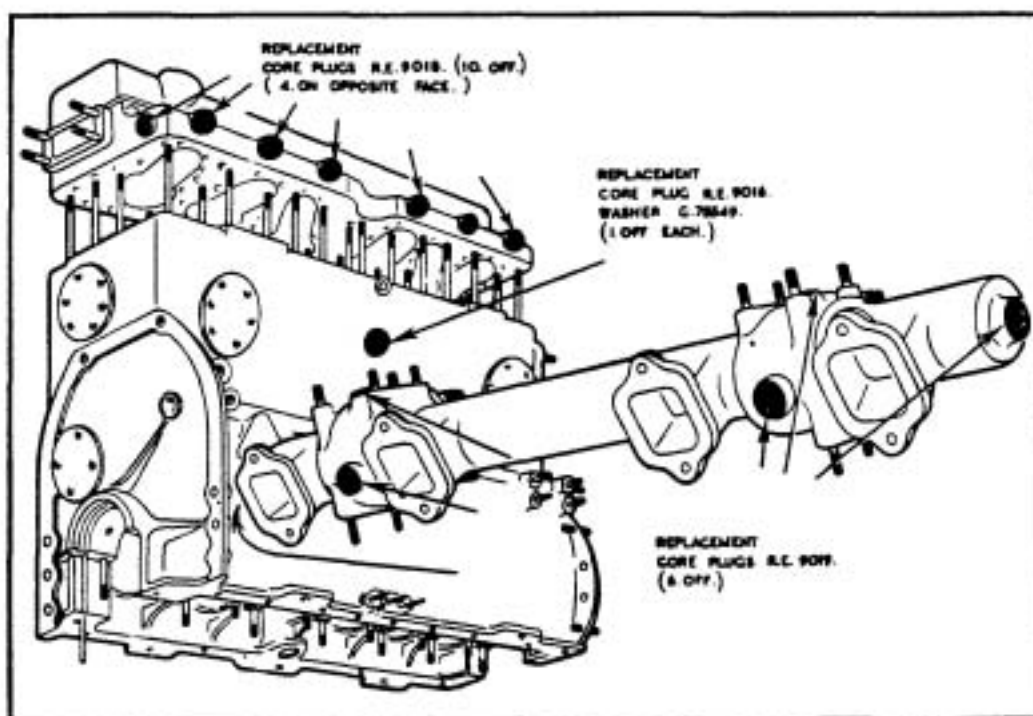
The following illustration gives fuller details of the location of the core plugs to be replaced, together with replacement part numbers.

It should also be noted that if a coolant leak develops from any of the core plugs when the engine is fitted with the pre-modified type, this may indicate that a state of corrosion exists in other core plugs caused initially by the engine remaining drained of coolant for lengthy periods of storage or shipment. If a leak is apparent therefore, the instructions given in Bulletin BB-19, limiting this modification to overhaul cases only, must be disregarded, and all core plugs replaced with the modified type.

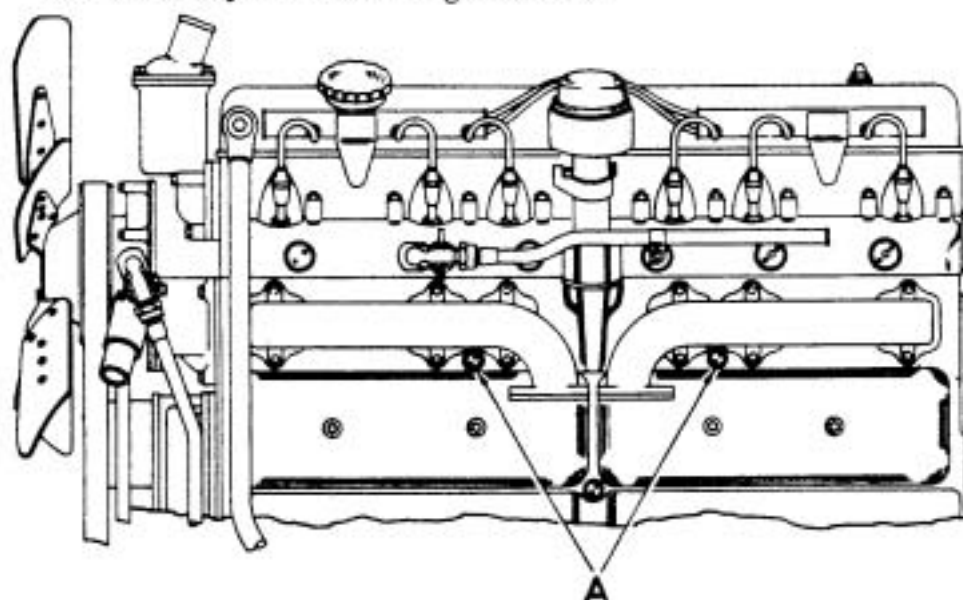
FIG.1 LOCATION OF CORE PLUGS

The aluminium plugs have proved subject to corrosion in service and are to be replaced with cadmium plated steel core plugs and aluminium washers as a retrospective modification. Retailers are asked to carry out replacement on all affected cars in their area when they are next being serviced.

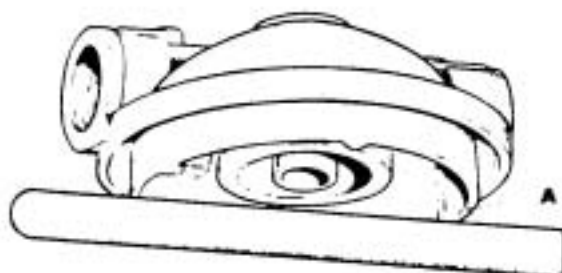
Fig.1 Outer Lip Proud of Inner Sealing Face.

Therefore when the bowl of the filter is removed to change the filter element and seals, on the 5,000 miles service schedule, Retailers should check the filter head with the aid of a straight edge as illustrated in Figures 1 and 2.

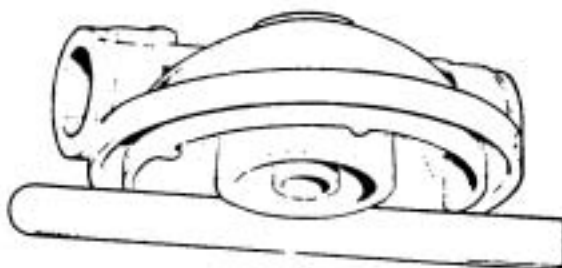
Fig.2 Inner Sealing Face Proud of Outer Lip.

If the inner sealing face stands proud of the outer lip (see Fig.2) the original 'Top Cap' (as shown in Fig.4) can be retained. For future replacements only the modified 'Top Cap' will be supplied.
