ENGINE

CATEGORY 2.

ENGINE REAR MOUNTING AND REAR EXTENSION BRACKET.

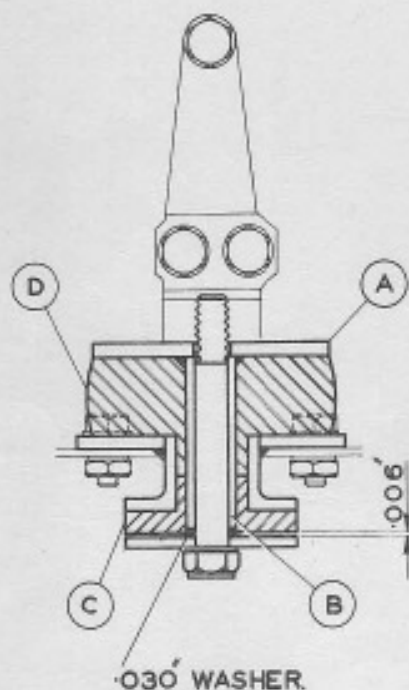
Engine Rear Mounting.

On certain vehicles it has been found that when the engine rear mounting bolt is fully tightened, the upper washer of the rear mounting distorts slightly to conical form, so that it seats only over an area close around the bolt hole in the undersurface of the bracket. This permits relative movement between the upper washer and the bracket, which may eventually cause fatigue failure of the engine mounting bolt at that point.

- A. Rear Mounting Upper Washer.
- B. Distance Tube (Welded to upper washer).
- C. Rebound Rubber.
- D. Upper Mounting Rubber.

This is overcome by machining a counterbore in the undersurface of the rear extension bracket .750" in diameter and .005" - .010" deep, so that should the upper washer distort, the effective seating will not be confined close to the bolt hole, but to the diameter of the counterbore.

The rear engine mounting is also to be checked to ensure that the lower rebound rubber is not held tight but has .006" vertical clearance, when the assembly is tightened in position with the engine load on. If there is insufficient clearance a .030" thick steel washer is to be placed between the lower steel washer of the assembly, and the distance tube, taking care to ensure that the washer seats directly on the base of the distance tube, and does not foul the inside of the hole in the rebound rubber. Alternatively the distance tube can be lengthened .030" by welding and machining to a length of 2.045".

When the engine mounting bolt has been finally tightened, the rebound rubber should have a .006" minimum vertical clearance.
