Bulletin

MODEL BENTLEY MARK VI

CLUTCH PEDAL.

CLUTCH SLIP.For Information:

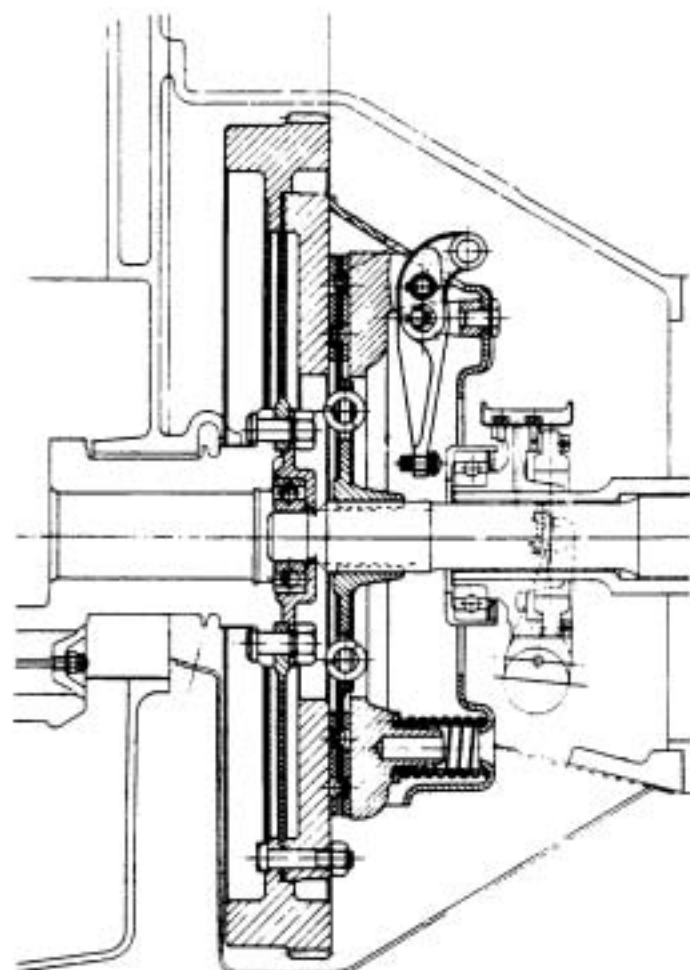
Fig.1. Section through flywheel and clutch.

Before resorting to any dismantling for slip, the free travel of the clutch pedal should be measured and adjusted if necessary as follows:-

With the clutch pedal lever against its up-stop under the pedal gap plate, place the edge of a rule against the centre of the side of the pedal and the end of it against the dash, depress the pedal by hand until the clutch release bearing just touches the three release levers of the clutch. Measure the free travel which should be $1\frac{1}{2}$ " (38 mm). A turnbuckle adjuster with a central spanning point is provided. Insufficient free travel of the clutch pedal can be one of the causes of clutch slip. If clutch slip is experienced at high engine R.P.M., it indicates that there is insufficient pedal clearance.

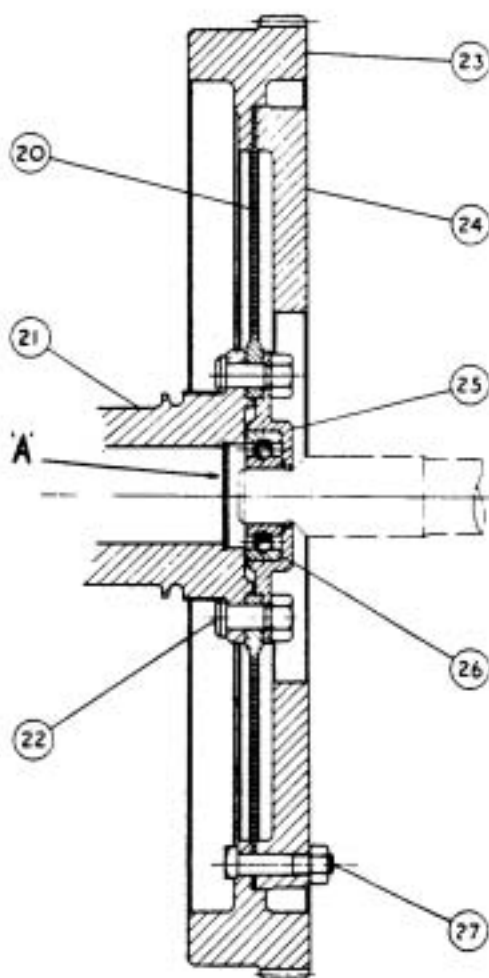
Fig.2. Section through flywheel.

1. Oil leakage past the sealing washer 'A' Fig.2 at the rear end of the crankshaft.
2. Excessive initial loading of grease into the clutch spigot ball bearing (26 Fig.2) of the flywheel, distinguished by radial grease marks on the friction plate (24).
3. Over zealous application of the foot-operated chassis oil pump or a faulty oil restrictor (Type ZEO), allowing too much oil to reach the clutch release bearing (32 Fig.5) eventually working its way along the splines on to the driven plate.

It has been found on investigation, that under certain conditions there is a possibility of an oil leakage past the sealing washer ('A' Fig.2) at the rear end of the crankshaft. If the leakage is sufficient, oil may reach the front facing of the driven plate. In practice, it is likely that the first indication will be a clutch shudder and then a slipping clutch. If after removal of the clutch, oil, apart from grease, is found to be present in the spigot bearing (26 Fig.2), it can be assumed that it is leaking past the sealing washer.

If too much grease has been packed into the clutch spigot ball bearings (26 Fig.2) in the flywheel, then it may eventually find its way on to the friction plate (24) of the flywheel with consequent contamination of the front facing of the driven plate. Remove all traces of grease, oil or foreign matter from the flywheel, friction plate and clutch casing. There should not be a repetition of this trouble, as any excess of grease in the spigot bearing will have found its way out. There is no need to remove the spigot bearing for cleaning purposes.

Whenever there is evidence of oil leakage past the sealing washer, a rubber plug should be fitted as described herein. If however, a rubber plug is not immediately available, then it will be necessary to solder the sealing washer ('A' Fig.2) to the crankshaft as described in Paragraph 1b.

With the clutch removed from the flywheel, remove the crankcase lower half. Remove the nuts from the twelve bolts (22 Fig.2). Providing the nuts have not been over centre punched, it should be possible to use them again. Leaving the flywheel assembly in position on the crankshaft, remove the bearing housing (25) complete with the spigot bearing (26). Remove any surplus oil or grease from the spigot bearing and housing and do not add any additional oil or grease.

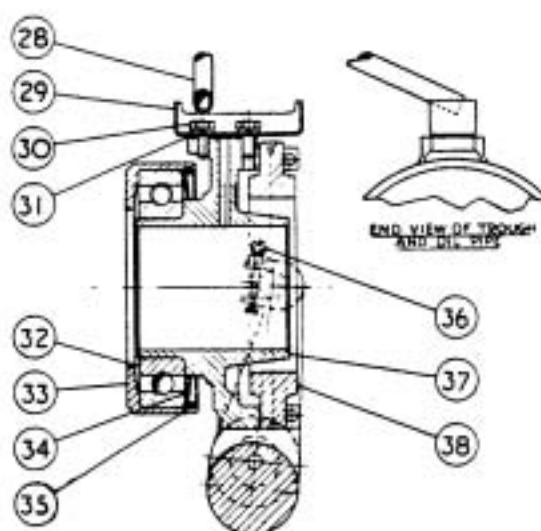
Fig.5. Section through clutch release bearing and trunnion.

The above will probably allow too much oil to reach the clutch release bearing (32 Fig.5) and eventually find its way on the rear facing of the driven plate assembly. The chassis oil pump should only be operated in accordance with the instructions given in the Owners Handbook i.e. "Depress

If the clutch has been removed for the purpose of fitting a new driven plate assembly, then prior to refitting the gearbox to the clutch casing, ascertain that the oil feed pipe (28 Fig.5) to the oil trough of the clutch trunnion is correctly positioned above the trough. The end of the pipe should be approximately over the front setscrew (i.e. the one nearer to the flywheel) retaining the trough to the trunnion when the clutch release bearing housing (33) is in contact with the adjusting screws of the three clutch release levers. Check that the oil feed hole from trough to the trunnion is clear. With sufficient oil in the foot-operated oil pump, depress the pedal once and count the number of oil drops delivered to the trough of the trunnion.

Approximately three to five drops should be delivered with each application of the pedal. If either above or below this rate of flow, check the restrictor elbow situated on the right-hand top side of the clutch casing, by replacing with a new one of the same type (ZEO).

If the flow is still too great, then fit a type ZEOO elbow which will give a reduced rate of flow, conversely if there is still insufficient oil delivered, then check for a leakage or pipe breakage at some other point in the centralised chassis lubrication system.

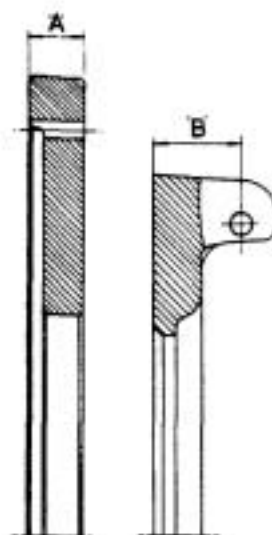
FIG.1 FLYWHEEL AND PRESSURE PLATE - ORIGINAL DIMENSIONS.

It is permissible to regrind the surface of both the flywheel friction plate and the clutch pressure plate should they show signs of scoring. Only the minimum amount of metal necessary to provide a clean, smooth surface should be removed. Grinding limits and original dimensions are given in Fig.1.

A flywheel friction plate that shows any sign of small, hair-line, contraction cracks should be discarded.

A surface grinder should be used and a Carborundum stone of grade BA80-N5-VBLU is recommended. The clutch pressure plate may be placed face downwards on the machine table and the backs of the lugs for the toggle levers lightly ground flat to provide a true surface. The plate may then be reversed and the face ground as required.
