CATEGORY 2.

AUTOMATIC GEARBOX LEAKS.

AUTOMATIC GEARBOX.

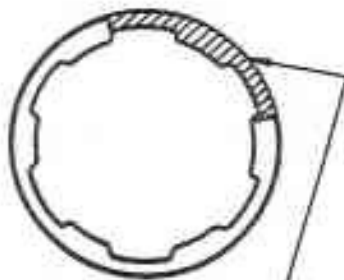
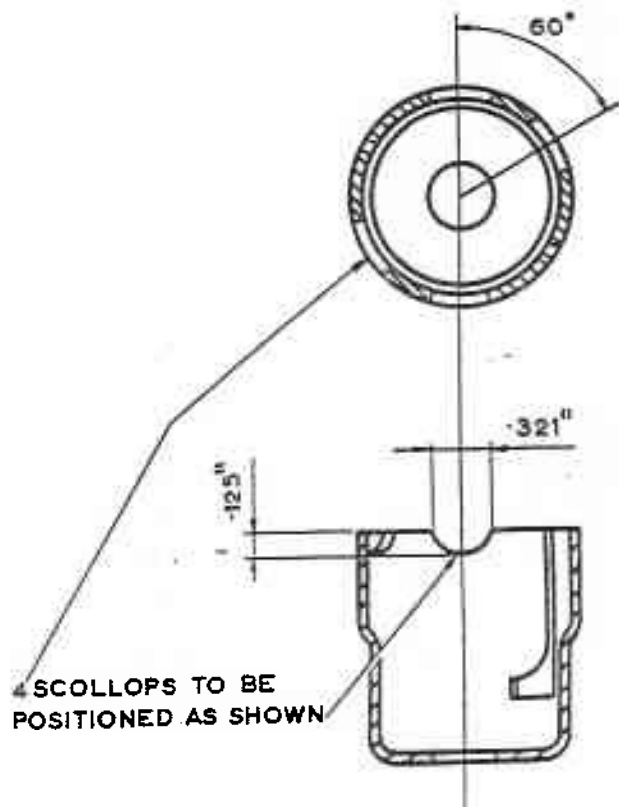
After prolonged running at high speed it may be possible for air pressure inside the gearbox to rise sufficiently to force oil through the normally satisfactory front pump oil seal.

Serrated Washer.

Retaining Cap.

This possibility is overcome by modifying the automatic gearbox oil breather and level indicator so that the pressure is relieved sufficiently to prevent oil leakage.

Take the oil breather and level indicator from the gearbox and carefully remove the retaining device securing the retaining cap to the indicator rod. The retaining device may be either a cee clip, spring clip, or split pin. This will allow the retaining cap, the copper mesh crimp and the serrated washer to be removed from the indicator rod. Cut the serrated washer and file the retaining cap as illustrated. Thoroughly clean and remove all metal particles, re-assemble the components and replace the assembly in the gearbox.

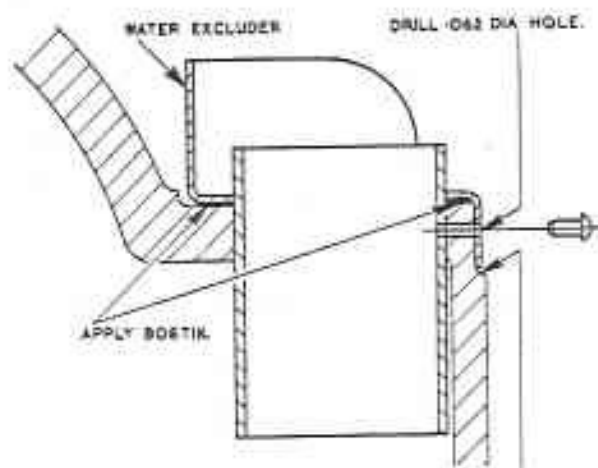
Fig. 1.

The following modification should be carried out to prevent water entering the gearbox by way of the dipstick aperture, only when the gearbox has already been removed for some other reason and is to be refitted into the chassis. All replacement gearboxes will incorporate this modification.

FILE HORIZONTAL FLAT .400 DEEP  
TO RECEIVE EXCLUDER LIP.

File a horizontal flat approx. 0.4" deep on the outside of the dipstick housing sufficiently deep to receive the right angled drilled location lip of the water excluder (see Fig. 1).

Locally clean surfaces free from dirt and oil, and remove the dipstick. Liberally coat the bottom of the water excluder and the matching surface of the dipstick housing with Bostik adhesive. Position the excluder over the dipstick sleeve and using the location lip as a guide, drill a 0.062" diam. hole through the dipstick housing and guide sleeve for the hardened hammer drive screw (see Fig.1). Ensure that no swarf enters the gearbox while drilling. Ascertain that the excluder is firmly stuck in place and hammer the hardened screw into position to securely retain the excluder.

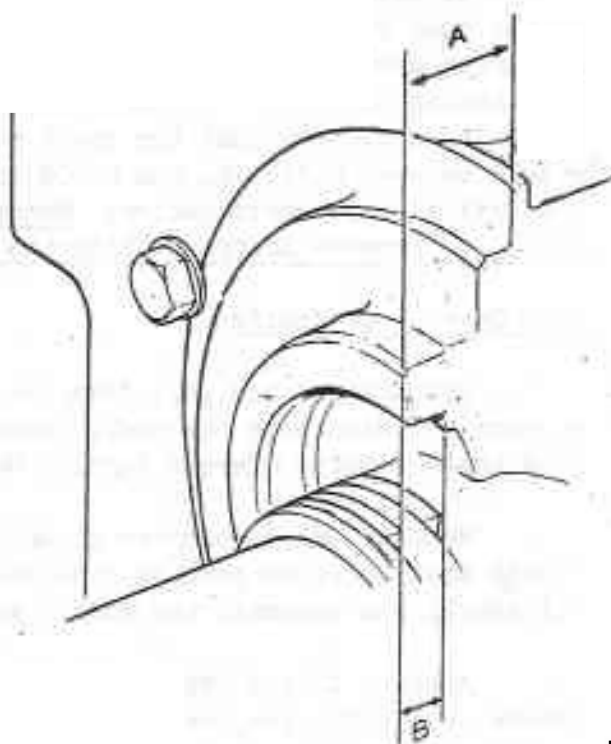
Fig.1. Pump Cover Checking Dimensions.

Using a depth gauge or vernier callipers, measure dimensions 'A' and 'B' given in Figure 1. Subtract dimension 'B' from dimension 'A'. A result which lies between 0.355 in. and 0.400 in. indicates that the cover is not of the modified type and that a washer must be fitted; a result between 0.415 in. and 0.450 in. indicates a modified pump, requiring no action.

Insert the washer UG.3941 into the recess with chamfered face leading, apply a little 'Wellseal' jointing compound to the outer wall of the recess, lubricate the new seal with transmission fluid and tap the seal into position with a hide mallet.

Machine the pump cover to increase the depth (Dimension B., Fig.1) of the seal location bore by .050 in. Thoroughly clean the cover to remove all swarf, and assemble the pump. Refit the unit to the gearbox.
