MODEL: BENTLEY MARK VI

## MODIFICATION.

### REAR BRAKE EQUALISER.

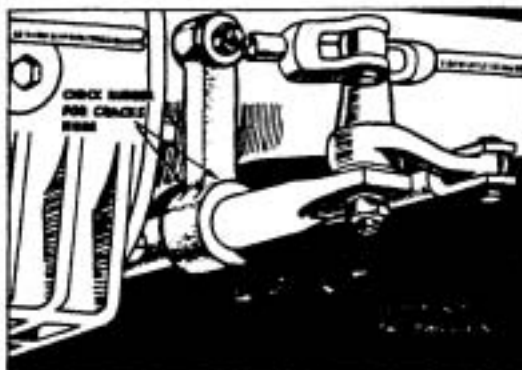
A certain number of cars were built with the rubber support of the rear brake equaliser fitted and positioned whilst in the chassis stage of production. When the body is mounted, the effect of its weight on the geometry of the rear suspension causes distortion of the support which may lead to fracture; repositioning of the support is therefore necessary in some cases.

1. Disconnect the rubber support from the axle tube and flex it backwards and forwards so as to examine for cracks in the neck at the junction with the main boss. If there are any signs of cracks, replace with a new support.
2. Check that the rear face of the main boss is 2.275 ins. from the centre of the rear brake equaliser bolt, and reposition if necessary.
3. Paint the letter 'E' on the rear face halfway down the rubber leg after examination and repositioning.

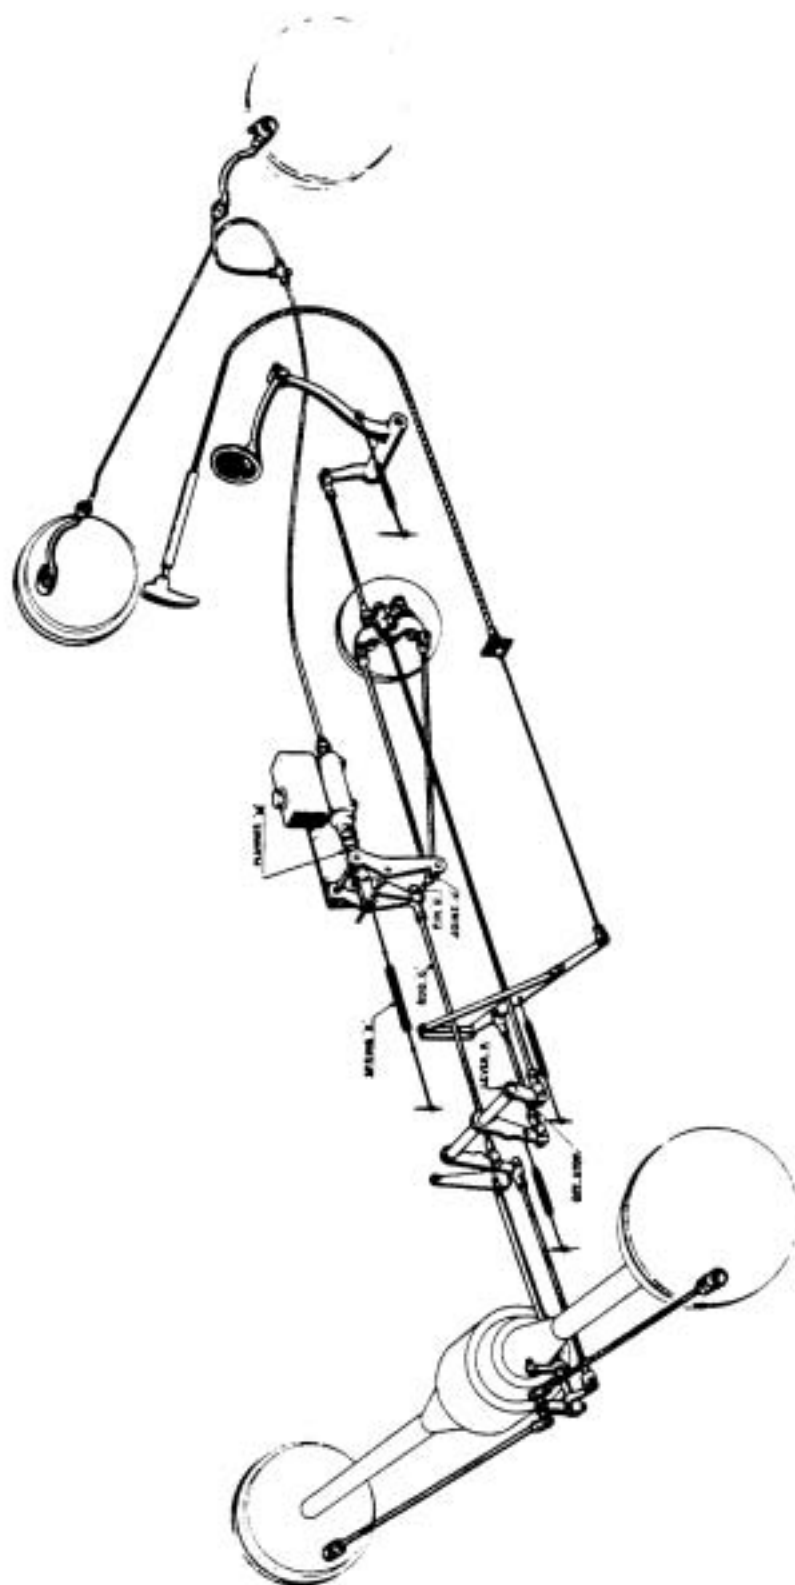
A modification is introduced to reduce a mechanical noise that can more accurately be described as a "clonk" from the brake linkage which may occur on application of the brakes.

In many cases, the origin of this noise has been traced to excessive free travel between the plunger and piston of the brake master cylinder, and adjustment of the brake linkage as described hereunder, has in certain instances effected a noticeable reduction of the noise.

1. Ensure that the rear brakes are in the OFF position and that the lever 'R' is against its OFF stop.
2. Remove the master cylinder pull-off spring 'X' and the clevis pin 'D'.
3. Adjust the rod 'C' so that the joint 'J' has zero to .050" free travel before the plunger 'M' contacts the master cylinder piston.
4. Tighten the locknut on the rod 'C'. Replace the clevis pin 'D' and the master cylinder pull-off spring 'X'.

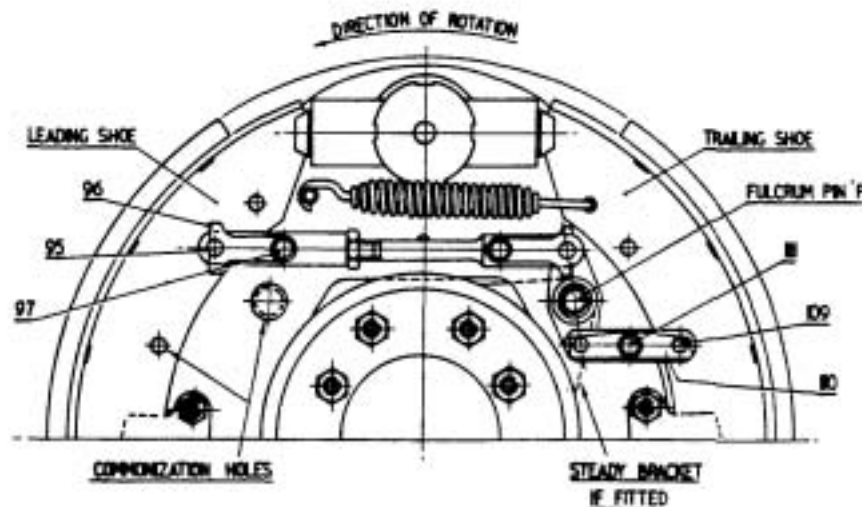
FIG. 1.

Instances have occurred in service with the Bentley Mark VI, where the front brakes have failed to release properly after application. This "Spragging" of the front brakes is due to an excessive self-servo action of the shoes, and manifests itself by a locking of the brakes even after the foot pedal has been released. In all such cases, the following modification should be carried out.

- (a) Remove setscrew and spring washer (111) and the locking plate (110) and by easing the load from the pull-off spring, withdraw pin (109).
- (b) Remove setscrew and spring washer (97) and locking plate (96) and withdraw pin (95).
- (c) Remove equal wear linkage from fulcrum pin (P) complete.

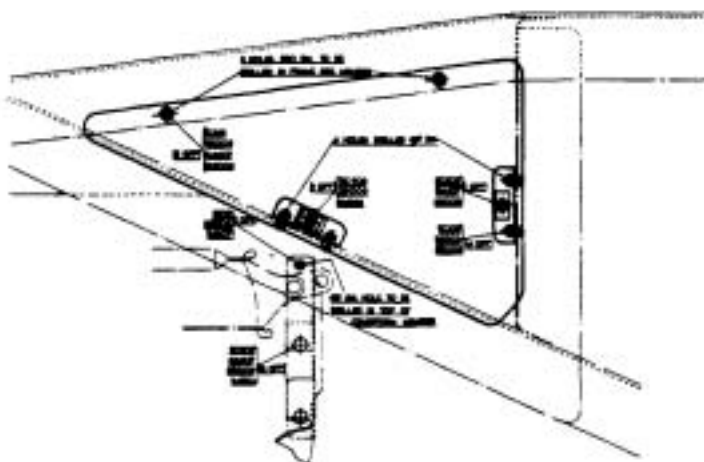
Current Bentley chassis in production are provided with protection against the possible loss in servo efficiency in wet weather, due to water finding its way on to the friction surfaces.

FIG. 1. FITTING OF UNDERSHIELD.

bolt holes in the lower flange of the frame side member, also for the two supporting brackets as shown in Fig.1. Drill the two 0.250" dia. bolt holes in the frame side member.

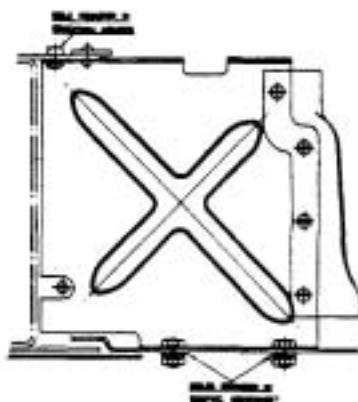
FIG. 2. BAFFLE PLATE.

## 8. Fit the rubber protection piece to the baffle plate as shown in Fig.2.

Both the rubber and the retaining strip should be fitted on the ENGINE side of the plate, with the nuts for the securing screws on the obverse face.

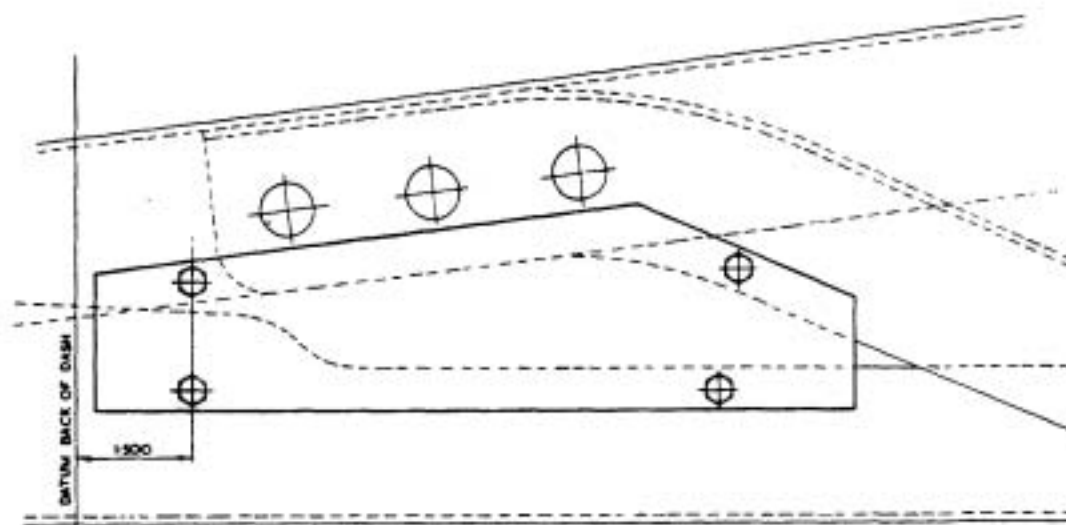
FIG. 1 FITTING OF UNDER-FRAME COVER PLATE.

1. Fit the under-frame cover plate (RP-6209) as shown in Fig. 1.
  - a) Offer up the plate, and mark off the relative positions for the four retaining setscrews.
  - b) Drill the four holes 0.1562" dia., and then tap 2 BA (31 T.P.I. R/H).
  - c) Fit the cover plate.

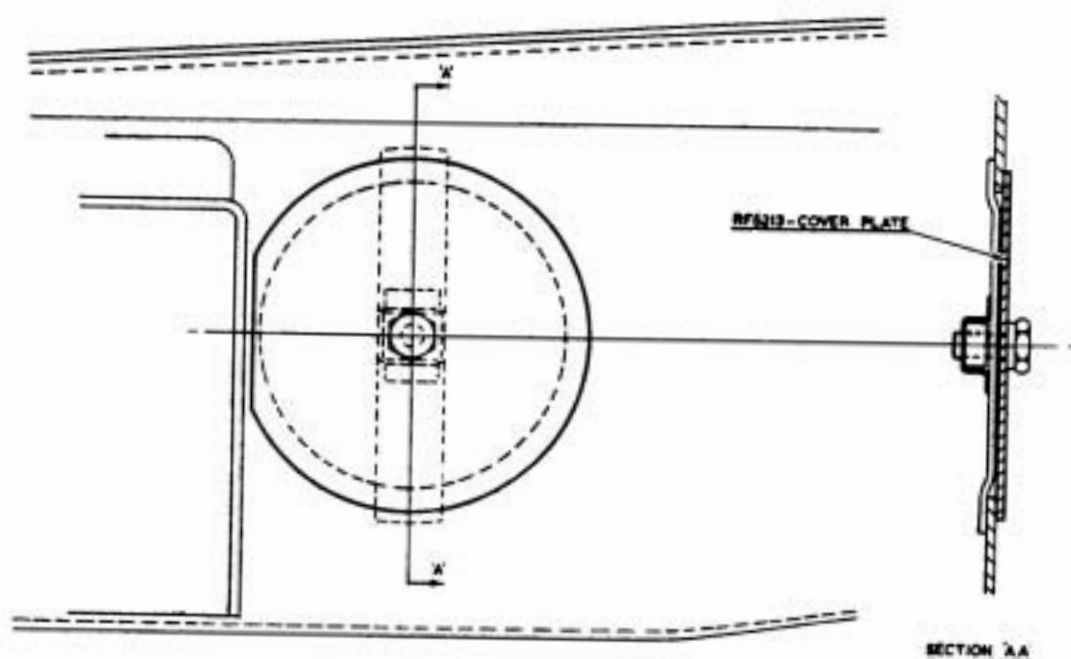
FIG. 2. METHOD OF FIXING COVER PLATE OVER HAND-HOLE.

2. Fit the hand-hole cover plate (RF-6213) as shown in Fig. 2.

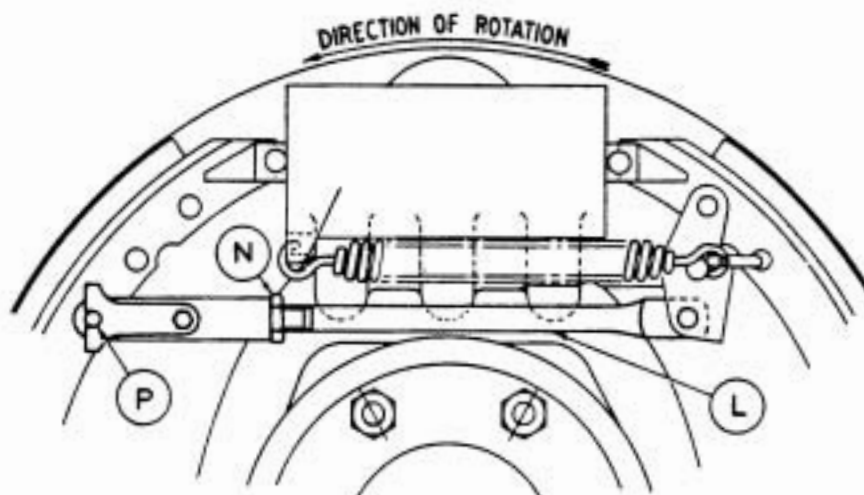
FIG. 1. DIAGRAM - SETTING INSTRUCTIONS - FRONT BRAKES.

- (i) Build up the brake complete, but do not fit the locking plate for pin P, Fig. 1, or lock the nut N. For an initial setting, the link L, should be adjusted to 7.375" (187.3 mm) between the pin centres.

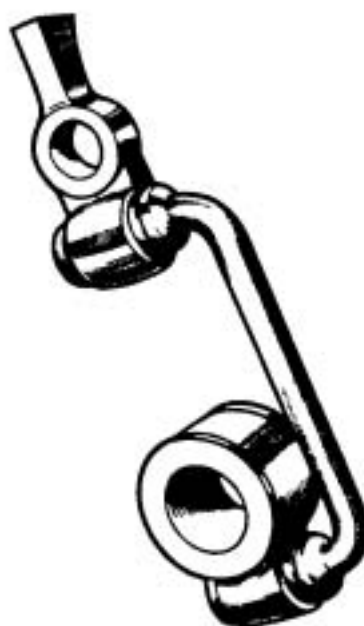
Instances have occurred where the rubber support (RG-3552) for the rear brake equaliser bar has fractured on existing Bentley Mark VI cars in service.

FIG. 1. MODIFIED TYPE SUPPORT

The modified type support assembly, illustrated in Fig.1 above, consists of a "U" shaped metal link, which is retained at either end by brackets in silentbloc bushes. The upper bracket has a radiused face to correspond with the outside of the rear axle tube, while the lower bracket carries another silentbloc bush through which the equaliser bar passes.

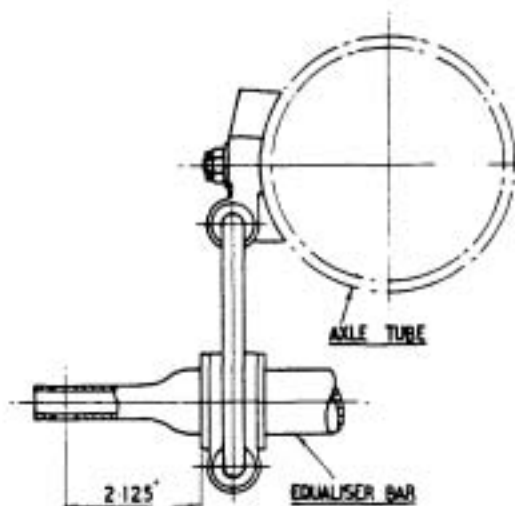
FIG. 2. FINAL POSITION FOR  
MODIFIED SUPPORT.

- (3) Thread on the new support assembly from the front end of the equaliser bar, and slide the assembly along the bar until the outer face of the silentbloc bush is exactly  $2\frac{1}{25}$ " distant from the centre of the bolt hole at the rear of the bar (See Fig. 2. above). Due to the interference between the rubber bush and the bar, it is recommended that some form of lubricant, e.g. French chalk or soap, is used to facilitate sliding the assembly along the bar.
  - (4) Fit the upper bracket to the existing stud on the axle tube, replace the existing plain washer (distance piece), and then secure by means of the thinner castellated nut provided, locking this by fitting a new  $1/16$ " split pin. Reconnect the equaliser bar.
- NOTE: - Constructional variations in the rear axle tube may result in

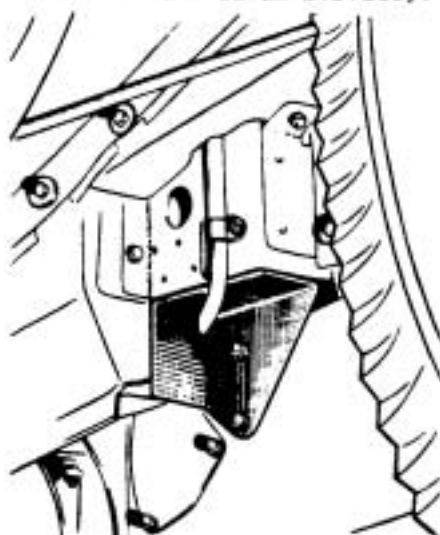
Investigations have shown that the deletion of the dashboard side mounting brackets (Service Bulletin BB-115) renders it possible in wet weather for water to reach the servo motor and gear change mechanism through the gap between the front of the body and frame member.

This protection consists of a flanged plate (Part No. RF-8881) which is fitted in the position originally occupied by the lower dash mounting bracket on the right-hand side of the chassis as shown in the above illustration. The existing bracket mounting holes in the frame are used for fixing the plate, and it should be noted that when this is finally fitted, there must be a clearance of approximately 0.187" between the top and rear flanges and the dash and body respectively. The two bolt holes drilled in the plate itself are of a slightly larger diameter than the retaining bolts supplied thus permitting a certain degree of adjustment when fitting the plate.

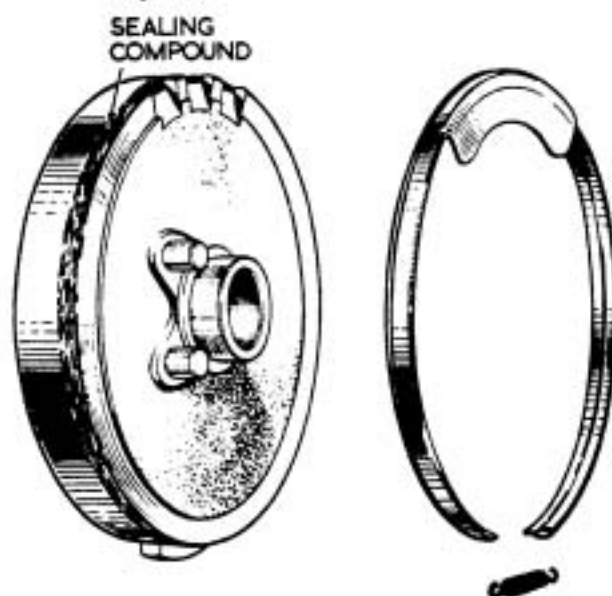
In order to prevent the possibility of oil seepage into the servo motor, the joint between the flange of the spring backing plate and the pressure plate is being coated with "Wellseal" on current production. "Wellseal" is a sealing compound with a rubber solution base which remains soft and pliable when dry.

Retailers are advised that, whenever a servo motor is removed for overhaul or other reason, it should be treated with "Wellseal" or an equivalent compound. After assembling the servo in the usual way, but before fitting the protector ring, the compound should be applied with a thin brush as shown in the illustration.

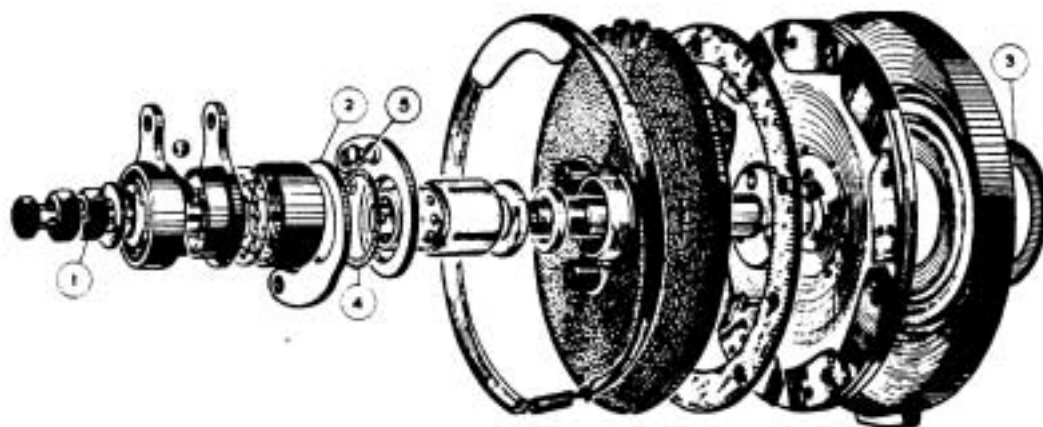
A corrugated washer, Part No. R.5037, has been developed to overcome cases of servo judder on brake application. The washer is fitted between the brake actuating levers in place of the plain washer GB.5083 and effectively damps the servo output to prevent minor fluctuations in the brake linkage from developing into judder.

FIG.1. EXPLODED VIEW OF SERVO MOTOR.

1. Adjusting Nut.
2. Brake Actuating Levers.
3. Ferodo Washer (To be replaced by R.5285 if necessary).
4. Plain Washer GB.5083 (To be replaced by R.5037).
5. Spring Clip (To be removed).

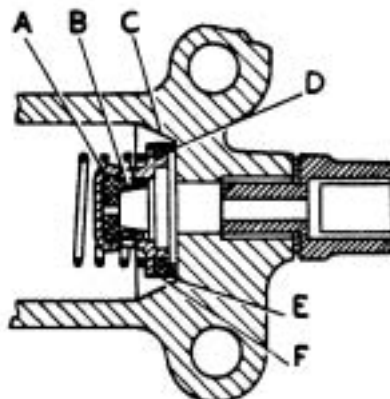
There have also been cases of ingress of air into the system due to non-sealing of the rubber valve washer 'F' Fig.2. against the face 'D' at the outlet end of the cylinder. The sealing lip 'A' Fig.1. of the rubber cups in the front brake expanders is normally held in firm contact against the bore of the expander by a residual hydraulic pressure of about 12-14 lbs. per sq. in. created by the spring loading of the return valve illustrated in Fig.2. Should this valve fail to maintain the hydraulic pressure, air may enter past the cups of the expanders owing to the comparatively low pressure exerted by the cups themselves against the bore.

Examination revealed that the primary cause of the valve washer 'F' not seating correctly, was due to the diameter of the face 'D' of the master cylinder being too small, causing the valve washer to make heavy contact with the rough un-machined tapered sides 'C' of the cylinder resulting in excessive wear and distortion of the valve washer.

Fig.2. Section-Return valve assy.  
master cylinder.

- (i) Fit a new rubber washer 'F' (RG-7043) and a rubber cup 'B' (CD-130) to the valve body 'A'. Place the coil spring on to the valve and enter into the cylinder and check that the valve assembly has a diametrical movement of approximately 0.020" (0.50 mm) to ensure that there is sufficient clearance between the outer diameter of the valve washer at point 'E' and the cylinder.
