**ELECTRICAL,
IGNITION AND RADIO**

CATEGORY 1 MODIFICATION.DYNAMO AND CURRENT VOLTAGE REGULATOR.

DYNAMO AND CURRENT VOLTAGE REGULATOR.

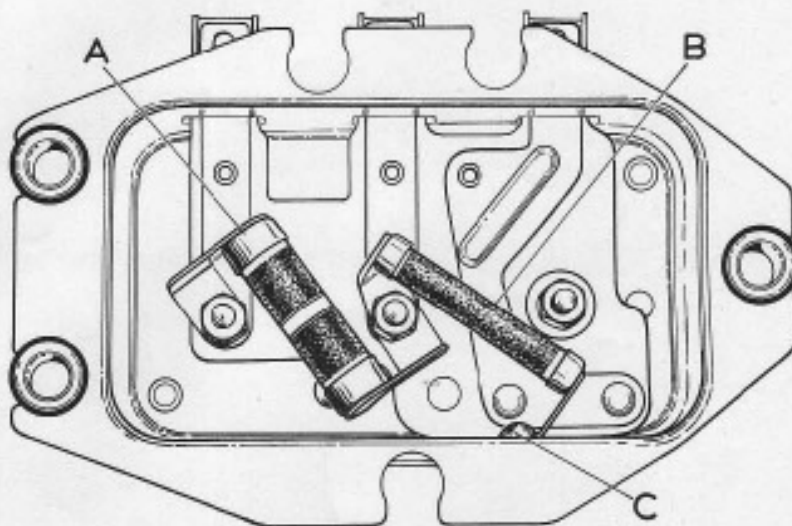
FIG. 1.

A further investigation has shown that considerable arcing of the regulator points takes place at certain engine speeds, and over a period of time, the regulator points surface becomes coated with an insulating layer of oxide, and the regulator ceases to function. This arcing at the regulator points, is also largely responsible for commutator blackening and brush burning.

To correct these conditions a further modification has been made to the regulator and to the dynamo. In the regulator the 150 Ohm resistor has been changed to a 63 Ohm resistor, an additional 40 Ohm "swamp" resistor has been fitted and the palette resistor deleted.

To modify a regulator stamped "M" to the "H" specification, the existing 150 Ohm resistor in the base is to be replaced with one of identical appearance but with a resistance of 63 Ohms. (A. Fig.1). Great care must obviously be taken not to confuse the two together. An additional "swamp" resistor (B. Fig.1) is to be fitted to the 2 BA terminal on the base of the centre coil assembly and soldered to earth

on the casing (C.Fig.1).

Regulators thus modified are to be marked with a yellow spot next to the letter "M" or, preferably, the letter "M" should be deleted and replaced with an "H".

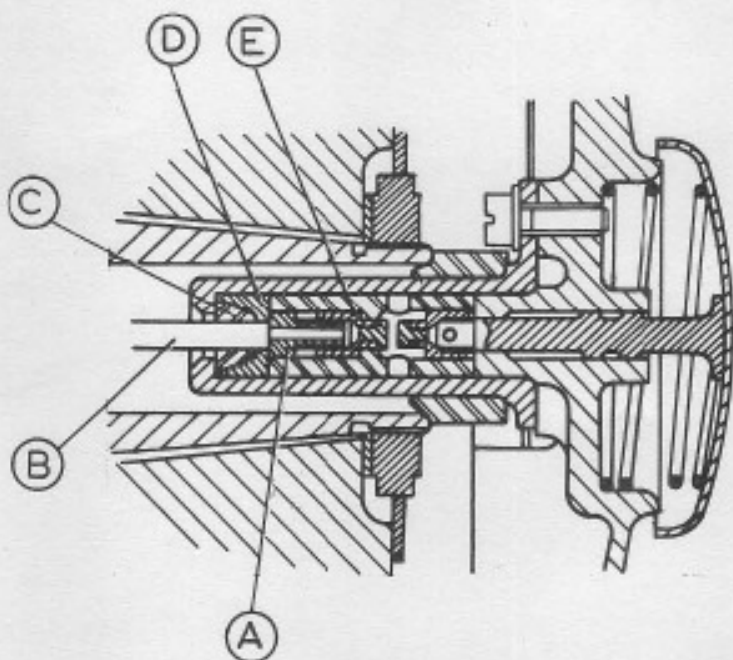
Horn Button and Horn Contact Assembly.

At the top of the steering column the horn cable terminal screw, into which the horn cable is soldered, moves with the steering wheel, whereas the horn cable tends to remain stationary; this action places a torsional load on the cable close to the terminal screw and may cause fatigue failure of the cable at that point.

To overcome this possibility the horn cable assembly is to be replaced with one having a cable more resistant to fatigue failure, and a horn cable bush (which fits next to the terminal screw), that will clamp the cable within the horn contact housing so that rotation of the steering wheel does not tend to twist the terminal screw relative to the cable but twists the whole cable.

Disconnect the cable from the snap connector at the base of the steering column and demount the horn button housing by removing the three retaining setscrews in the underside of the steering wheel boss. This will allow the horn button housing and the contact housing to be removed complete with cable. Remove the insulator bush and unscrew the horn cable contact point noting the number of turns taken to unscrew it, so that on re-assembly the horn contact can be screwed onto the new cable the same number of turns which will approximately give the correct horn contact gap.

Discard the existing horn cable assembly and fit the modified one, re-screwing the horn contact as mentioned previously.

Remount the whole assembly and check the horn button movement before the horn operates; this should be approximately .040" and is measured by placing feeler gauges under the rim of the horn button and noting the clearance between the under surface of the horn button and the horn button housing, then reducing the feeler gauge thickness to .040" and pressing the horn button; the horn should sound just as the feeler gauges are gripped.

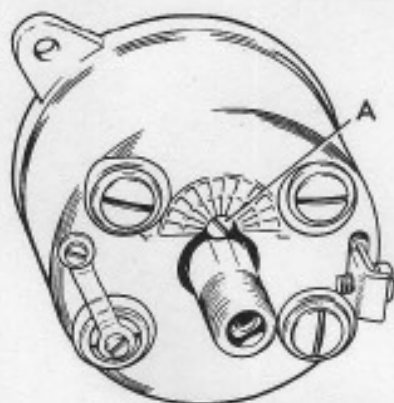
FIG.1.
A - REGULATING SCREW

Clocks have been returned to Rolls-Royce Ltd for the complaint of poor timekeeping which has not been substantiated when the clock has been correctly regulated on inspection.

The standard clock is regulated by turning the adjustment screw at the rear to the right to lose time and left to gain time (A Fig.1). The other clock is regulated by turning the screw (A Fig.2) so that the indicator dial moves in the correct direction (B Fig.2). Clockwise rotation of the adjusting screw rotates the indicator face towards the "S" thus slowing the clock, and vice versa.
