No. CB.72

DISCHARGED BATTERIES.

DYNAMO FAILURE.

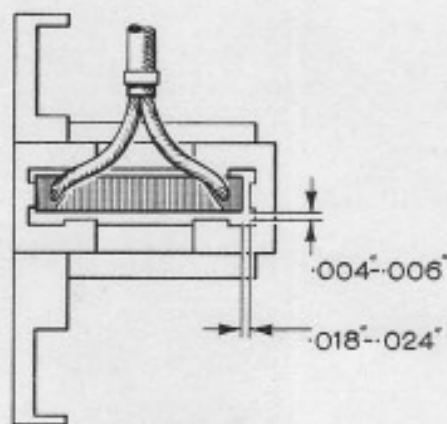
Fig.1. Die-cast brush
carrier
(pre- "Q" type)

Investigation into the causes of electrical failure of the dynamo, has shown that the majority of this trouble on equipment modified as detailed in Bulletin CB.4, is due to sticking of the brushes.

Slight tilting of the brush in its carrier is permitted by the spring, and in order to accommodate this, it has been found necessary to increase the brush end clearance to $.018" - .024"$ by reducing the brush width. The existing face clearance of $.004" - .006"$ was found to be satisfactory (See Fig.1).

This modification has been incorporated on replacement machines supplied recently, but where trouble is encountered with any dynamo up to and inclusive of type "M", the brush dimensions

should be reduced, with a smooth file as necessary to obtain the clearance shown. Renew the brushes and clean the commutator if necessary, as detailed in Bulletin CB.4. Should excessive burning have occurred, a replacement dynamo must be fitted. Messrs. J. Lucas Ltd., are issuing instructions to their agents abroad, in order that this modification may be incorporated overseas.

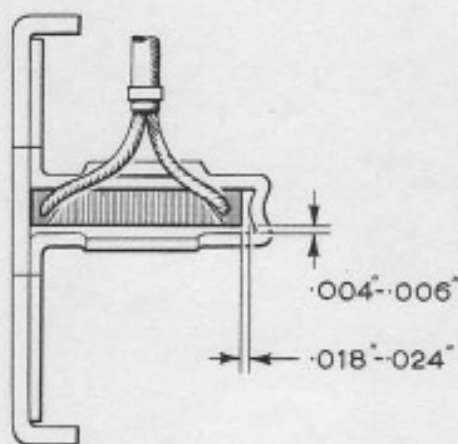
Fig.2. Pressed strip
brush carrier
(Type "Q")

Some machines identified as type "Q" have been fitted. These incorporate pressed brass strip brush carriers in lieu of the standard die-cast boxes (see Fig.2). On these machines the brush end clearance was not increased above the existing value of .006" - .008" because of the danger of pronounced brush noise, with this type of carrier. It has now been found that increasing the end clearance to .018" - .024" does not increase the noise to an objectionable level, and these machines are being produced with the clearance amended accordingly.

In service, complaints of failure should be dealt with in similar manner to that detailed for the die-cast brush carrier machines.

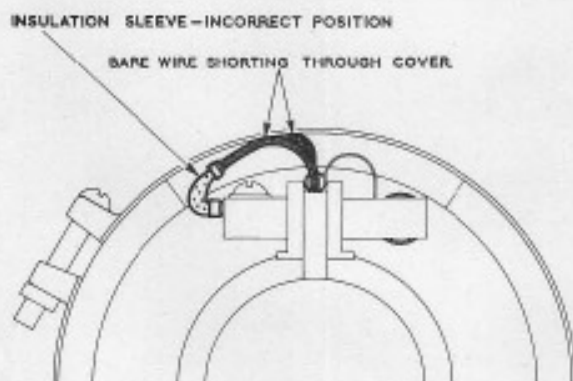
Fig. 1.

Dynamo charging failure has sometimes been caused by a short circuit between the brush flexible leads and the band cover. This will only occur if the insulation sleeves have been pulled back from their normal position, exposing the bare wires (see Fig. 1.). Rectify by stretching sleeves into their original position (see Fig.2).

If the band or brushes are removed for any reason, ensure that the insulation sleeves fully cover the brush leads and are in the correct position before finally assembling.
