CHASSIS FRAME

CATEGORY 3A MODIFICATION.

WELDED FRAME STIFFENERS.

FUEL TANK MOUNTING STRAP INTERMEDIATE BRACKET.

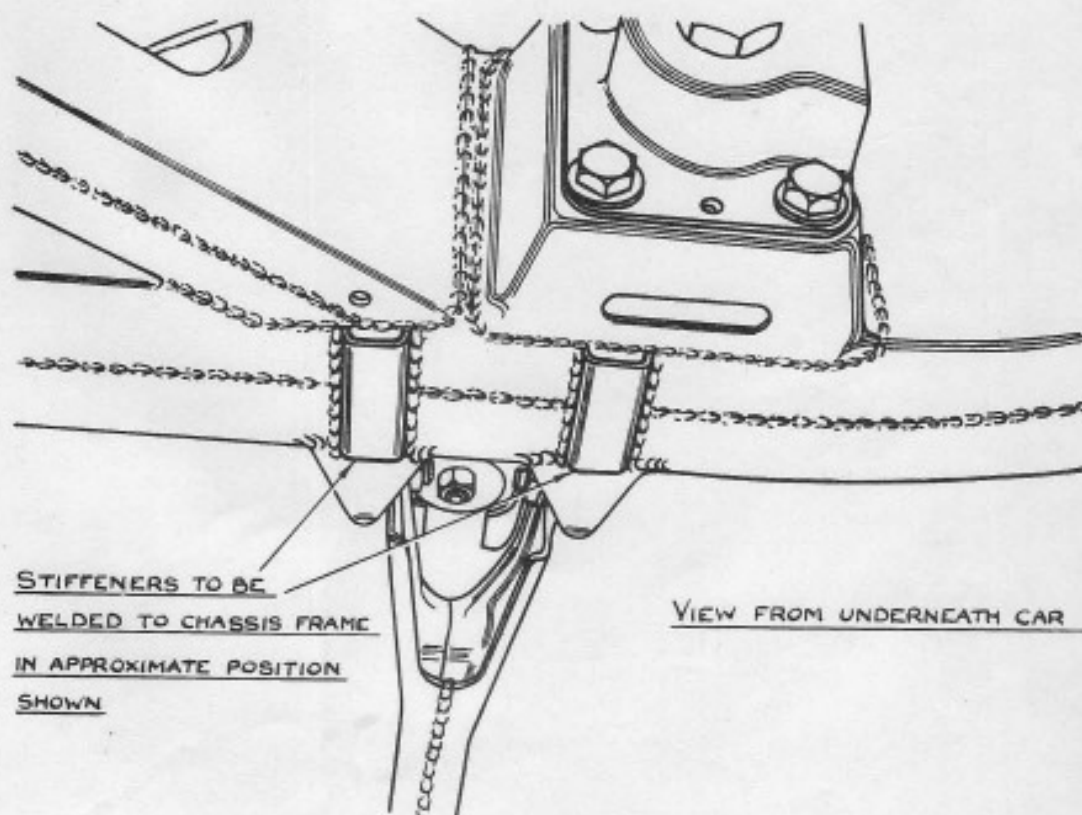
On certain cars it may be found that when raising the car with the car jack provided, the jacking spigot "springs" relative to the frame, and it may even be possible in extreme cases for this to damage the frame.

In the unlikely event of damage to the frame, which will be evident in the form of a split in the welding along the underside of the frame, the frame is to be welded electrically. It is neither desirable nor practicable for these components to be gas welded.

To prevent any "springing" at the jacking point and to overcome any possibility of damage to the frame, stiffening pieces are to be electrically welded to the underside of the frame adjacent to the jacking points as illustrated.

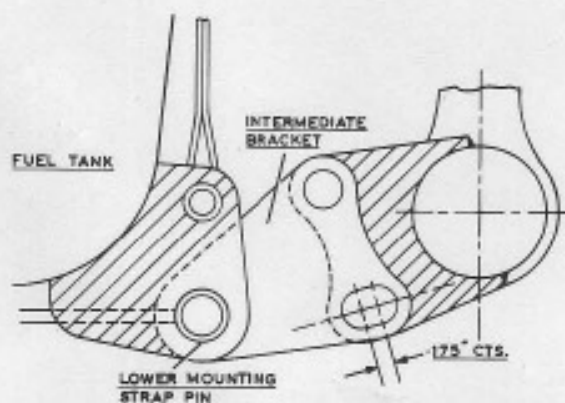
MODIFICATION TO THE FUEL TANK MOUNTING STRAP
INTERMEDIATE BRACKET.

It may be necessary on certain cars to lower the rear of the fuel tank so that the wiring loom fitted to the undersurface of the boot floor cannot be chafed between the top of the fuel tank and the undersurface of the boot floor.

Support the fuel tank in such a manner that it cannot be damaged by its own weight and so that the load is removed from the mounting straps. Disconnect the mounting straps by removing the two lower-most strap pins, one each side, and withdrawing the lower straps from the strap pins by removing the two adjusting nuts. Remove the intermediate bracket securing nuts and bolts and elongate the lower bolt holes as indicated.

Replace the brackets and strap pins leaving the intermediate bracket fixing bolts loose until the fuel tank mounting shoes have been positioned to allow the tank to assume the correct clearance from the undersurface of the boot floor. Inspect to ensure that the fuel tank does not foul elsewhere. It will be necessary to relieve the fuel tank support to facilitate this operation, but leaving it close in position for safety.
