MODEL BENTLEY MARK VI

STONE GUARDS ON REAR WINGS AND SILL.

Bulletin

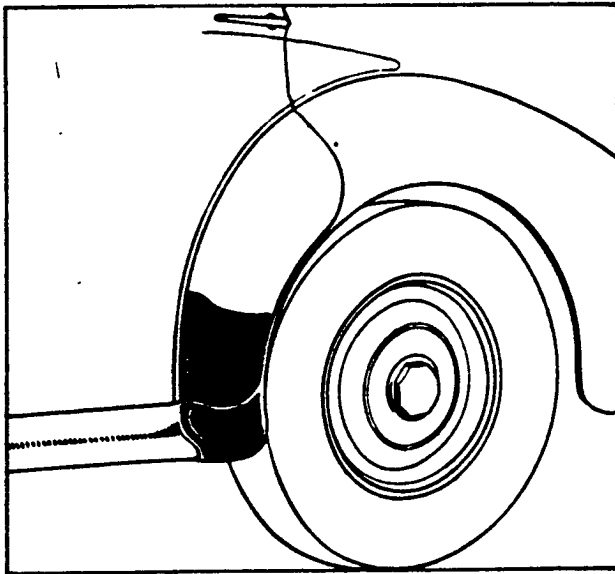
STONE GUARD IN POSITION.

To fit the stone guards, first, accurately align the front edge, and with the guard pressed tightly to the wing, mark out the outline. Remove the guard, and thoroughly clean and degrease the paint using a reliable agent, trichlorethylene being the most satisfactory. Brush on a thin even coat of Bostik Company's Primer 81-15 and allow this to dry for $1\frac{1}{2}$ hours, taking precautions to keep it free from dust. Rice paper if available, will not permanently adhere and is an excellent cover.

When applying the rubber to the metal after the requisite drying period, tack the front top corner in position, gently align the front edge, and when sure of the position, firmly press it home. Then work from front to rear with a roller keeping the top edge in line with the marking out, and squeezing out any wrinkles and air bubbles. The

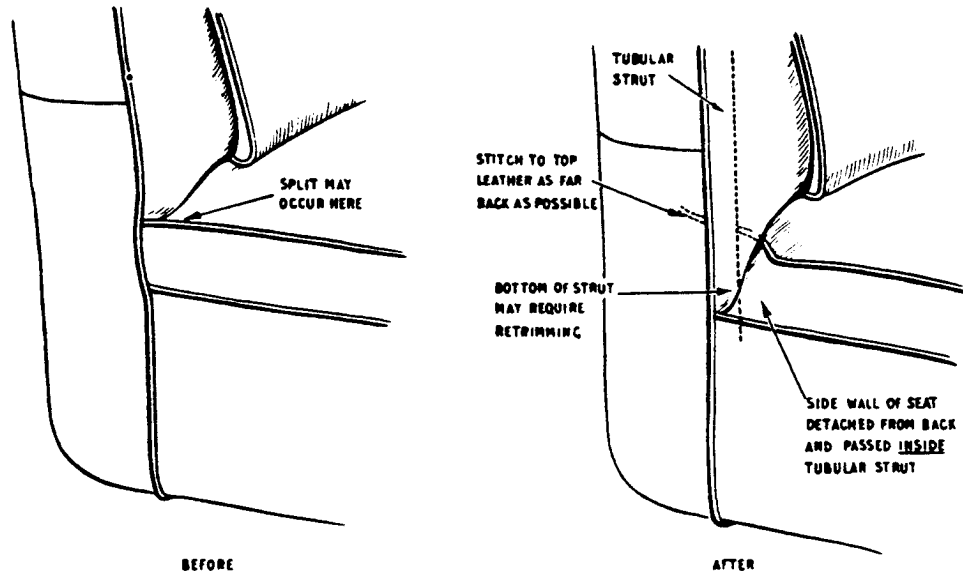
An alteration has therefore been made as shown in the drawing herewith. It will be seen that the side wall is now detached from the back and is passed inside the tubular strut. This alteration can be applied to existing seats in the event of any complaint of splitting.

1. Remove seat back millboard with carpet and hide.
2. Take side wall of seat cover inside the tubular strut and "french" securely to the top of the cover and piping. (This will allow the side wall to flex with the seat cover instead of being constrained by the tubular strut.
3. It may be found necessary to cut a small portion of surplus hide from the rear of the cushion cover to enable you to cover a portion of bare tube which may be left exposed. This is only a matter of an inch or so of hide and may not be necessary in all cases.
4. Replace the millboard seat back together with the carpet, using the same seat back hide which is also refrenched round the top edge of the seat back.

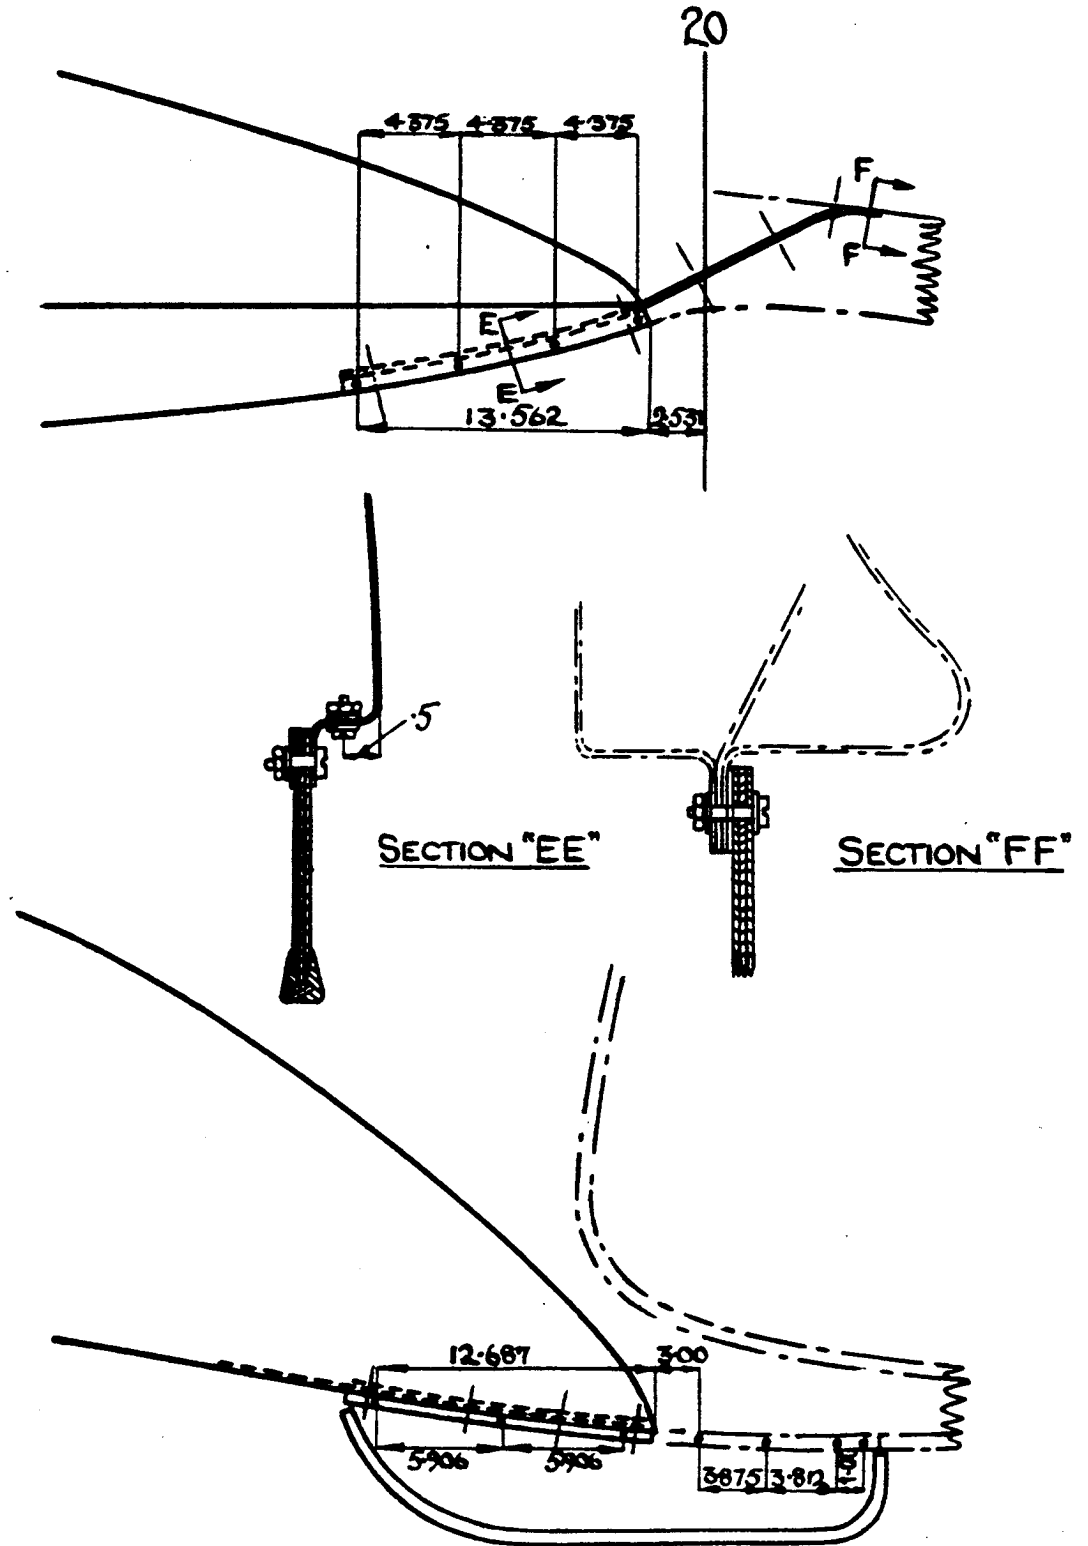
The mud flaps are fitted to the rear underside of the front wings, the method of attachment being by angle plates and 2-BA bolts and nuts, the positioning of these may be noted from the attached drawing.

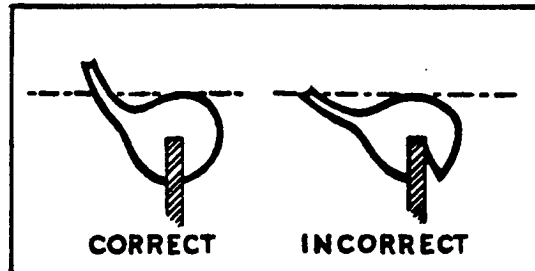
Section through rubber seal, showing correct methods of sticking seal in position.

- (v) Examination of the underside of the lip of the ventilator will show that there are depressions at each corner caused by the cut-away of the sheet metal before turning over the lip. These depressions prevent a good seal being made with the rubber, so it will be necessary to fill them in with paint fillers in order to make the surface smooth and flat.
- (vi) When refitting the ventilator, great care should be taken to ensure that it is accurately positioned in relation to the rubber seal before the four screws which secure it to the hinge are tightened. These screws pass through clearance holes which allow a limited amount of adjustment to the position of the ventilator, thus enabling an even pressure on the rubber seal to be obtained in the closed position.

Also, before allowing the adhesive to set, make sure that the rubber is so positioned that it will contact the lip of the ventilator all the way round. This can easily be checked by placing the ventilator in position and then trying to rock it.

It is recommended that a test is carried out by pouring water over the ventilator in order to check that an effective seal has been obtained.

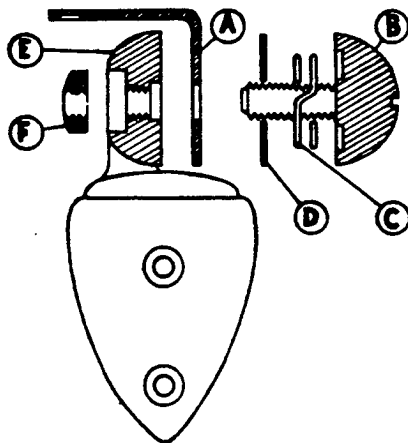
This Bulletin is issued for guidance in adjusting sun vizor hinges which are either too tight to operate or have worked loose.

1. With the lock nut (F) loose, screw in B as far as it will go. This should completely lock the assembly.
2. To obtain the correct amount of friction, unscrew B slightly, the precise amount can be determined by testing the movement of the vizor, but it will be approximately $\frac{1}{4}$ turn. Tighten the lock nut with a forked screwdriver as tightly as possible.
3. Increase the locking action by further unscrewing B very slightly, at the same time turning the lock nut with it. The friction of the bolt and nut thread is thus used to help the lock nut to tighten up an extra fraction of a turn against E.

The brass washer D may not always be found on early chassis Nos. and if this is the case, a similar washer should be fitted about .025" thick. This prevents the end of the Thackery washer C from biting into the bracket.

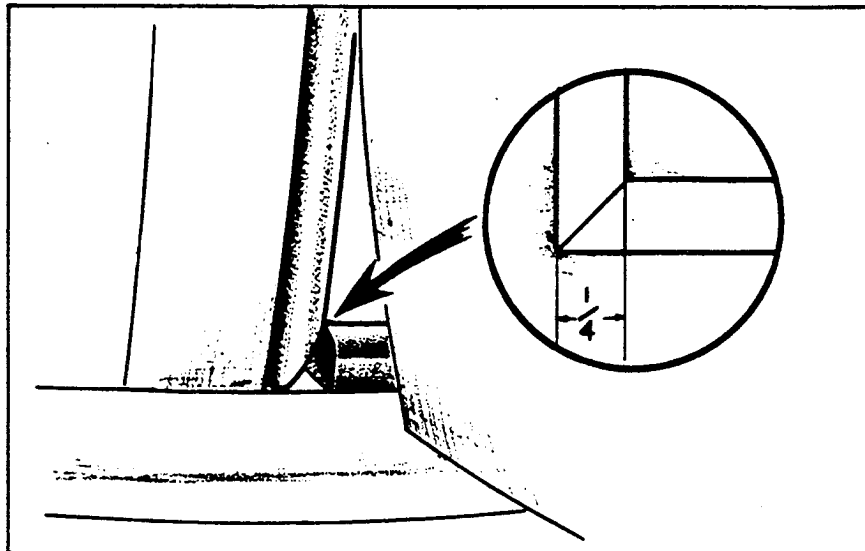
In order to compensate for this tendency to spread, and at the same time provide adequate means for drainage during wet weather, all current Standard Saloons in production have the bottom sealing rubber along the outer edges of the sills "cut back", leaving a gap of approximately $\frac{1}{4}$ " at the point of juncture with the vertical sealing strip at the foot of the centre door pillars as shown in the attached sketch.

Retailers are advised, therefore, when dealing with complaints of such a nature from owners of earlier models of Standard Saloons, to cut the existing lower door seals to conform with the current procedure.

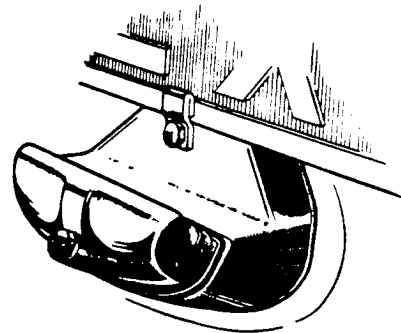
MODIFIED ASSEMBLY.

This modified support bracket differs from the standard fitting by having a built-up boss, the outer face of which is set at an angle of 28° relative to the bracket itself. The lamp is fixed to this inclined face, thus ensuring that the number plate is directly lit.

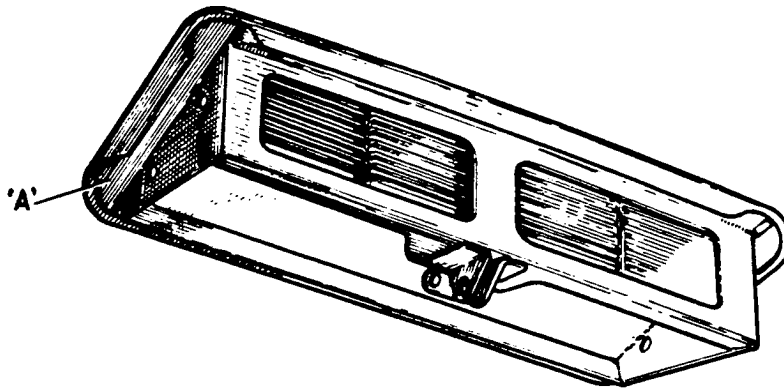
Fig. 1.

Note: If upon examination of the sealing surface of the underside of the lid it is found there is a depression at each of the four corners, ('A' Fig.1), caused by the clinched-over flange, then opportunity should be taken to fill them in as described below, in order to make the surface smooth and flat, thus making a better water seal.

In the event of a complaint from a customer of insufficient ventilation through the top scuttle ventilator, a modification has been introduced as described below for improving the air flow, by removing the existing two grilles from the scuttle ventilator lid and fitting a nickel plated wire mesh screen. (Part No. RB.5266 - obtainable from the London Service Station.)

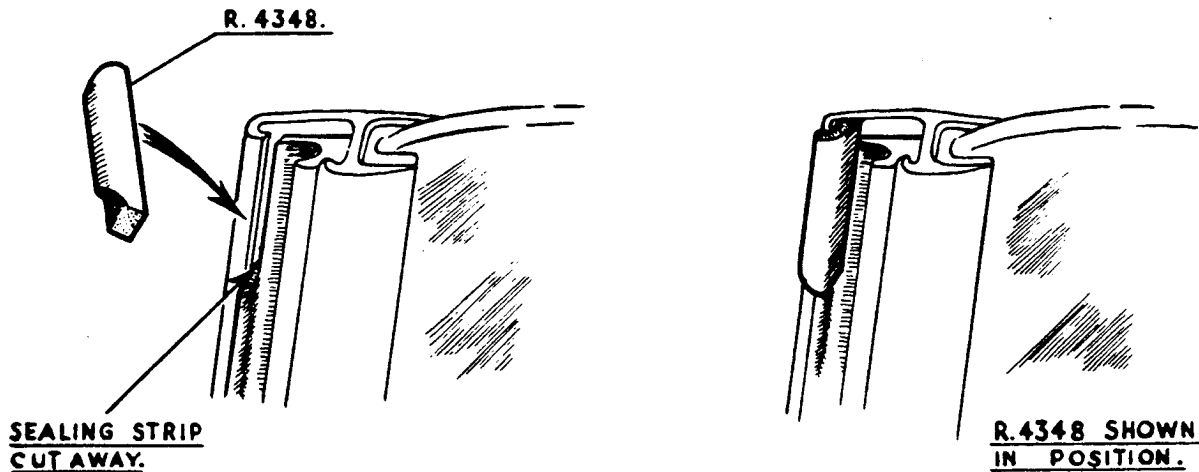
Cases have occurred in service where vibration has caused the front windows on early type Bentley Standard Saloons to rattle when these are in the half open position.

This will involve the cutting away of approximately 1.00" of the existing seal to accommodate the rubber buffer at the topmost corner of the window frame as shown in the sketch below.

As a means of obviating this a special rubber buffer strip (Part No. R-4343) has been introduced, and Retailers are recommended to incorporate this whenever dealing with complaints of this nature.

A suitable sealing compound for retaining this buffer strip in position is Bostik No. 252.

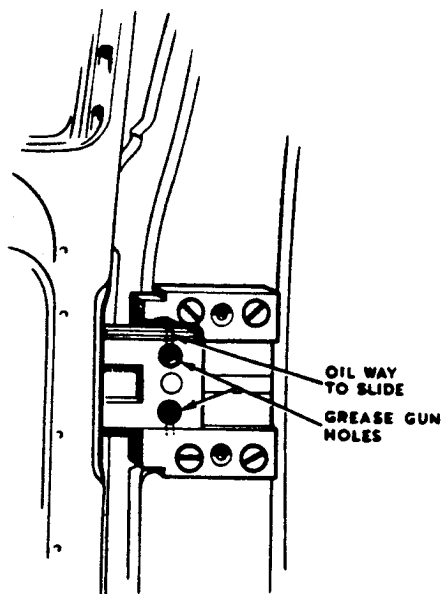
It is realised that the effective lubrication of the top slide, where roughness occurs due to the tilting action of the hinges under the weight of the door, presents some difficulty, as the lubricant is likely to be scraped off by the sliding action of the moving parts.

It has therefore been decided that on the original build up of the car at the Factory, that the door hinges are to be lubricated with a graphited grease, namely D.A.G. graphite grease "G.A", and Retailers are recommended that if a door is being overhauled in service, that they should also carry out similar action.

A modification is to be introduced by the drilling of two suitable holes in the slide piece for the insertion of the grease gun, (see illustration) and it will be recommended in the Owner's Handbook that this part is periodically serviced, every 10,000 miles by the Owner, using Mobilgrease No. 2 as the grease gun in the car tool kit is already charged with this grease.

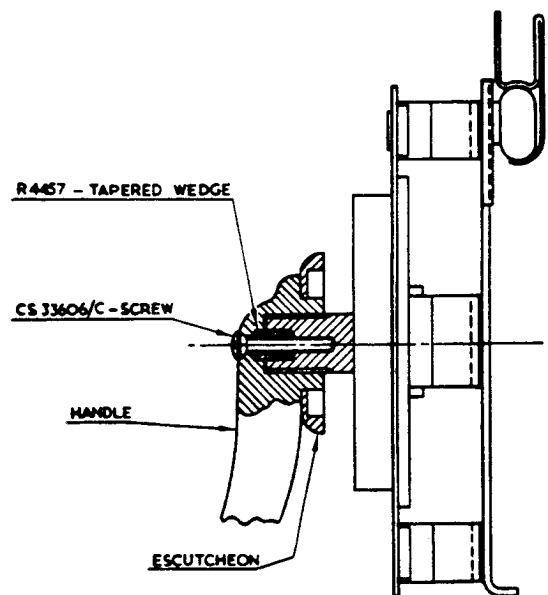
FIG. 1.

A few instances have been reported where the quick-lift window regulator handle has worked loose during service on existing models of Bentley Mark VI Standard Saloon.

Fig. 1 illustrates the general arrangement of the regulator assembly with the plug in position.

As a means of overcoming this, a tapered plug (Part No.R-4457) has been introduced for fitting into the end of the existing splined shaft of the window regulator, and Retailers are recommended to incorporate this whenever dealing with complaints of this nature.
