**Bulletin**

MODEL BENTLEY MARK VI

EXCESSIVE LEAKAGE OF OIL AT THE CENTRE STEERINGLEVER AND STUB AXLES(CENTRALISED CHASSIS LUBRICATION SYSTEM).FOR INFORMATION:

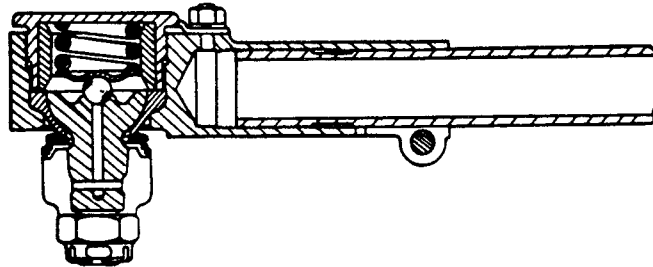
Fig. 1. Section through ball joint at front end of side steering tube.

When the pedal of the chassis oil pump is operated, a relatively large quantity of air is trapped in the three ball joints connected to the centre steering lever and compressed. During the next few hours, the trapped air expands, pushing the oil along until it escapes past the fulcrum pin bearings of the centre steering lever pivot assembly and the bearings of the stub axles.

The cure lies in packing the four joints of the cross steering tubes and the ball joint at the front end of the side steering tube with a soft type of grease such as Duckham's HBB grease in order to displace the air.

- (i ) Remove the front right-hand undershield. Jack up front wheels and turn wheels to full right-hand lock.
- (ii ) Remove split pin and nut from ball pin.
- (iii) Place a substantial steady block in contact with the lever near the ball pin to be removed, in order to provide a solid re-action point, and then with the aid of a large steel drift and hammer, give the eye of the lever (adjacent to the ball pin) one or more sharp blows which will release the tapered shank of the pin from its location in the lever. NOTE: The above method applies to all the ball joints to be removed.
- (iv ) Collect the pressure spring and the sealing disc.
- (v ) Remove the cap nut of the joint (see Fig.1) and completely pack the joint with grease.

- (vi) Before refitting the ball joint (ball pin) to the lever, clean the tapered shank of the pin and corresponding hole. With the sealing disc and pressure spring in position on the pin and the correct way round (See Fig. 1), refit the ball pin to the lever, fully tighten up the nut and secure with a new split pin of the correct size.

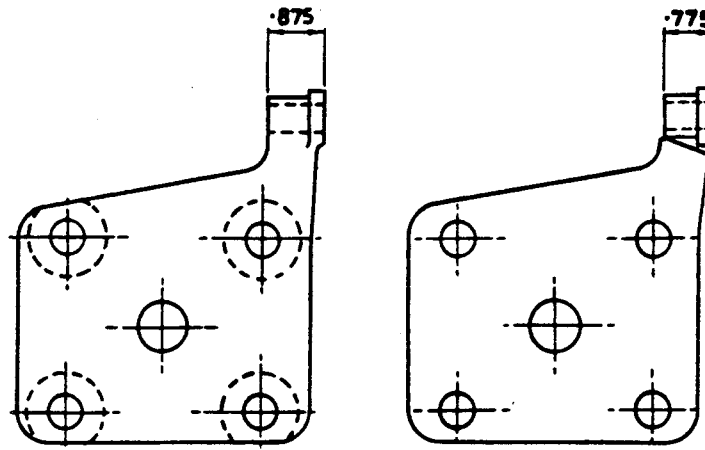
The new plate (Fig.1) is similar in general shape to the earlier designs, but no machining has been carried out on either face beyond the spot facing on the underside of the 'U' bolt holes. Owing to this, left-hand and right-hand plates are now required as follows:-

An intermediate type of modified spring plate, RF-8101 (Fig.2) was used for a short period prior to the introduction of the latest design, but this has proved unsatisfactory in service. In view of this, it has been decided to request Retailers to modify all cars in their areas fitted with this intermediate type plate on a Category 1 basis.

It should be noted, that due to the increased width of the boss on the new type plate (0.875" as against 0.775" on the earlier design) new anchorage pins for the lower shock damper linkage will also be required when these new plates are fitted. These pins are supplied separately, and should be assembled in their respective plates prior to these being fitted to the car.

Proceed as follows:- Insert the pin from the shouldered face of the boss, shorter end first, push fully home, and then fit and fully tighten up the lock nut. **Peen** over to lock.

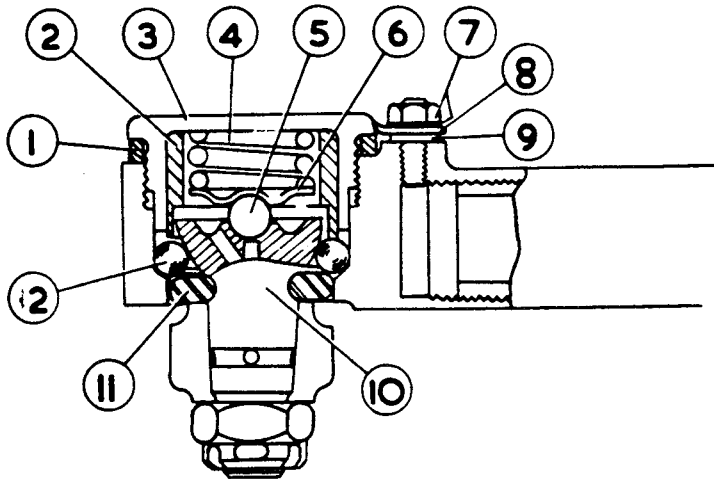
FIG.2. SECTION-SOCKET-SIDE STEERING TUBE FRONT END (PRIOR TO MODIFICATION.)

Commencing at Chassis No.B-215-PU steel balls (12 Fig.2) were incorporated in place of the previous bronze seat (2 Fig.3) in the front end socket of the side steering tube to reduce steering friction.

Owing to the steel balls grooving and causing hard steering, these have been discarded and reversion has been made to the original bronze seat as from Chassis No.B-390-TN and onwards on right-hand and left-hand drive cars.

NOTE: When it is found that the ball end pin (10 Fig.2) of the front socket has been grooved or pitted by the steel balls, a new pin FW-1000 (included in the list of parts on Page 1) should be fitted.

- (i) Remove the rubber seal (11 Fig.2) from the groove in the ball pin.
- (ii) Remove the nut and spring washer, (7), the locking plate (8), the plain washer (9), and with a 'C' spanner, remove the cap nut (3).
- (iii) Remove the joint ring (1) from the cap nut, the sleeve (2), the spring (4), the spring pad (6), the ball (5), the ball pin (10), and finally the steel balls (12). Items 1, 2, 9, 11 and 12, should be discarded. The sleeve (2) is replaced by the sleeve RF-3561. Clean the remaining dismantled parts.
- (iv) Re-assemble the ball joint, using the new parts as illustrated in Fig.3, and refit to the centre steering lever.
