**Bulletin**

MODEL BENTLEY MARK VI

CLUTCH PEDAL.

CLUTCH SLIP.For Information:

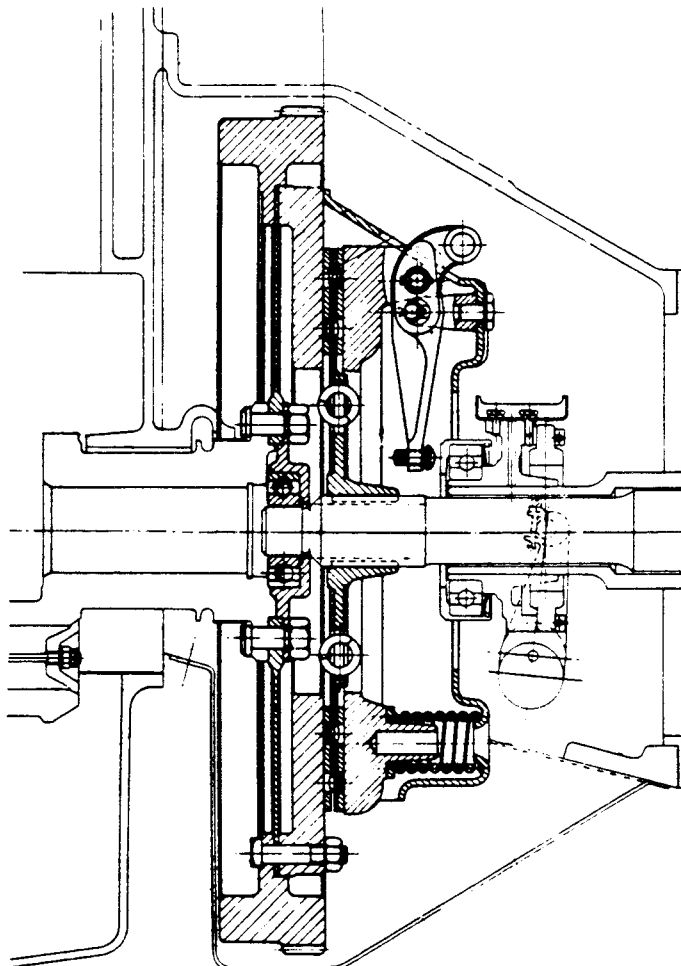
Fig.1. Section through flywheel and clutch.

With the clutch pedal lever against its up-stop under the pedal gap plate, place the edge of a rule against the centre of the side of the pedal and the end of it against the dash, depress the pedal by hand until the clutch release bearing just touches the three release levers of the clutch. Measure the free travel which should be  $1\frac{1}{2}$ " (38 m/m). A turnbuckle adjuster with a central spanning point is provided. Insufficient free travel of the clutch pedal can be one of the causes of clutch slip. If clutch slip is experienced at high engine R.P.M., it indicates that there is insufficient pedal clearance.

Before resorting to any dismantling for slip, the free travel of the clutch pedal should be measured and adjusted if necessary as follows:-

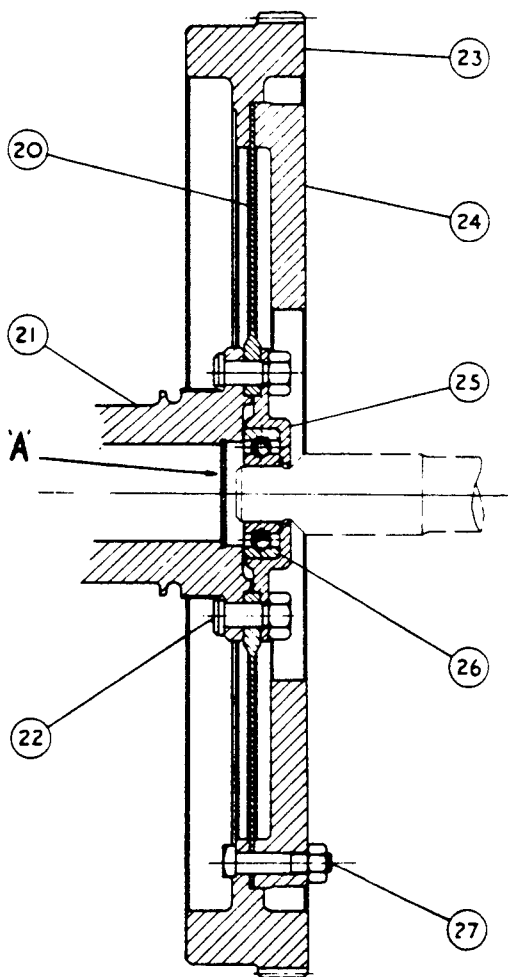
Fig.2. Section through flywheel.

1. Oil leakage past the sealing washer 'A' Fig.2 at the rear end of the crankshaft.
2. Excessive initial loading of grease into the clutch spigot ball bearing (26 Fig.2) of the flywheel, distinguished by radial grease marks on the friction plate (24).
3. Over zealous application of the foot-operated chassis oil pump or a faulty oil restrictor (Type ZEO), allowing too much oil to reach the clutch release bearing (32 Fig.5) eventually working its way along the splines on to the driven plate.

It has been found on investigation, that under certain conditions there is a possibility of an oil leakage past the sealing washer ('A' Fig.2) at the rear end of the crankshaft. If the leakage is sufficient, oil may reach the front facing of the driven plate. In practice, it is likely that the first indication will be a clutch shudder and then a slipping clutch. If after removal of the clutch, oil, apart from grease, is found to be present in the spigot bearing (26 Fig.2), it can be assumed that it is leaking past the sealing washer.

If too much grease has been packed into the clutch spigot ball bearings (26 Fig.2) in the flywheel, then it may eventually find its way on to the friction plate (24) of the flywheel with consequent contamination of the front facing of the driven plate. Remove all traces of grease, oil or foreign matter from the flywheel, friction plate and clutch casing. There should not be a repetition of this trouble, as any excess of grease in the spigot bearing will have found its way out. There is no need to remove the spigot bearing for cleaning purposes.

Whenever there is evidence of oil leakage past the sealing washer, a rubber plug should be fitted as described herein. If however, a rubber plug is not immediately available, then it will be necessary to solder the sealing washer ('A' Fig.2) to the crankshaft as described in Paragraph 1b.

With the clutch removed from the flywheel, remove the crankcase lower half. Remove the nuts from the twelve bolts (22 Fig.2). Providing the nuts have not been over centre punched, it should be possible to use them again. Leaving the flywheel assembly in position on the crankshaft, remove the bearing housing (25) complete with the spigot bearing (26). Remove any surplus oil or grease from the spigot bearing and housing and do not add any additional oil or grease.

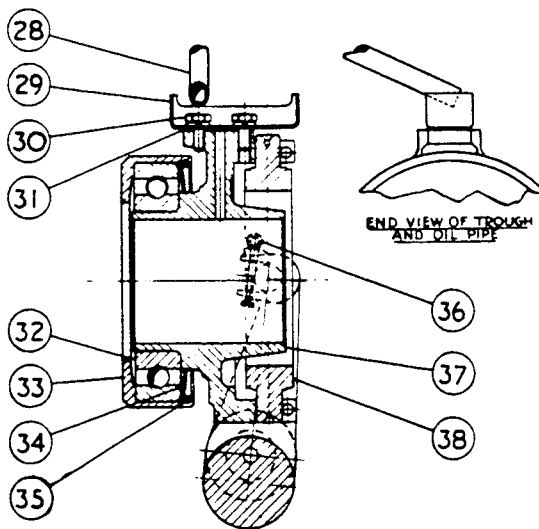
Fig.5. Section through clutch release bearing and trunnion.

The above will probably allow too much oil to reach the clutch release bearing (32 Fig.5) and eventually find its way on the rear facing of the driven plate assembly. The chassis oil pump should only be operated in accordance with the instructions given in the Owners Handbook i.e. "Depress

If the clutch has been removed for the purpose of fitting a new driven plate assembly, then prior to refitting the gearbox to the clutch casing, ascertain that the oil feed pipe (28 Fig.5) to the oil trough of the clutch trunnion is correctly positioned above the trough. The end of the pipe should be approximately over the front setscrew (i.e. the one nearer to the flywheel) retaining the trough to the trunnion when the clutch release bearing housing (33) is in contact with the adjusting screws of the three clutch release levers. Check that the oil feed hole from trough to the trunnion is clear. With sufficient oil in the foot-operated oil pump, depress the pedal once and count the number of oil drops delivered to the trough of the trunnion.

Approximately three to five drops should be delivered with each application of the pedal. If either above or below this rate of flow, check the restrictor elbow situated on the right-hand top side of the clutch casing, by replacing with a new one of the same type (ZE0).

If the flow is still too great, then fit a type ZE00 elbow which will give a reduced rate of flow, conversely if there is still insufficient oil delivered, then check for a leakage or pipe breakage at some other point in the centralised chassis lubrication system.

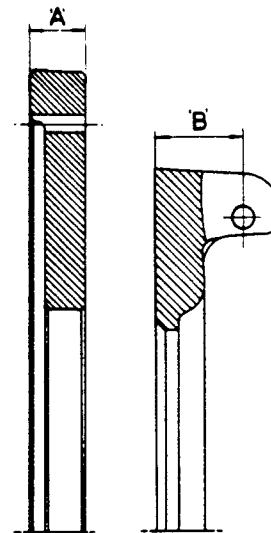
FIG.1 FLYWHEEL AND PRESSURE PLATE - ORIGINAL DIMENSIONS.

It is permissible to regrind the surface of both the flywheel friction plate and the clutch pressure plate should they show signs of scoring. Only the minimum amount of metal necessary to provide a clean, smooth surface should be removed. Grinding limits and original dimensions are given in Fig.1.

A flywheel friction plate that shows any sign of small, hair-line, contraction cracks should be discarded.

A surface grinder should be used and a Carborundum stone of grade BA80-N5-VBLU is recommended. The clutch pressure plate may be placed face downwards on the machine table and the backs of the lugs for the toggle levers lightly ground flat to provide a true surface. The plate may then be reversed and the face ground as required.
