**Bulletin**

MODEL BENTLEY MARK VI

**MODIFICATION.****REAR BRAKE EQUALISER.**

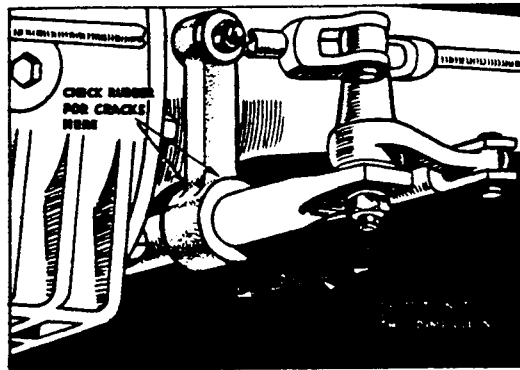
A certain number of cars were built with the rubber support of the rear brake equaliser fitted and positioned whilst in the chassis stage of production. When the body is mounted, the effect of its weight on the geometry of the rear suspension causes distortion of the support which may lead to fracture; repositioning of the support is therefore necessary in some cases.

1. Disconnect the rubber support from the axle tube and flex it backwards and forwards so as to examine for cracks in the neck at the junction with the main boss. If there are any signs of cracks, replace with a new support.
2. Check that the rear face of the main boss is 2.275 ins. from the centre of the rear brake equaliser bolt, and reposition if necessary.
3. Paint the letter 'E' on the rear face halfway down the rubber leg after examination and repositioning.

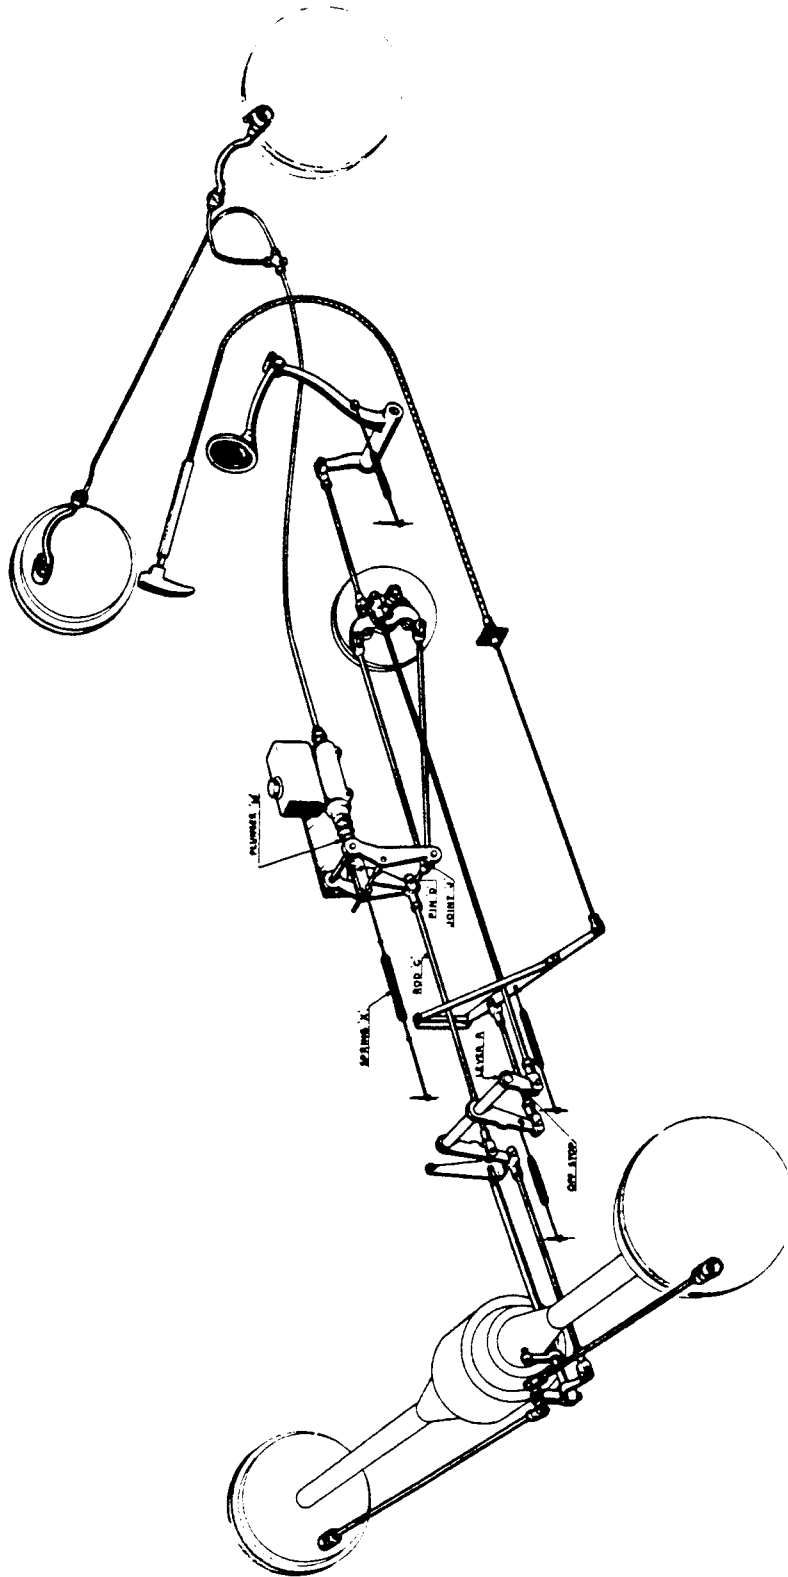
A modification is introduced to reduce a mechanical noise that can more accurately be described as a "clonk" from the brake linkage which may occur on application of the brakes.

In many cases, the origin of this noise has been traced to excessive free travel between the plunger and piston of the brake master cylinder, and adjustment of the brake linkage as described hereunder, has in certain instances effected a noticeable reduction of the noise.

1. Ensure that the rear brakes are in the OFF position and that the lever 'R' is against its OFF stop.
2. Remove the master cylinder pull-off spring 'X' and the clevis pin 'D'
3. Adjust the rod 'C' so that the joint 'J' has zero to .050" free travel before the plunger 'M' contacts the master cylinder piston.
4. Tighten the locknut on the rod 'C'. Replace the clevis pin 'D' and the master cylinder pull-off spring 'X'.

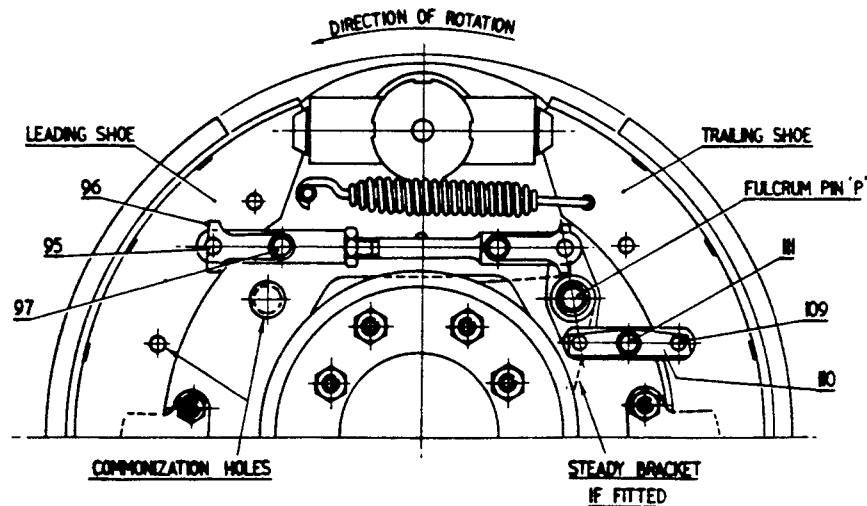
FIG. 1.

Instances have occurred in service with the Bentley Mark VI, where the front brakes have failed to release properly after application. This "Spragging" of the front brakes is due to an excessive self-servo action of the shoes, and manifests itself by a locking of the brakes even after the foot pedal has been released. In all such cases, the following modification should be carried out.

- (a) Remove setscrew and spring washer (111) and the locking plate (110) and by easing the load from the pull-off spring, withdraw pin (109).
- (b) Remove setscrew and spring washer (97) and locking plate (96) and withdraw pin (95).
- (c) Remove equal wear linkage from fulcrum pin (P) complete.

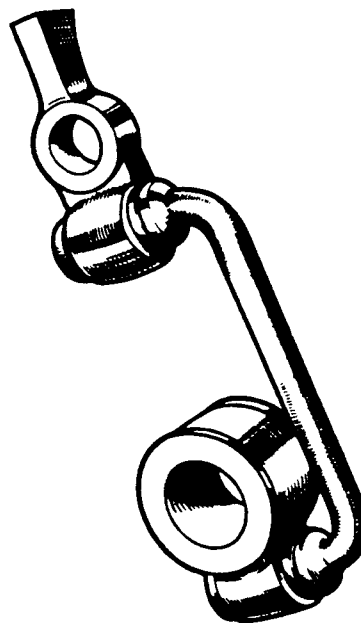
FIG. 1. MODIFIED TYPE SUPPORT

Instances have occurred where the rubber support (RG-3552) for the rear brake equaliser bar has fractured on existing Bentley Mark VI cars in service.

The modified type support assembly, illustrated in Fig.1 above, consists of a "U" shaped metal link, which is retained at either end by brackets in silentbloc bushes. The upper bracket has a radiused face to correspond with the outside of the rear axle tube, while the lower bracket carries another silentbloc bush through which the equaliser bar passes.

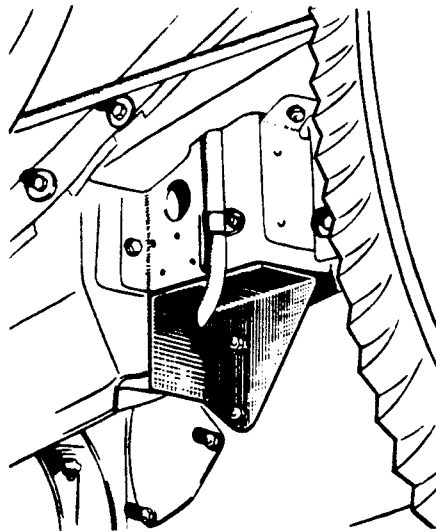
Investigations have shown that the deletion of the dashboard side mounting brackets (Service Bulletin BB-115) renders it possible in wet weather for water to reach the servo motor and gear change mechanism through the gap between the front of the body and frame member.

This protection consists of a flanged plate (Part No. RF-8881) which is fitted in the position originally occupied by the lower dash mounting bracket on the right-hand side of the chassis as shown in the above illustration. The existing bracket mounting holes in the frame are used for fixing the plate, and it should be noted that when this is finally fitted, there must be a clearance of approximately 0.187" between the top and rear flanges and the dash and body respectively. The two bolt holes drilled in the plate itself are of a slightly larger diameter than the retaining bolts supplied thus permitting a certain degree of adjustment when fitting the plate.

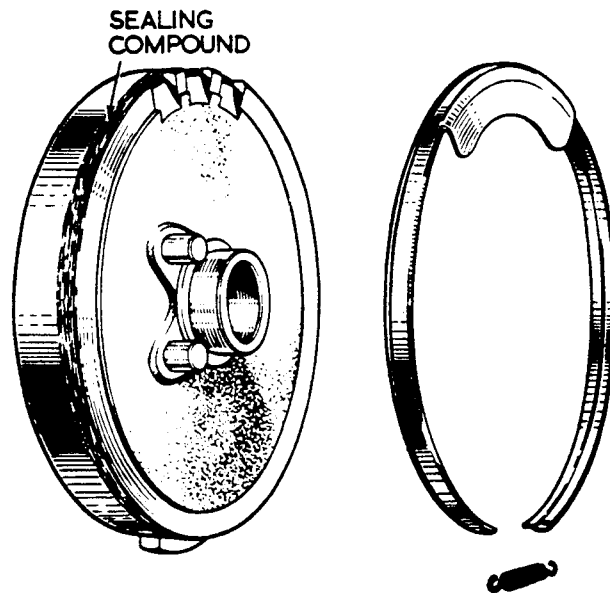
In order to prevent the possibility of oil seepage into the servo motor, the joint between the flange of the spring backing plate and the pressure plate is being coated with "Wellseal" on current production. "Wellseal" is a sealing compound with a rubber solution base which remains soft and pliable when dry.

Retailers are advised that, whenever a servo motor is removed for overhaul or other reason, it should be treated with "Wellseal" or an equivalent compound. After assembling the servo in the usual way, but before fitting the protector ring, the compound should be applied with a thin brush as shown in the illustration.

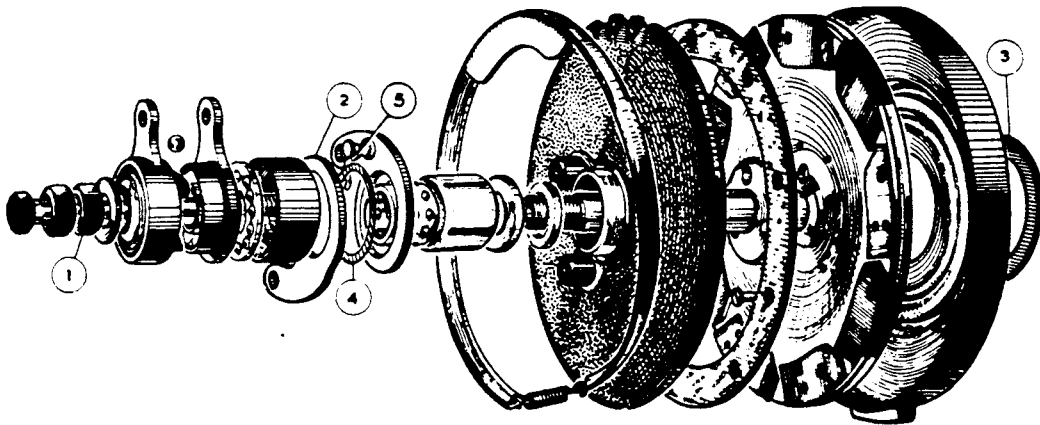
FIG.1. EXPLODED VIEW OF SERVO MOTOR.

A corrugated washer, Part No. R.5037, has been developed to overcome cases of servo judder on brake application. The washer is fitted between the brake actuating levers in place of the plain washer GB.5083 and effectively damps the servo output to prevent minor fluctuations in the brake linkage from developing into judder.

1. Adjusting Nut.
2. Brake Actuating Levers.
3. Ferodo Washer (To be replaced by R.5285 if necessary).
4. Plain Washer GB.5083 (To be replaced by R.5037).
5. Spring Clip (To be removed).

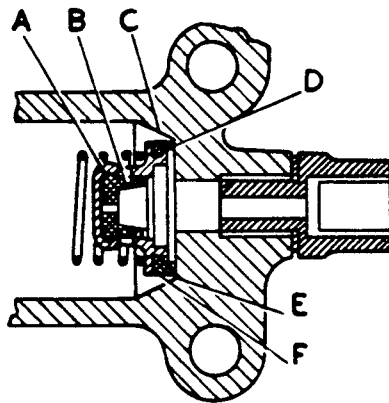
Fig.2. Section-Return valve assy.  
master cylinder.

There have also been cases of ingress of air into the system due to non-sealing of the rubber valve washer 'F' Fig.2. against the face 'D' at the outlet end of the cylinder. The sealing lip 'A' Fig.1. of the rubber cups in the front brake expanders is normally held in firm contact against the bore of the expander by a residual hydraulic pressure of about 12-14 lbs. per sq/in. created by the spring loading of the return valve illustrated in Fig.2. Should this valve fail to maintain the hydraulic pressure, air may enter past the cups of the expanders owing to the comparatively low pressure exerted by the cups themselves against the bore.

Examination revealed that the primary cause of the valve washer 'F' not seating correctly, was due to the diameter of the face 'D' of the master cylinder being too small, causing the valve washer to make heavy contact with the rough un-machined tapered sides 'C' of the cylinder resulting in excessive wear and distortion of the valve washer.

- (i ) Fit a new rubber washer 'F' (RG-7043) and a rubber cup 'B' (CD-130) to the valve body 'A'. Place the coil spring on to the valve and enter into the cylinder and check that the valve assembly has a diametrical movement of approximately 0.020" (0.50 m/m) to ensure that there is sufficient clearance between the outer diameter of the valve washer at point 'E' and the cylinder.
