MODEL BENTLEY MARK VI

MODIFICATIONENGINE OIL FILLER CAP WASHER.

REPLACEMENT OF TAPPETS.

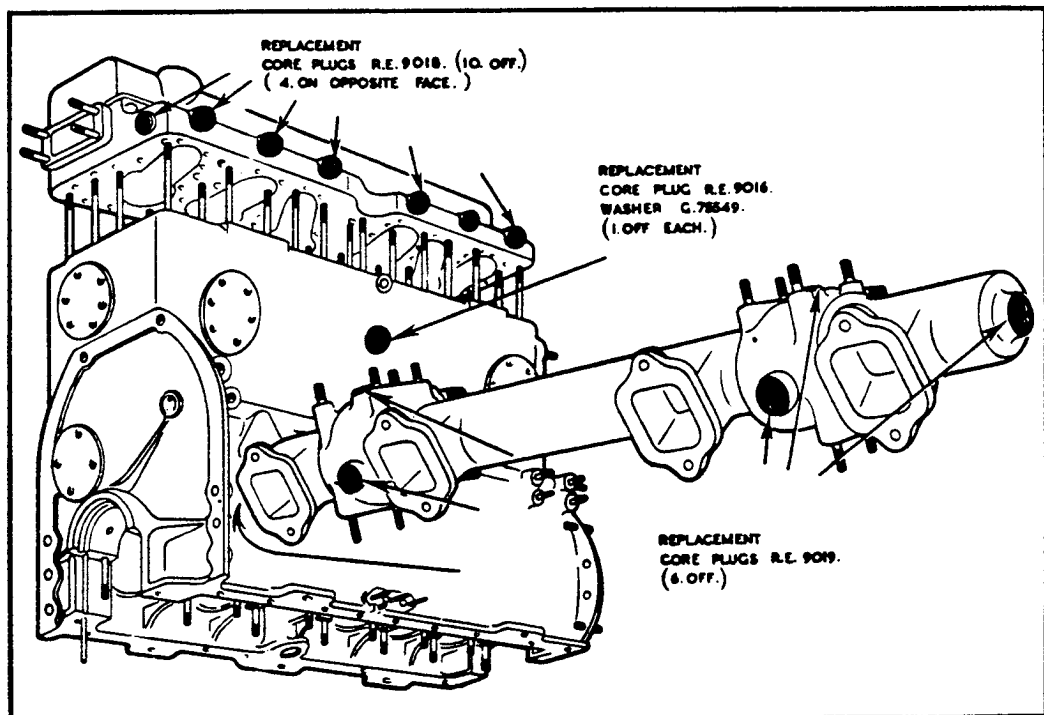
The following illustration gives fuller details of the location of the core plugs to be replaced, together with replacement part numbers.

It should also be noted that if a coolant leak develops from any of the core plugs when the engine is fitted with the pre-modified type, this may indicate that a state of corrosion exists in other core plugs caused initially by the engine remaining drained of coolant for lengthy periods of storage or shipment. If a leak is apparent therefore, the instructions given in Bulletin BB-19, limiting this modification to overhaul cases only, must be disregarded, and all core plugs replaced with the modified type.

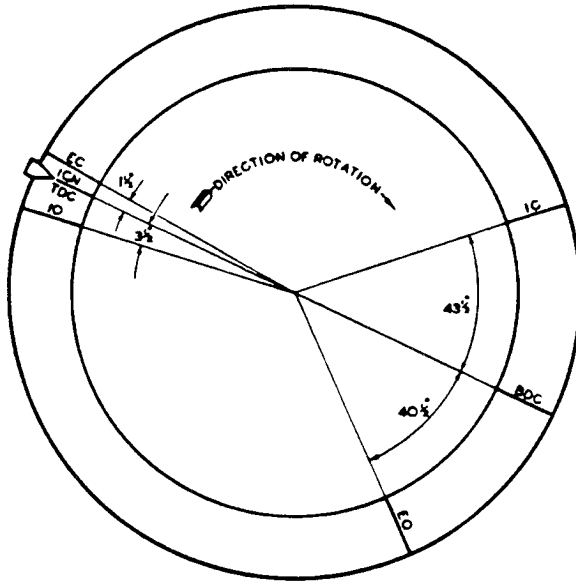
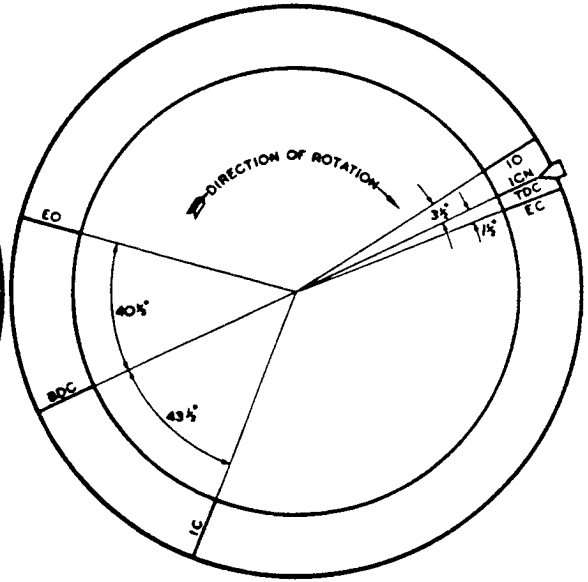
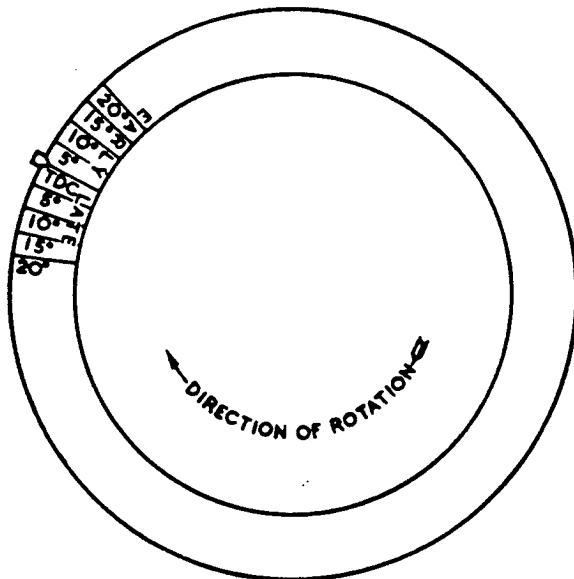
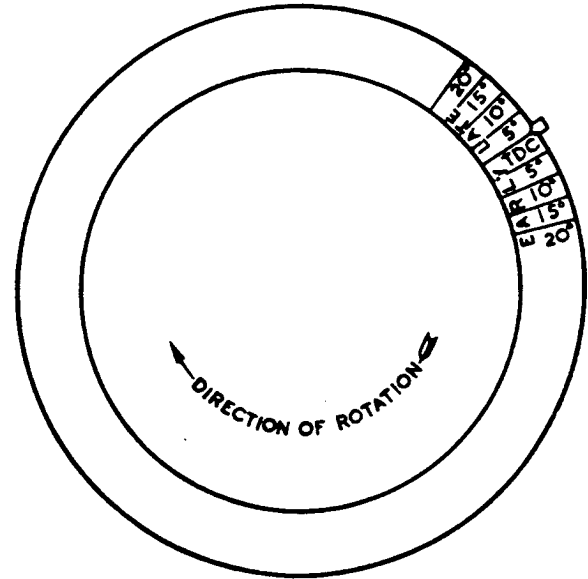
Early type flywheels are marked as shown in Fig. 1 and 2. Later type flywheels and replacement flywheels, will be marked as shown in Fig. 3. It will be noted that the T.D.C. mark only is shown with additional markings at five degree intervals from 5° to 20° on either side of the T.D.C. mark designated EARLY and LATE.

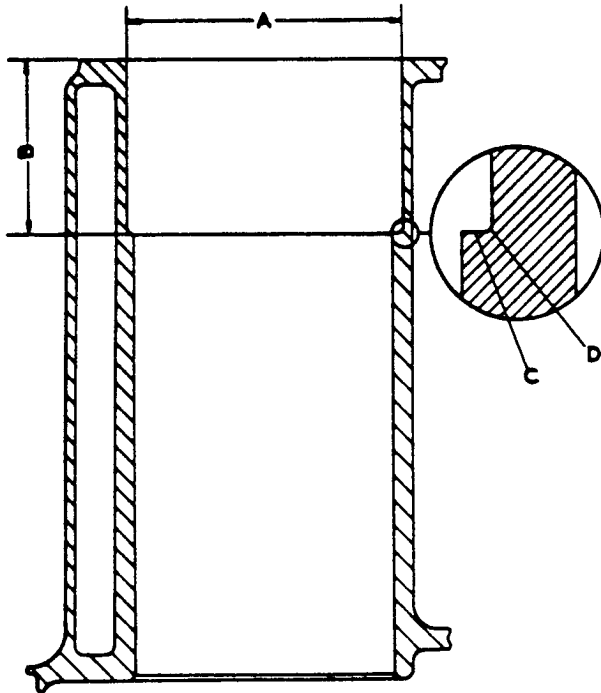
FIG.1. SECTION - CYLINDER-SHOWING COUNTERBORE.

The bottom face, 'C' Fig.1, of the counterbore must be machined perfectly true. Any slight discrepancy on this end will cause a gap on one part of the "butt" joint.

NOTE: If, when measuring the diameter of a counterbore ('A' Fig.1), it exceeds 3.6265" (92.11 m/m), it will be necessary to fit an R-4610 oversize short liner. This liner is marked with white paint and has an external diameter of 3.631" to 3.632" (92.23 to 92.25 m/m), and one should be selected that will not allow an interference exceeding .004" (.1 m/m), or less than .0025" (.06 m/m).

- (iii) Re-adjust the cutter and continue the counterboring to a depth as above and to a diameter that will allow a liner to have an interference fit of .0025" to .0035". The number of secondary cuts will of course, depend upon the depth of the initial cut, but it is recommended that these are kept to a minimum.

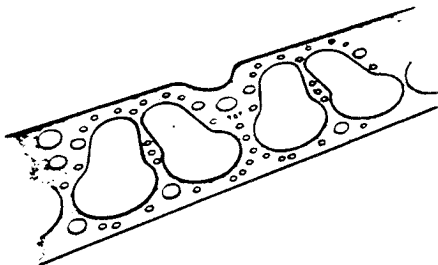
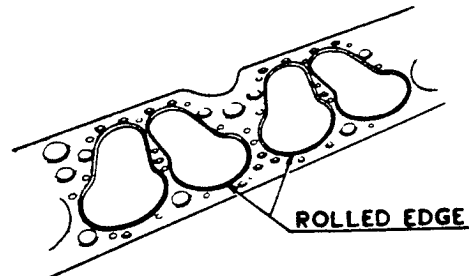
Retailers are advised that the correct procedure when fitting replacement C & A cylinder head gaskets in service is to ensure that these are fitted with the plain face uppermost and the rolled, or lapped, face to the cylinder block.

As an aid to recognition the characteristic differences between the top and bottom faces of the gasket are illustrated in the above two sketches. A further means of identification is provided by the word "TOP" which will be found stamped between Nos. 3 & 4 cylinder openings on the plain face as shown.

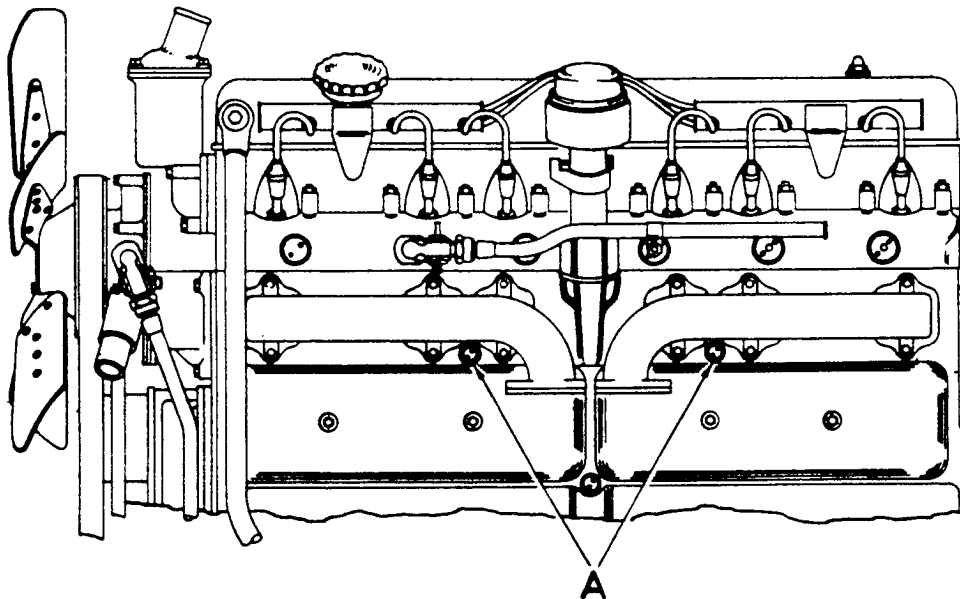
FIG.1 LOCATION OF CORE PLUGS

The aluminium plugs have proved subject to corrosion in service and are to be replaced with cadmium plated steel core plugs and aluminium washers as a retrospective modification. Retailers are asked to carry out replacement on all affected cars in their area when they are next being serviced.

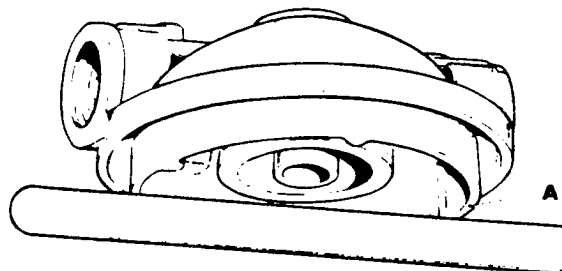
Fig.1 Outer Lip Proud of Inner Sealing Face.

Therefore when the bowl of the filter is removed to change the filter element and seals, on the 5,000 miles service schedule, Retailers should check the filter head with the aid of a straight edge as illustrated in Figures 1 and 2.

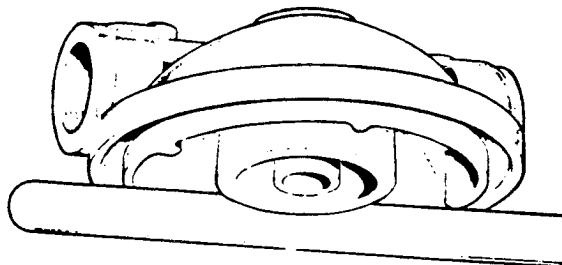
Fig.2 Inner Sealing Face Proud of Outer Lip.

If the inner sealing face stands proud of the outer lip (see Fig.2) the original 'Top Cap' (as shown in Fig.4) can be retained. For future replacements only the modified 'Top Cap' will be supplied.
