Post-War Pre-Shadow Tune-Up Seminar

Based on notes from
Roger Hadfield, Ont. & Bob Leonard, PA
Photography © 1992 M. Karger

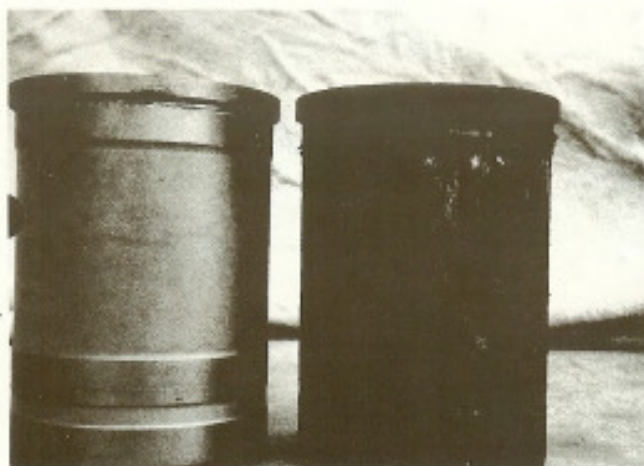
The old sleeve shows why the sleeves are often well-secured to the block. The build-up is basically aluminum corrosion.

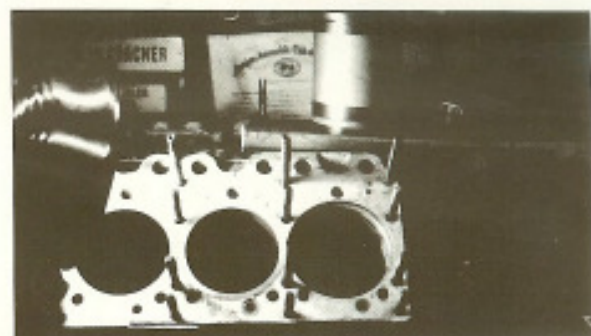
Block with one sleeve removed. Sign in background cautions re-builder to use oil for a lubricant.

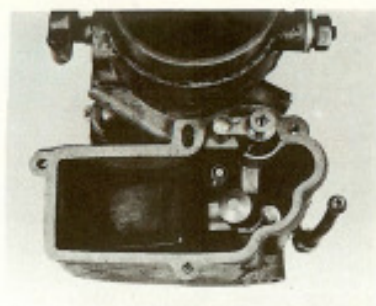
The gasket on the Zenith carb float bowl must not cover the low speed jet, center top.

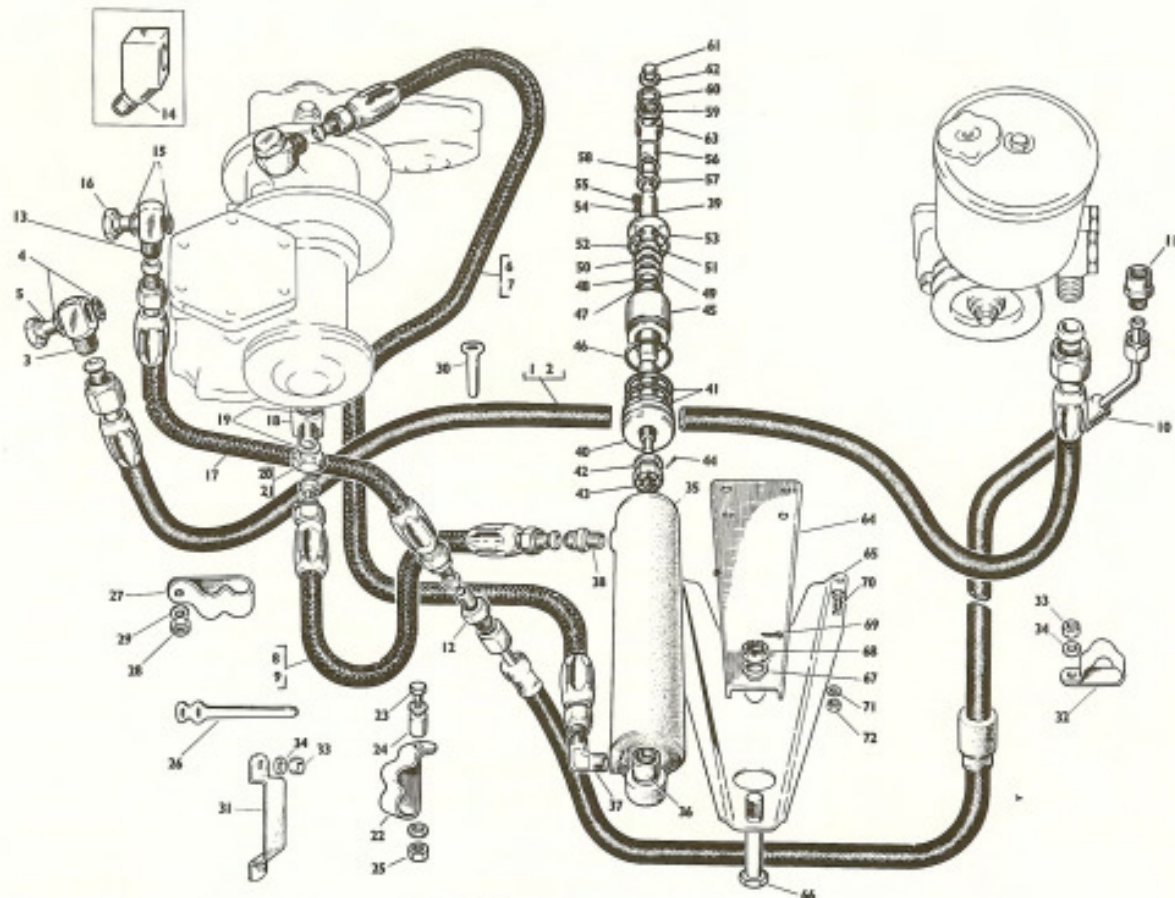
Herewith the entire power-steering assist system. Part #39 is the ram shaft.

Recently encountered was a power-steering ram with a severely pitted ram shaft. After examination it was found that each end of the shaft has the same thread and taper, making reversal somewhat less complicated.

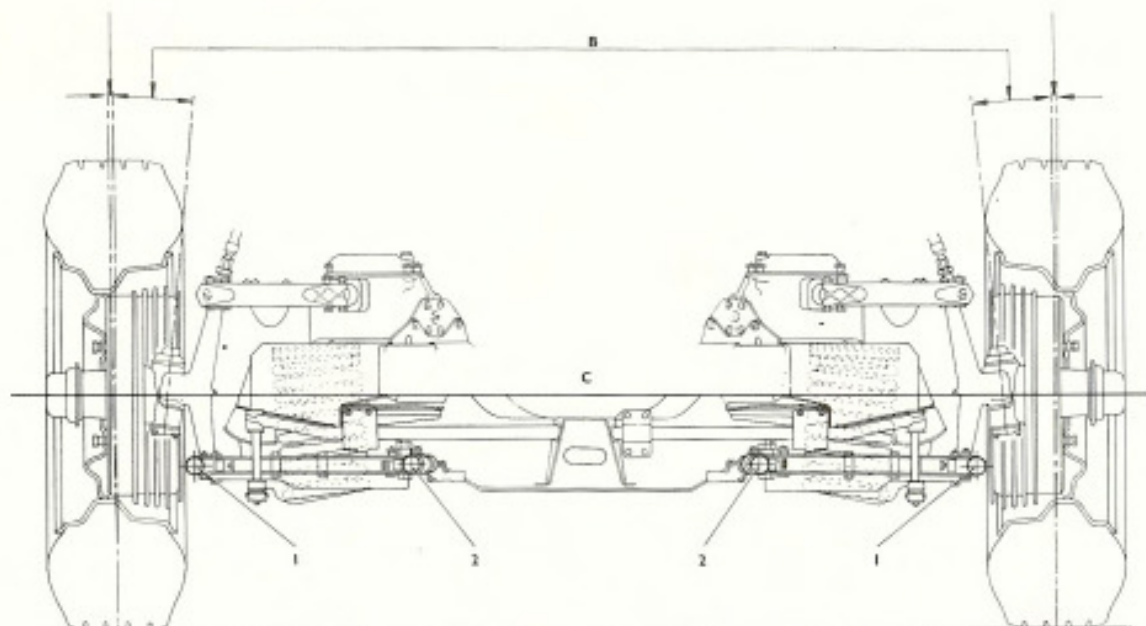
The standing height is the vertical height of point "2" above point "1". The car must be unladen and tires properly inflated when checking this measurement. Tolerances for Standard Car are 0.800" to 1.400". For the Colonial Car, 1.300" to 1.900". Also see page H2 in the Silver Cloud workshop manual for more explicit details.

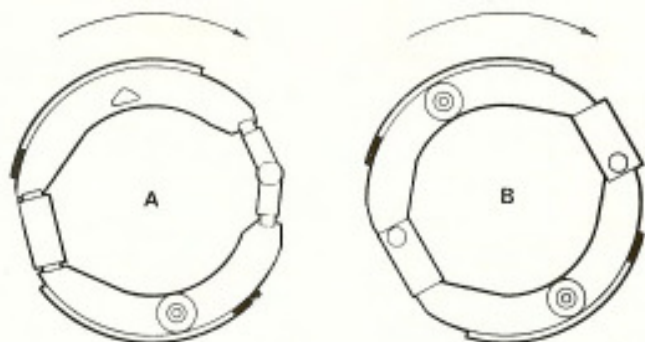
FIG. 1 SHORTENED BRAKE LININGS
A. Rear B. Front
**SHORTENED BRAKE LININGS—
S3 CARS**

Rivet the brake lining to the shoe in the normal manner.

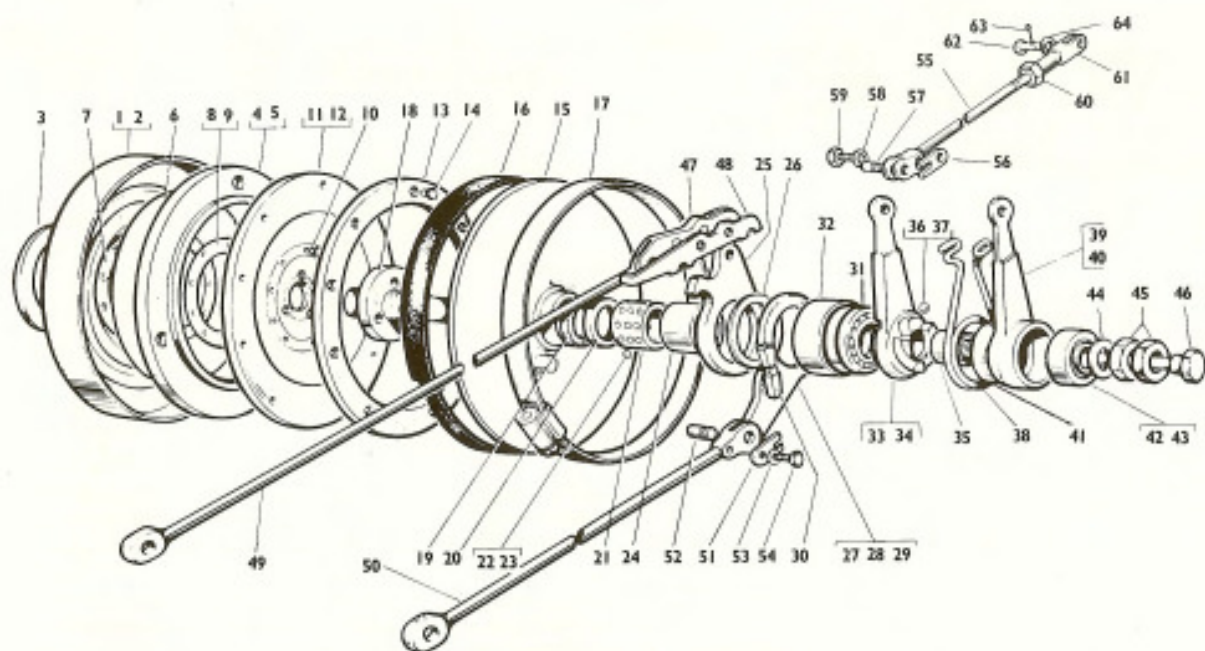
An exploded view of the servo. Lined disc is shown as number 11 and 12. Be certain ball bearings 36/37 are clean and lubricated.

To clean the servo, remove it from the car. This is no serious undertaking and should be accomplished in about an hour (all figures for time are taking into consideration the Rolls-Royce Rule of Three . . . simply multiply by three the amount of time you think a project should take). Once removed, take it apart, and break the glaze on the surface of the linings. I like a piece of 100 grit paper glued to a sheet of plate glass to get everything in one plane to accomplish this "glaze-busting." Replace the seal in the transmission, check the ball bearings, and reassemble, using a new seal for the tin covers. Reinstall the unit.
