TEE ONE TOPICS

Issue 53 May, 2006

WHEN THE USE BY DATE OF THE USE BY DATE EXPIRES FOR A SET OF BRAKE DRUMS!

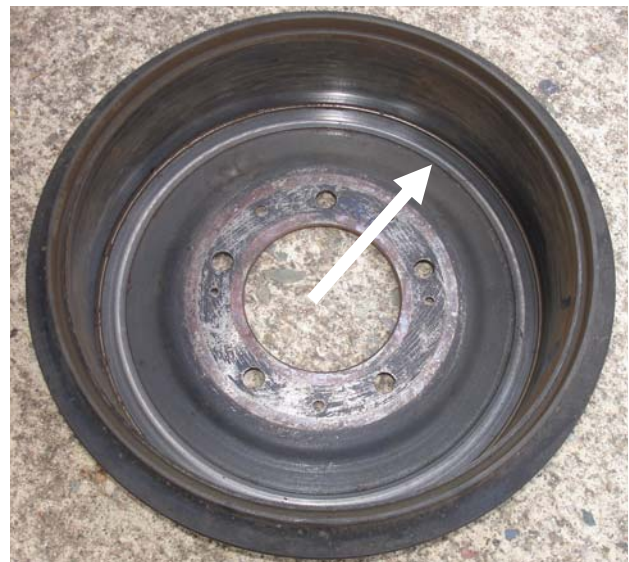
At right:- The bright rubbing ring on the side of one of the rear drums.

look inside the drums – there were bright rings around the sides of them. Even more interesting the bearing faces of the shoes – where they sit on the adjusters and the expanders were very brightly polished indeed.

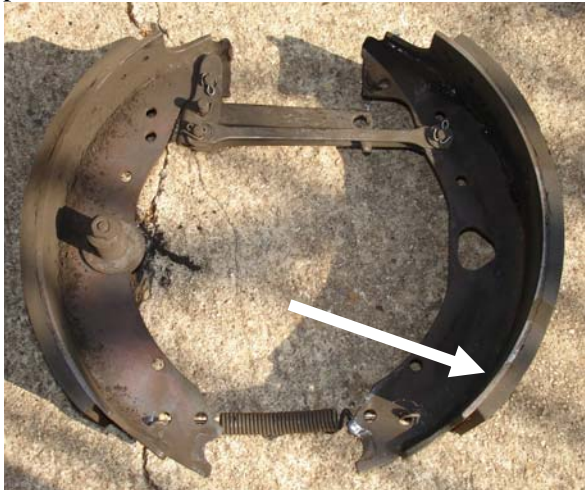
At left:- Note the shiny abrasion on the lower edge of the right hand shoe.

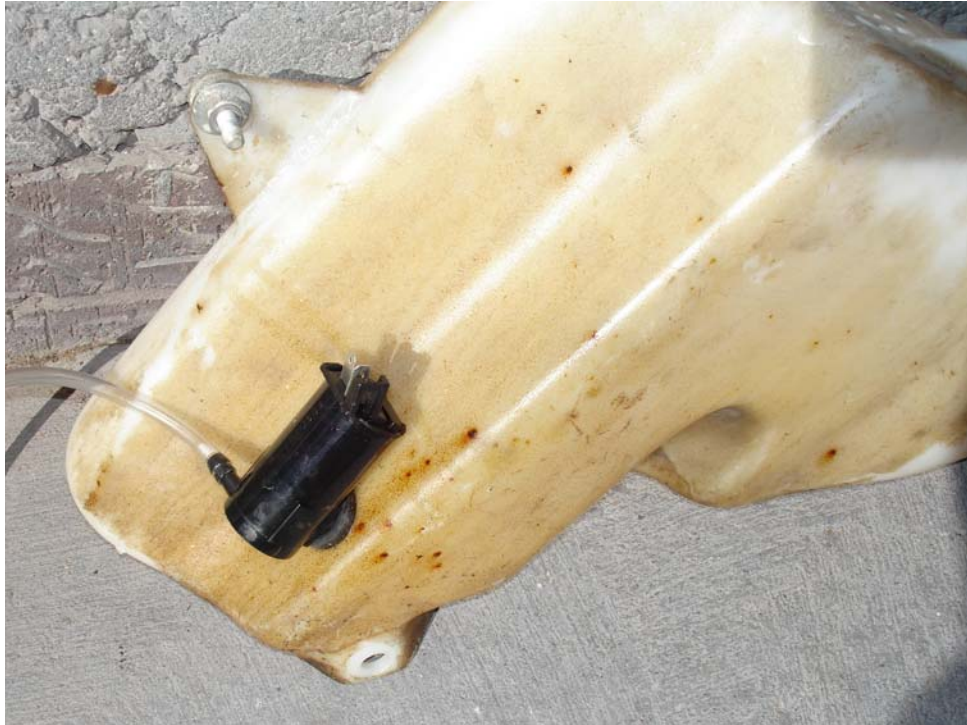
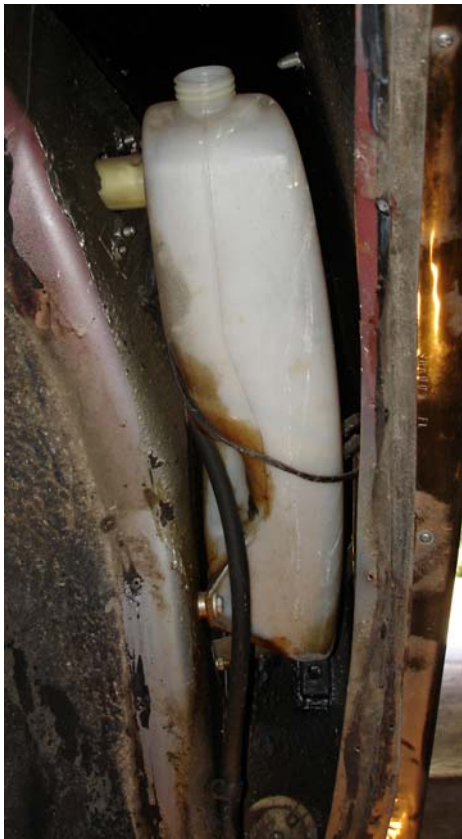
I wonder how many of you would recognise the above. Up until the Shadow appeared, windscreen washer bottles were of glass, neatly clipped to the valance with neat Bakelite caps and rubber plugs and nicely coated wiring.

At Left:- And here is the little darling nestled in behind the left hand mudguard. The function of the top filler orifice is unknown and is normally closed by a cap!!! Note the gooseneck coming through the valance on the left of the reservoir!

And that is what you are looking at on the previous page! To get the water in, a goose neck is inserted through a hole in the valance and one or more pumps were inserted beside

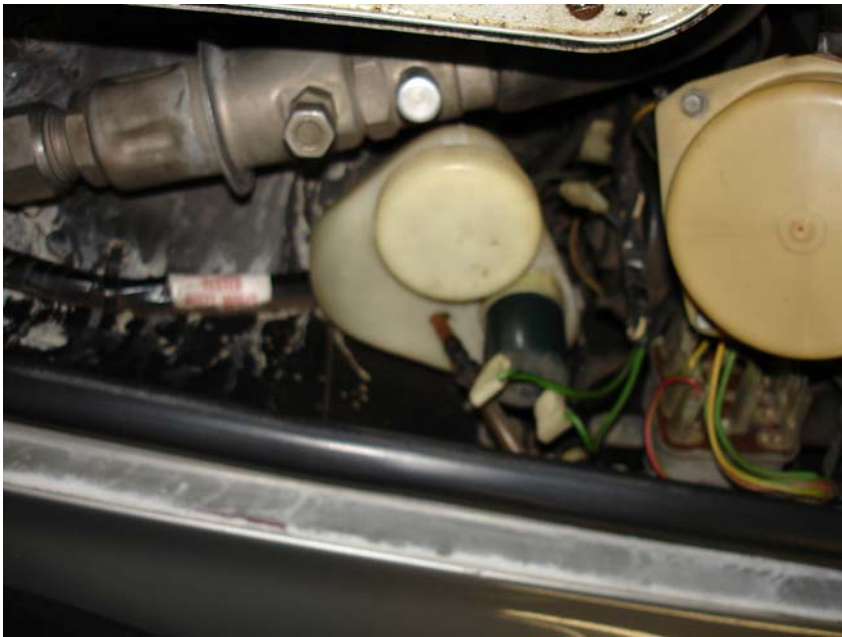
At left:-This is the filler plug end of the reservoir seen on most Australian delivered cars. The little black cylinder is the irreplaceable motor bit.

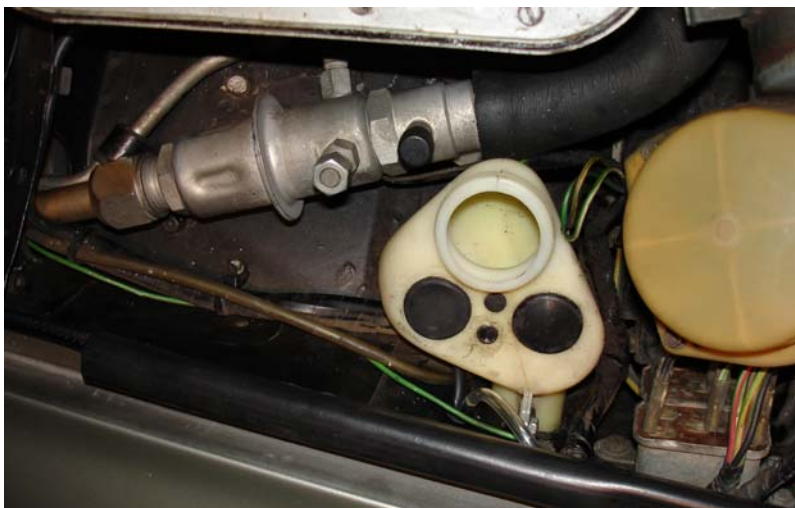
At Left:- The system from Hell! The two rubber grommets hide holes where the two motors were originally fitted to handle squirt requirements for the windscreen and separately for the headlights. Neither are required now in the picture as the pump motor is now under the mudguard! The filler cap is yet to come, having been dispensed with by a previous modifier.

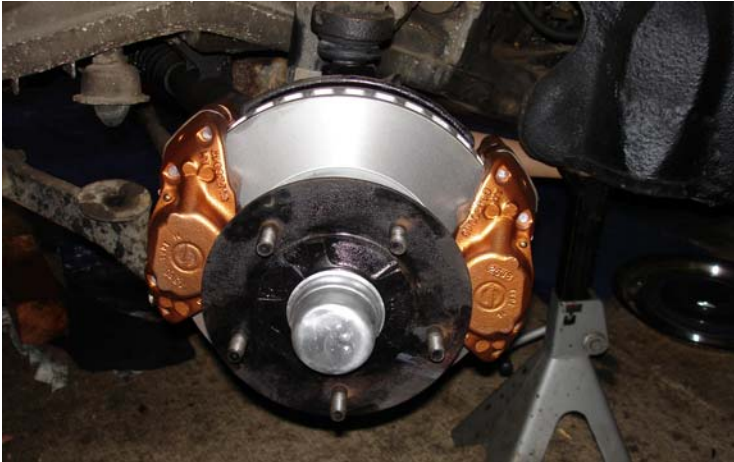
Aren't these pretty? Actually they are tarted up with a bit of good metal suitable spray paint to slow down the rust mites. Certainly not essential but then if you take a friend under the car you can gesture vaguely at your units and infer that only the most specialized operators

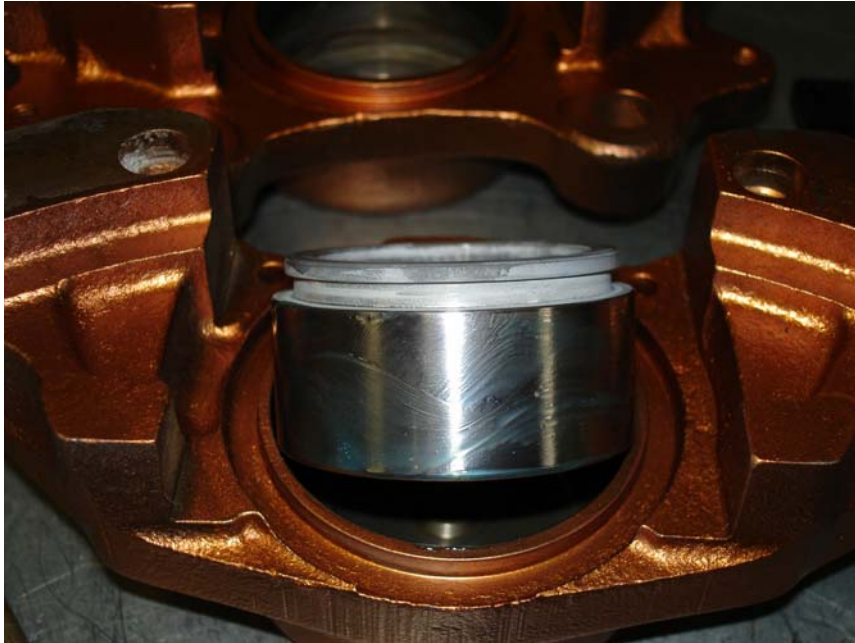
Callipers as we have seen in previous issues seldom need attention. Keeping them reasonably clean of accumulations of brake dust by a good hosing, keeping an eye on the rubber boots that they haven't become unclipped or punctured and of course checking that the brake pads still have adequate 'meat' on them to do their job. We have also mentioned that mineral oil callipers for some reason leak! If this

occurs or the boots are torn or punctured then they should be overhauled, cleaned out and new seals fitted.

The callipers are simple to remove. Obviously, exhaust the accumulators then detach the supply pipes to the callipers. There only remains undoing two fitted bolts that hold the units to the stub axle and the calliper in your hands. If the brake rotor is worn and has a peripheral lip simply lever the pads back into the calliper body giving you more room to slide the callipers off the car.

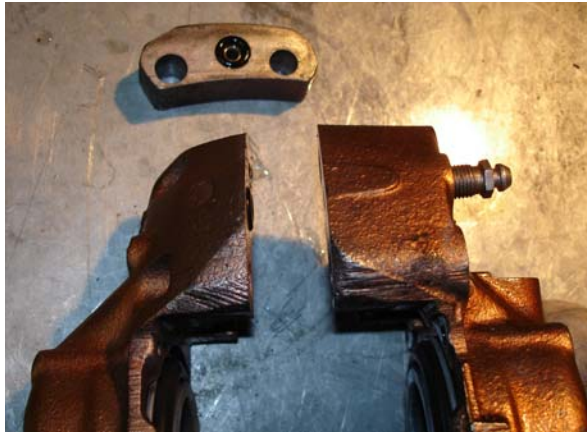
they go back where they came from. Probably not essential – just good practice. You will notice the callipers are in two halves held together by four bolts. The halves in turn are separated by substantial shaped spacers which allow the manufacturers to use the castings on different cars if required simply by changing the thickness of the spacers. For reasons I have never been able to ascertain, instruction manuals will always instruct repairers to NOT separate the two halves of a calliper. To not do so however makes them very hard to dismantle, clean and fit new seals. It is for that reason the repair kits do not include the special 'O' rings needed to seal the passage

between the two halves. Fortunately these are available but unless your spares man is on the ball you will have to ask for them!

To undo the bolts securing the two halves you will need stout sockets and a long break bar since they are usually very tight. Having a substantial vice to hold them goes without saying. Having separated the halves the pistons can easily be withdrawn either with compressed air if you have it or judicious use of a couple of wide bladed screw drivers levering under the piston lip. Carefully undo the bleed nipple as these are often significantly corroded and can easily snap off.

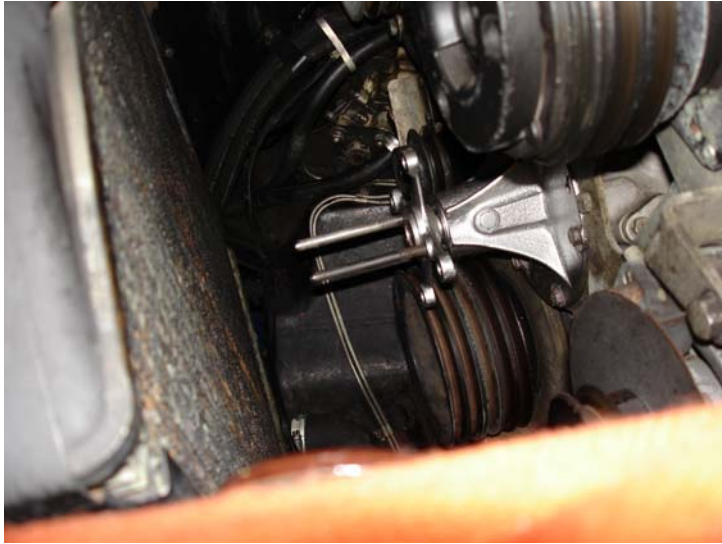
Just getting a new set of drive belts in place is a challenge and no amount of accounts will assist in making the job easier. In the picture at left the water pump had a re-repair having been fitted initially with a seal, the carbon face of which was microscopically cracked. Here the pump has been re-installed and the drive pulley about to be fitted. There are various arrangements of pulleys and spiders (the thing they bolt to) but this one uses two bolts to hold the pulley to the spider then the four bolts holding the distance piece and fan viscous mount, in turn to the spider hold the

whole thing together. Trying to reach in and hold a heavy pulley in exactly the right position required skills seen only with Houdini. Knocking the heads off a couple of appropriate bolts and screwing them into the spider at least simplifies the initial bolt up.

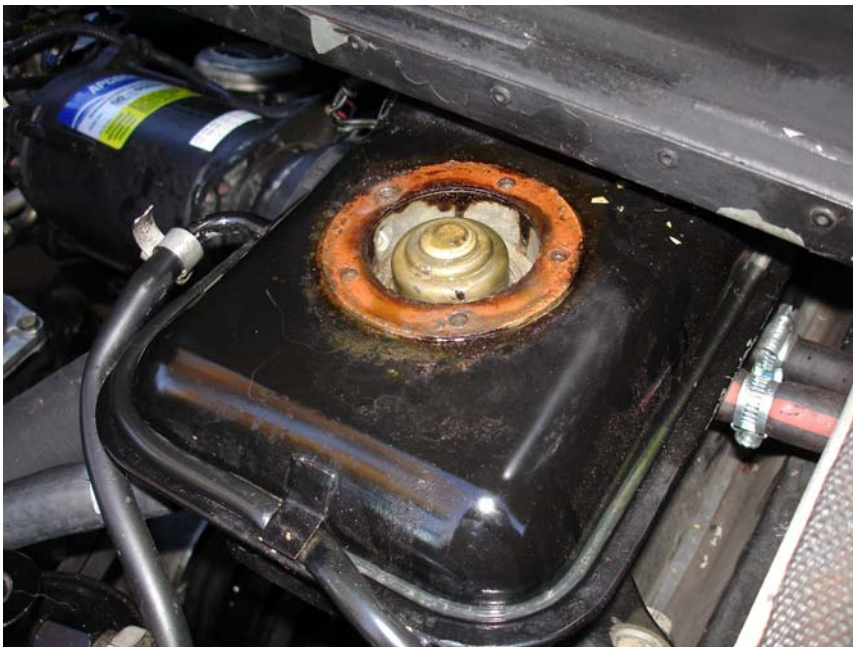
And while you are about it remember that little steam valve nestling in the top of your header tank or radiator top tank. It is difficult to test these for performance but an easy test is simply to re-route the overflow tube seen disappearing out the bottom of the picture, into a well secured container. Without overfilling the radiator and normal running there should be very little found in your catch can. If there is a lot suspect this valve. It blows at 15 psi!
