# TEE ONE TOPICS

Number 40 November 2004

## HEADER TANK FITTINGS

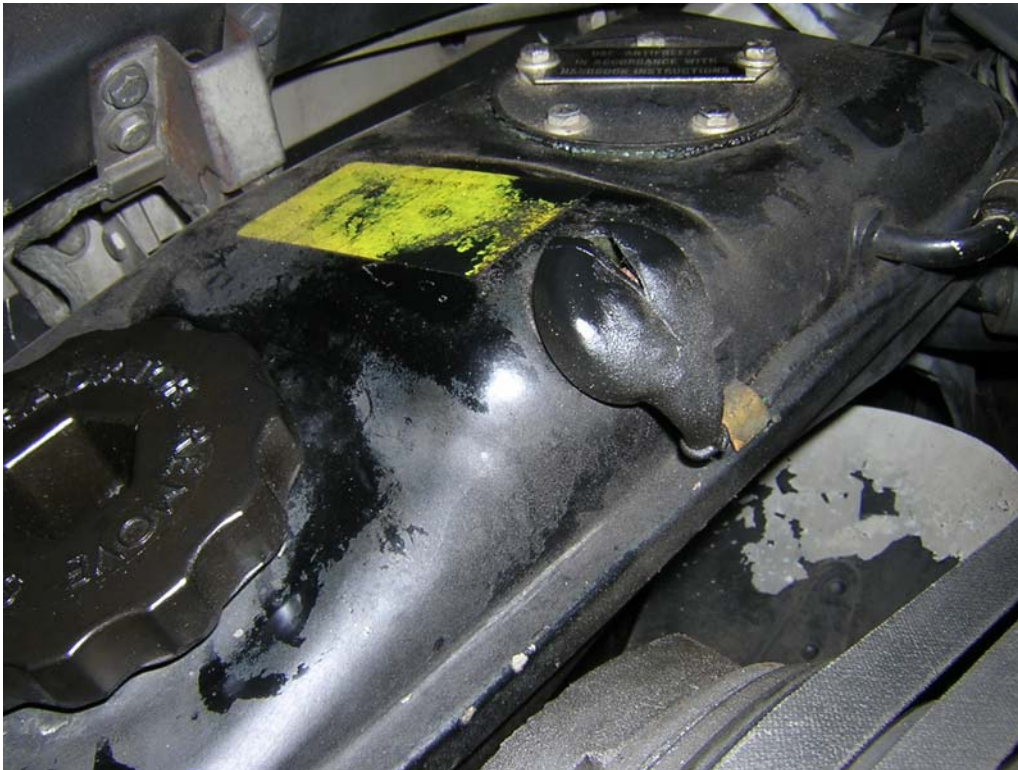
There are three things staring at you here. The filler cap, the cover of the level sensor and the steam valve cover.

**The Cap.** This arrangement was used on all Shadows and Phantoms V and VI. The filler cap was a hangover from the pre-war days when the Factory finally decided that the grille should be decorative and not contain the multi cellular radiator core! Its sole purpose was

to seal which it did by forcing a molded ridge on the lower part of the cap, onto a soft rubber annular seal. Two things can go wrong, the rubber seal will perish and/or the sealing ridge on the underside of the cap can be chipped through dropping it, destroying its sealing properties.

**The Level Sensor.** This consists of two prongs that poke into the tank. When the ends are exposed through the water level dropping, a circuit is broken a relay relays and the lights she's a-blinkin. Little trouble at this end except that in a few early cars their angle of 'insertion' was a little high. This resulted in the blinkin light coming on when going a bit quick around corners. The solution is to remove the prongs and bend them down slightly. They must not touch the internal surfaces. Occasionally one of the baffles in the tank becomes unsoldered and wanders around until it touches the prongs and presto the light she is on again. The only cure is to take the tank off and deliver it to your friendly radiator man who will unsolder the side seams open the tank up, re-solder the baffles and re assemble the tank.

**The Steam Valve.** Conventional radiator setups as you know use a spring loaded cap that seals on a flange at the bottom of the filler hole. When the pressure gets high enough through overheating it lifts the seal against the spring letting out the steam and coolant until the pressure has returned to normal.

The steam valves came in two sizes and consisted of a cage in which there was a disc valve sitting on a seat with an appropriate small spring holding it on its seat. The valve then worked the same way as the conventional radiator cap. The steam valve assemblies came in two sizes, large and small. The former are no longer available. To use the smaller valve the seat in the header tank needs to be modified with an appropriate washer for a seat. Either way the valve sits on a rubber seat to contain the coolant and is held down by the round cover seen so prominently on our cars.

There is another way. A number of operatives remove the screwed cap assembly and the steam valve, sealing the latter off. A 'conventional' radiator filler neck is then soldered to the tank and a conventional cap fitted. This arrangement was nearly used on the later Corniches except that the Factory went one step further and used a cap that is quite common these days is used for recovery systems. These caps have a two way valve. When the pressure gets too high the valve opens and allows coolant to escape but instead of squirting on the floor the overflow squirts into a bottle. When the engine cools, because the radiator is sealed a vacuum occurs and a separate valve in the cap allows the system to suck fluid back from the bottle. All cars now use this system, it just took the Factory over 50 years to adopt it. It does require that the whole cooling area is full and free of air.

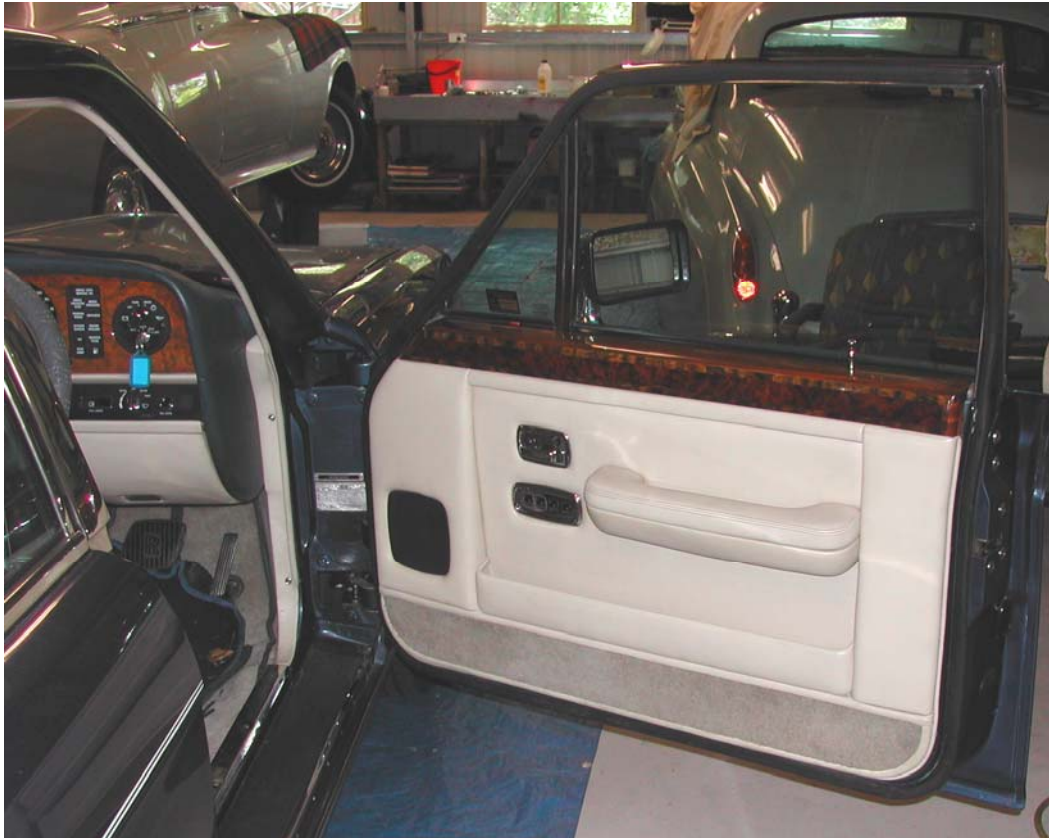
It is a pity I can't produce this picture in colour for you, but the finished product in this 1987 Spirit is probably better than original.

These cars have been bearing up under our relentless sun and the top of the wooden waist rails are starting to shed their coatings.

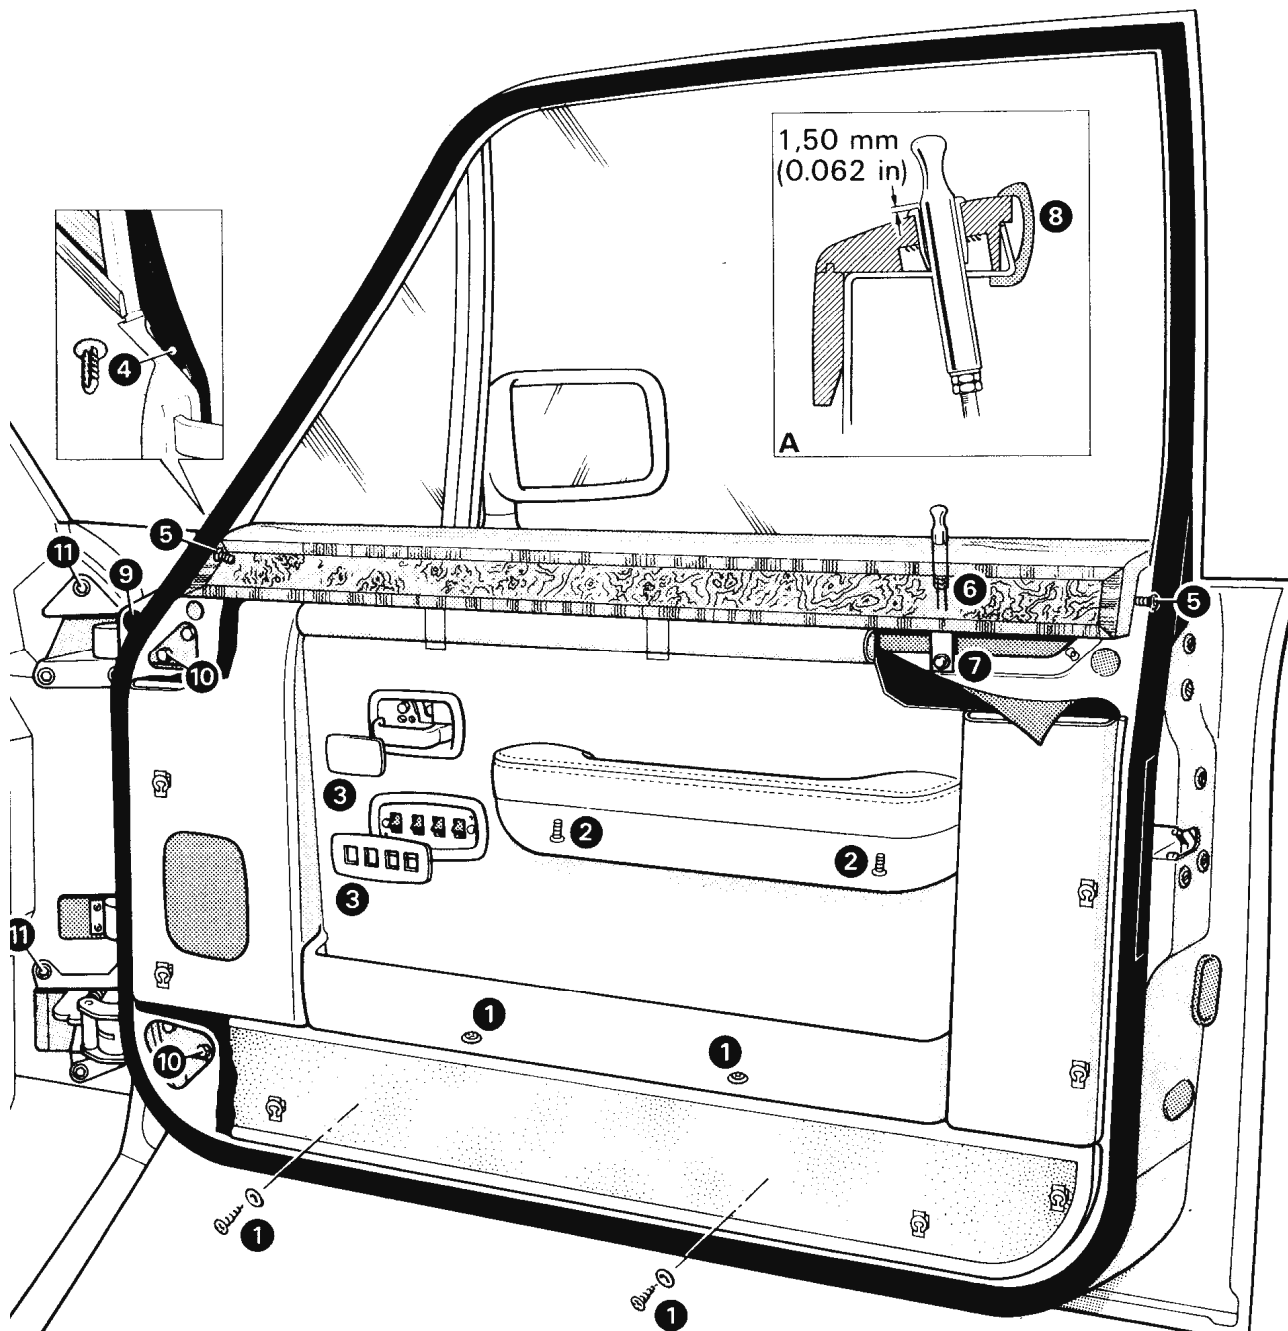
### Front Doors

This is a time consuming job but doesn't require the skills of either Einstein or Henry Royce. But a few hints may help.

### **Item 1 the pocket screws**

These are chrome plated self tappers countersunk heads and pass through finishing washers. If these are missing or rusted replace them

### **Item 3 the escutcheon plates.**

### **Item 5 Waist rail end screws**

You need to be bloody bold and resolute here. The door seals and the push button (4) needs to be prised free of the door before you can get at these screws. They are a countersunk metric metal thread.

### **Item 6 Locking Push Button.**

You need to loosen the locknut under the button before remove the latter. If the waist rails are to be re-finished then order black sleeves and retaining clips that the button runs in since trying to remove them will break them.

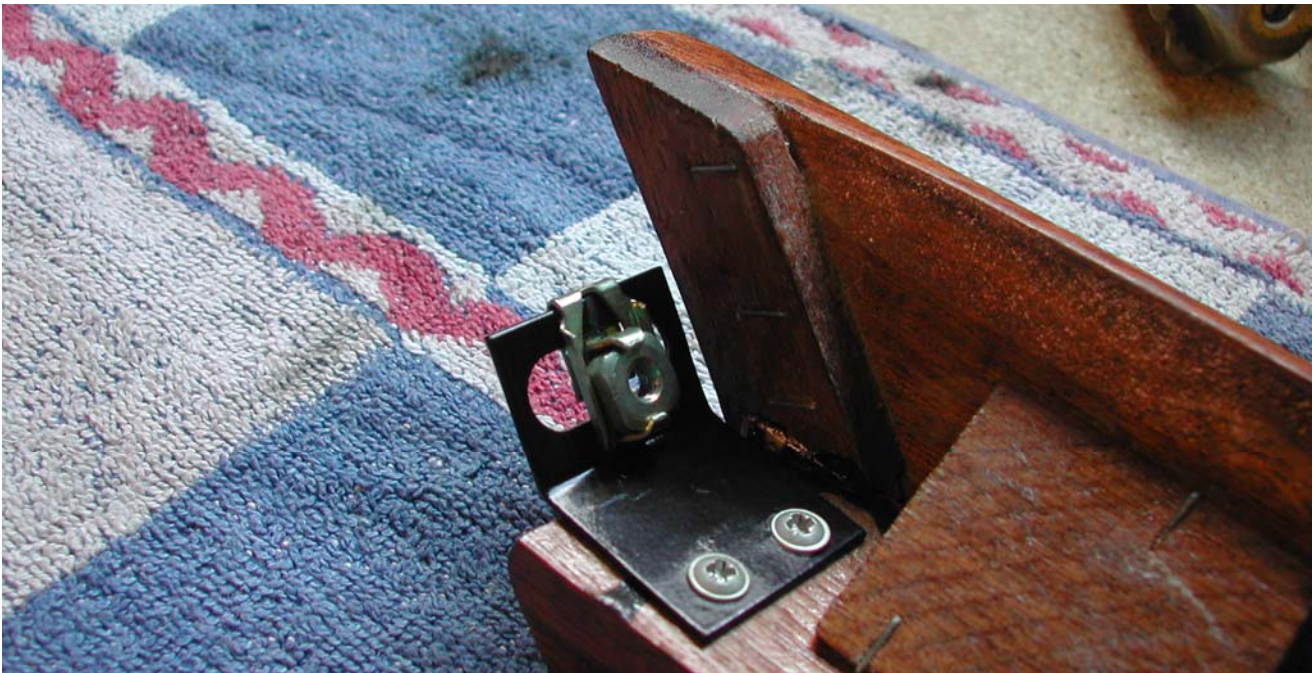
The above is the front end of one of the rails. The captive nut is a metal thread and not infrequently you will find vandals have been there and inserted self tappers. The assembly is the one into which the end screws (5) under the door seals screw.

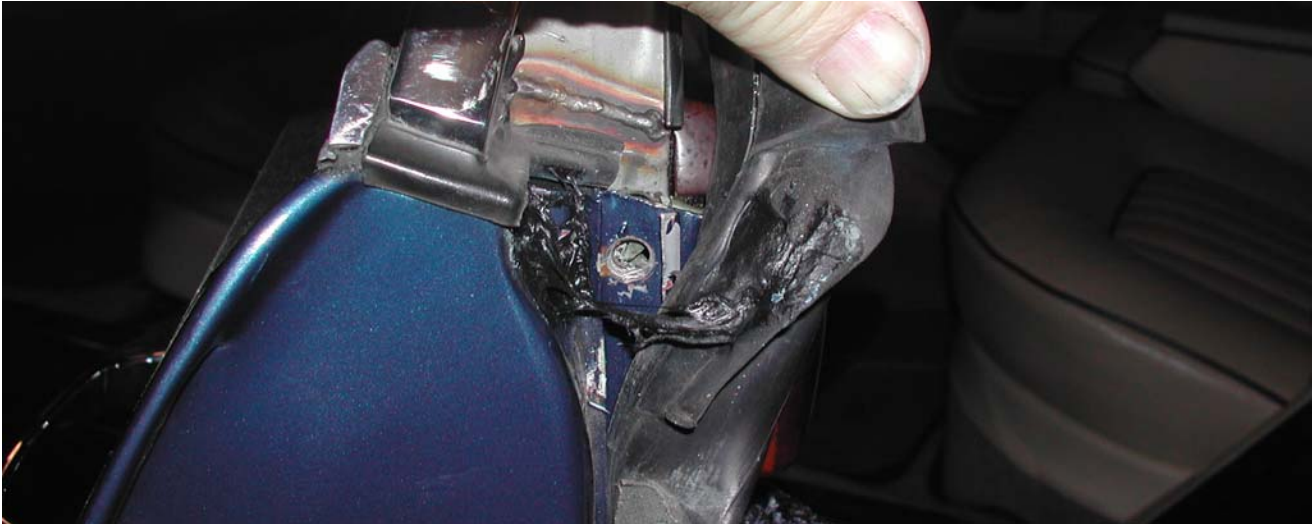
One of the elusive end screws. When you deliver the rails to the finisher you may choose to remove all the hardware or leave it to him. Note however that the window side seal attached to the glass side of the waist rail requires both gluing and stapling.

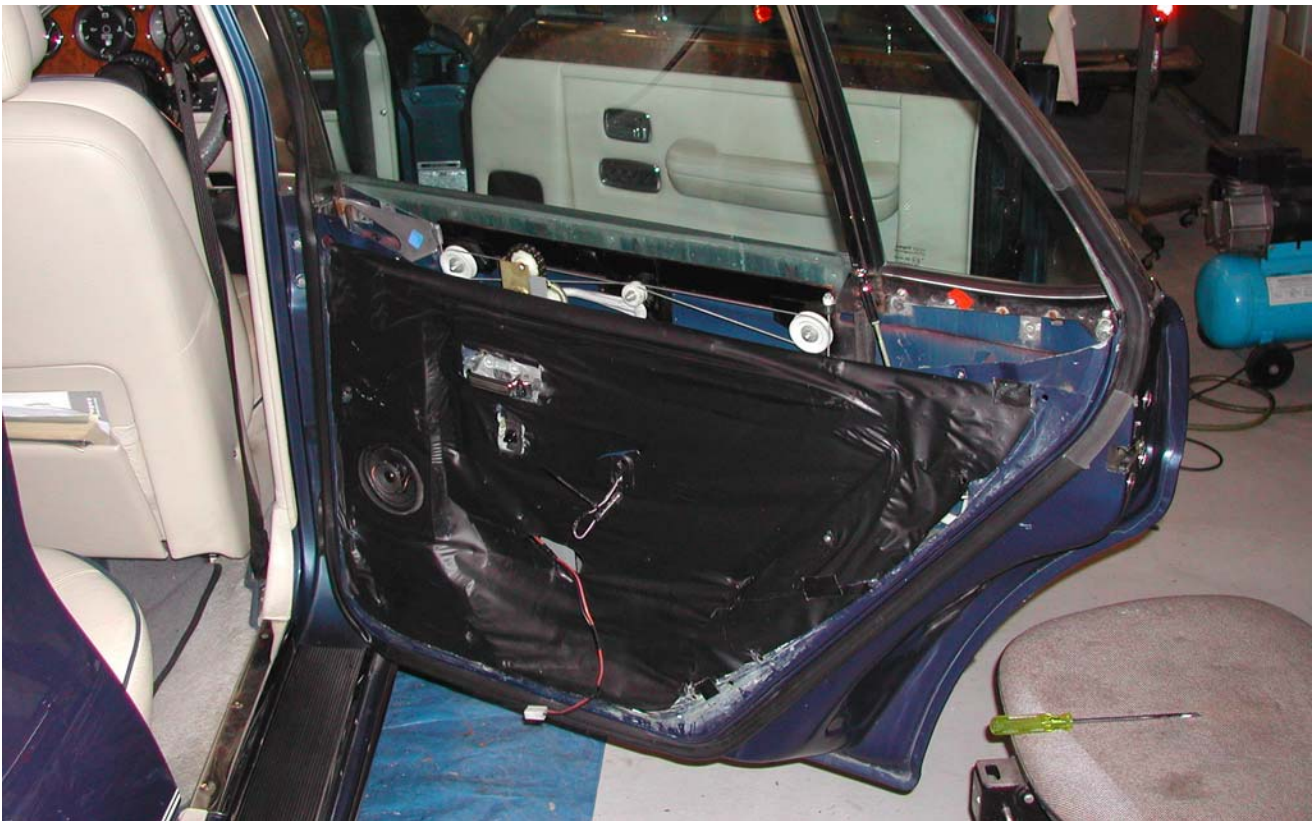
If the fume seal or plastic liner is missing or badly torn get a sheet of builders' plastic and make a new one. Without it moisture that inevitably gets down into the door will damage the door liner and rot the wooden base.

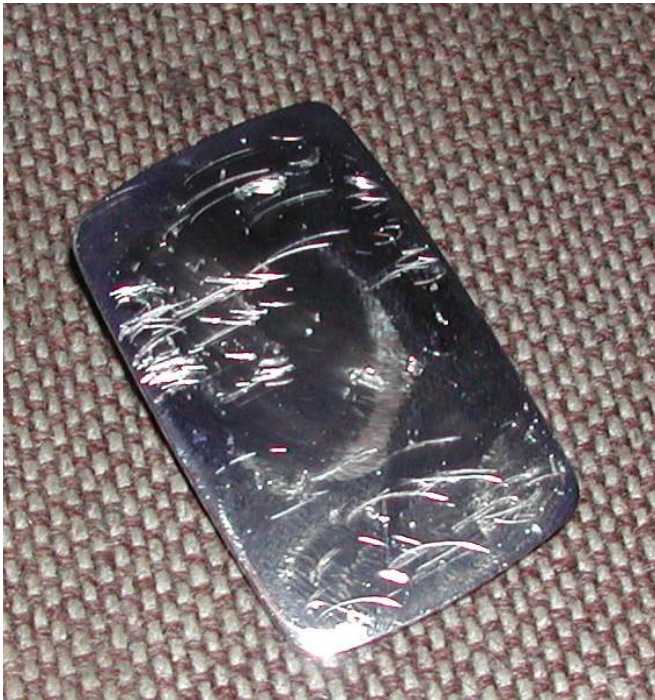
And whilst on the subject of doors, have you noticed the number of cars with badly scratched escutcheon plates around the inner door handles?

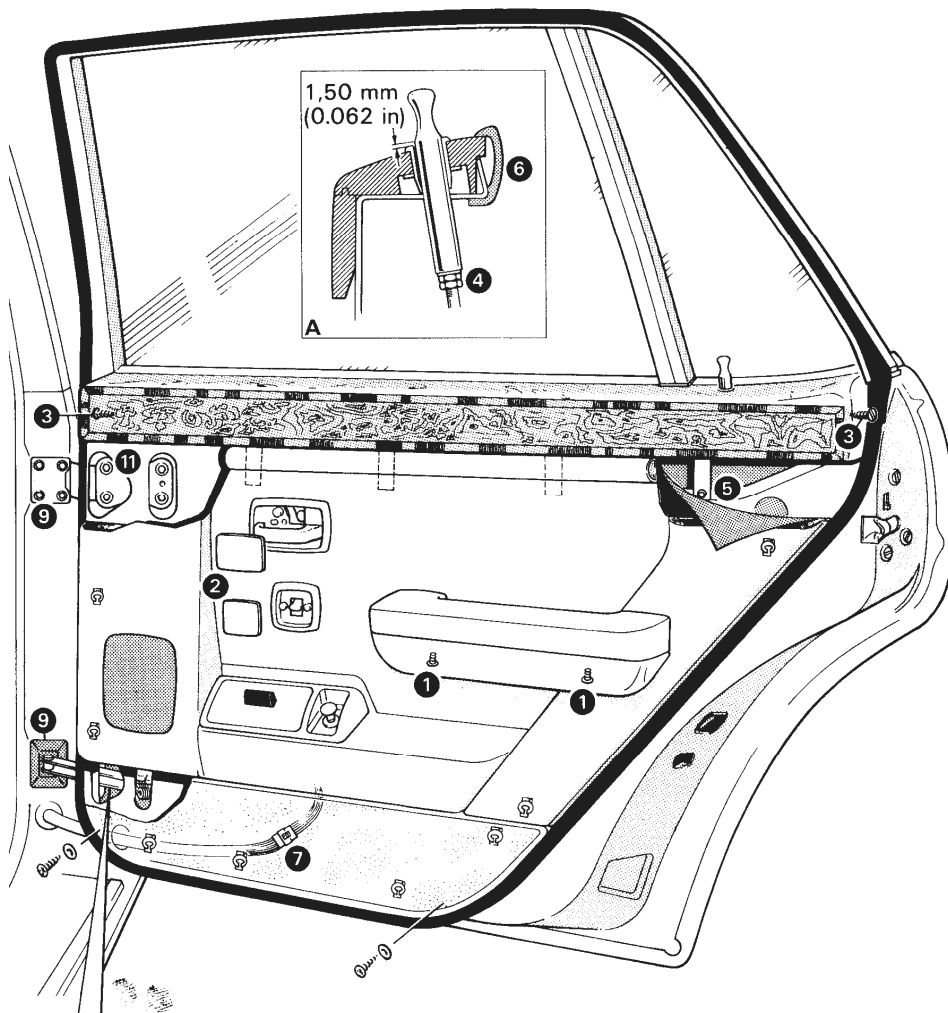
The back door presents no new problems and the method of dismantling is much the same but here is a diagram for that.

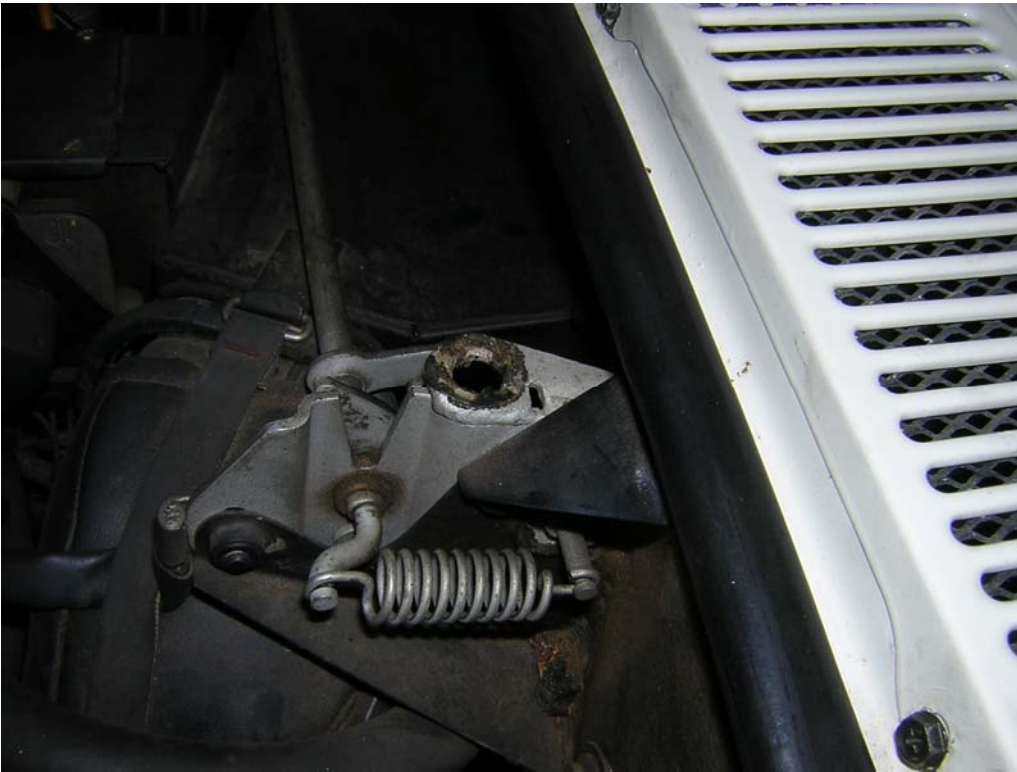
None of my readers would be guilty of this, a missing bonnet cushion – see the dirty hole in the centre and no filter on the air intake for the air conditioning. Both items are used on both Shadows and the Spirits and their derivatives. Both are important. The bonnet cushion is the only positive locator for the panel. If it is not there the thing can get damaged if slammed but more likely the sideways movement of the

bonnet while traveling will damage the paintwork. The filter of course prevents the air conditioner harvesting the local leaf population and mulching it through the fans.

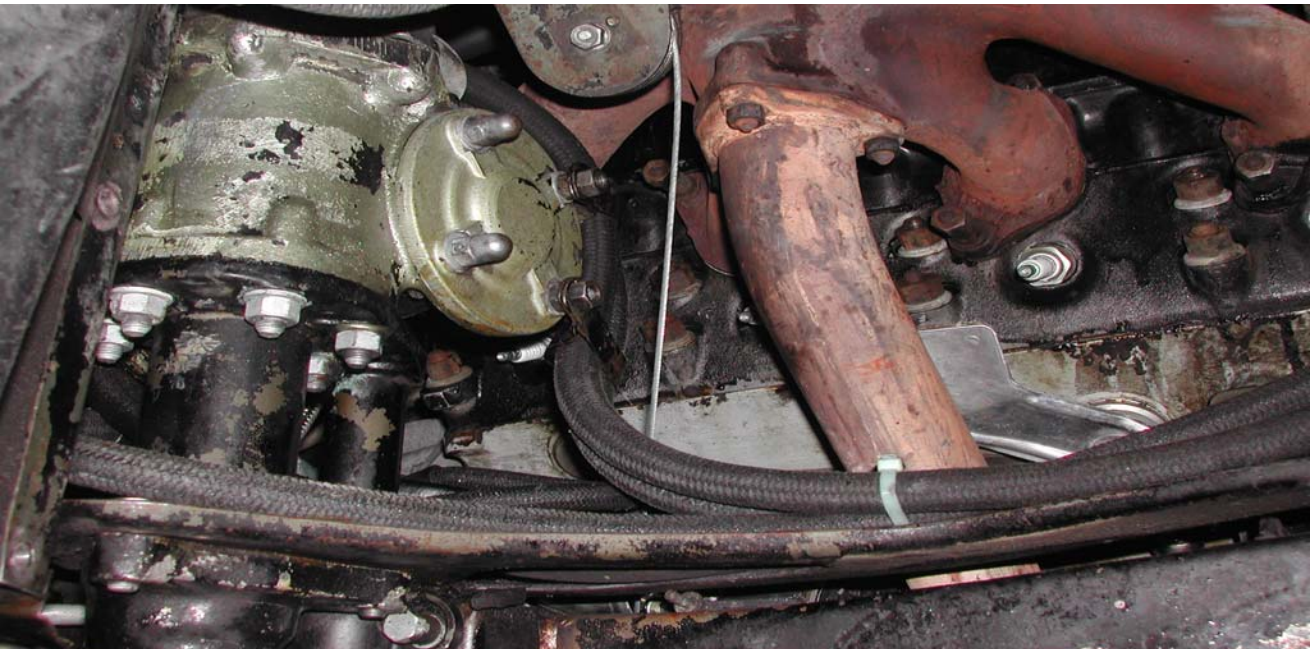
The pipes getting the oil from the pump to the box however deserve watching. Referring to the top picture again, this is a view of the vee eight engined power steering box fitted to the 'S' series cars. This would have to be the worst situation since the box is under the toe board, the push pull bit up in front of the radiator and the pump up on the engine. This needs lots of hose. The hoses on these cars most at risk are the ones seen coming over the top of the box and passing uncomfortably close to the 'A' bank exhaust pipe. It is at this point that hoses have been known to burst, spray the hot manifold and create an instant barbecue!

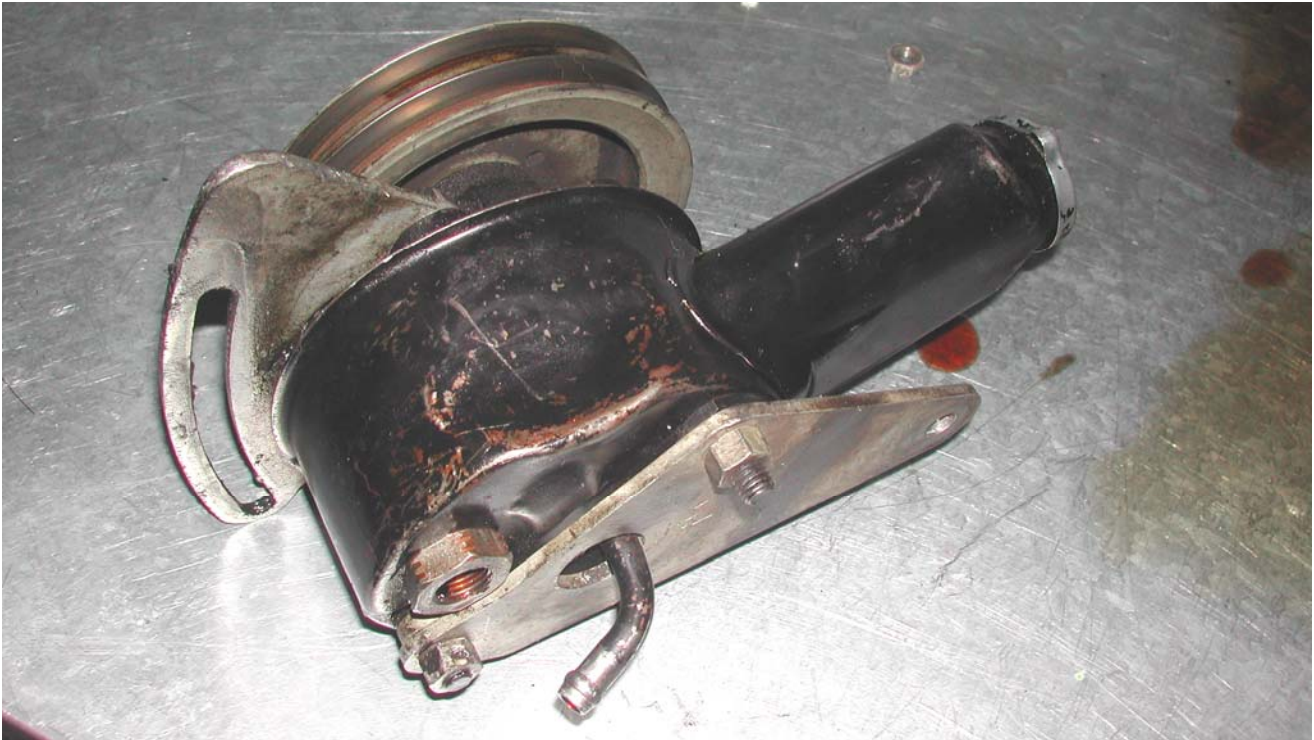
The above is a later pump used by many car makers and replaces the old Hoburn Eaton pump used on the Silver Clouds. The only repairs (apart from panel beating) these pumps seem to need is seal replacement and with age the replacement of the main shaft bearing which being basically white metal crystalises with age.

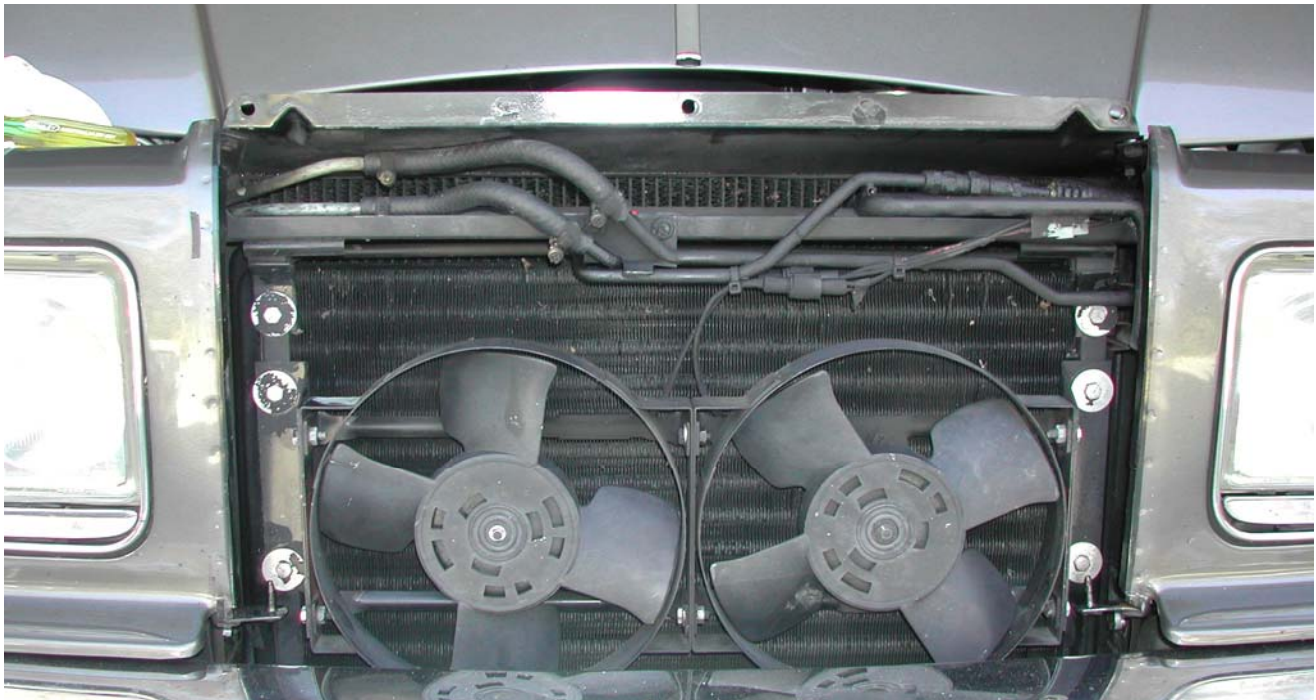
And while on hoses don't forget the little darlings behind the grille. Seen here on an '85 Spirit they connect the low pressure side of the power steering system through a variety of heat exchanger to try and keep the oil at a reasonable temperature. They are not eternal and usually dribble a lot which is difficult to pick up. But when they eventually blow the result is quite spectacular with jets of oil squirting out of the front of the grill. It is difficult to ignore at this stage.

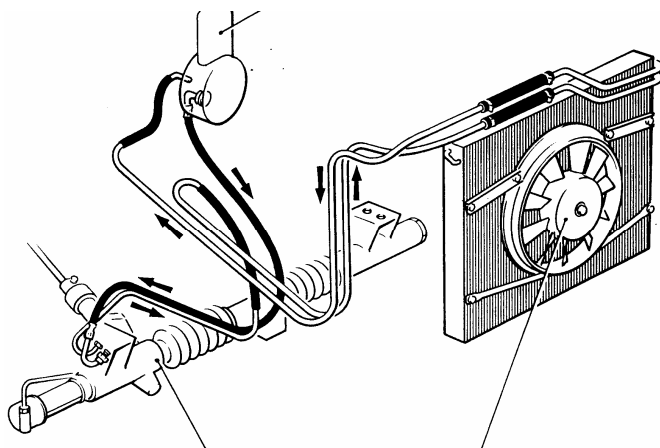
This schematic applies to the Silver Shadow II and the Spirit. The oft forgotten small hoses behind the grill are clearly shown and which should be inspected regularly for leakage.

Given the trouble many owners have had with rack and pinion units on these cars, an in-line filter on the low pressure return line is highly desirable. The filters are regular transmission units of a throw away design and are very efficient at removing damaging particulate.

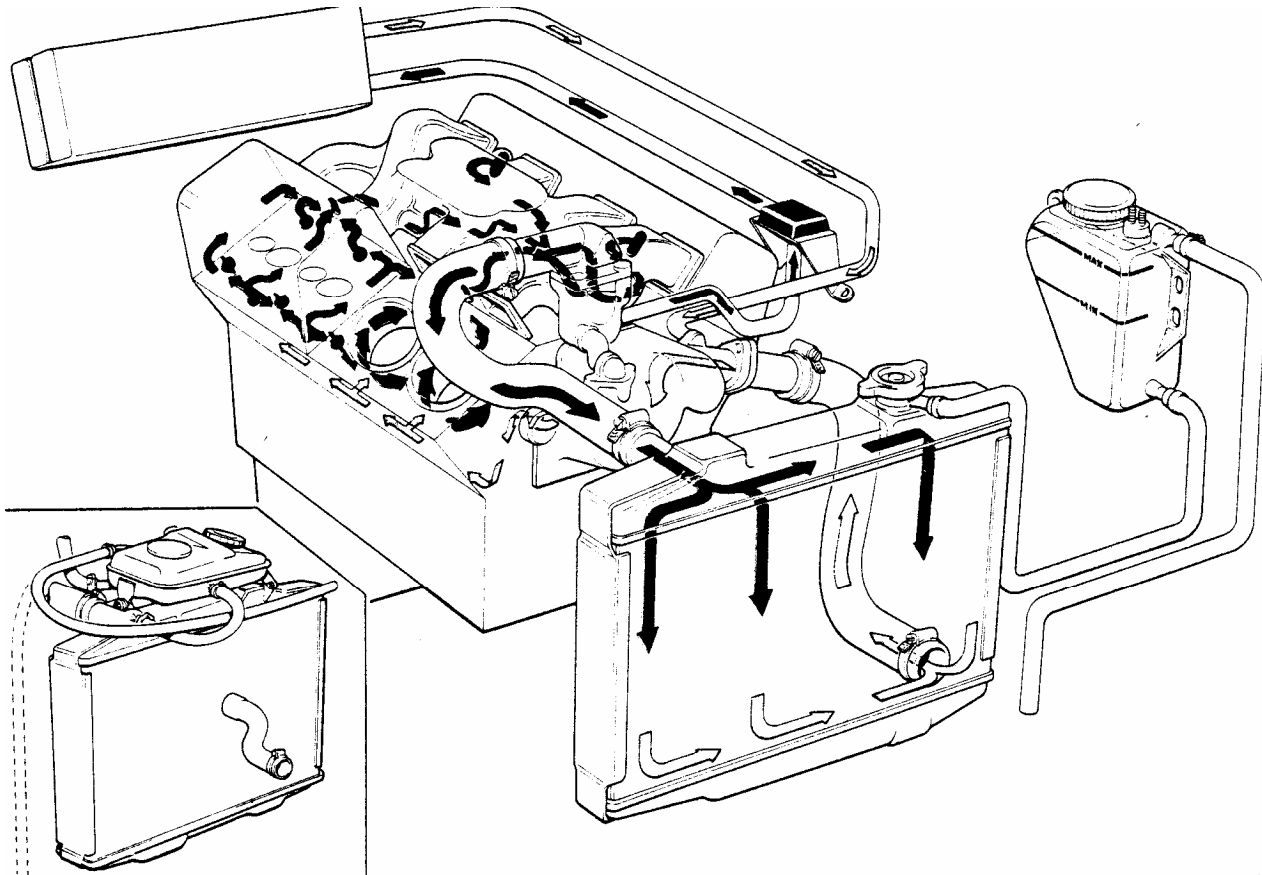
This is the original system. Water is sucked out of the lower part of the radiator through the lower hose and into the pump where it is forced back through the engine casting and emerges through the thermostat. The hot coolant then passes from the thermostat through the upper radiator hose to the top of the radiator where it descends whilst being cooled by the air flow through the radiator. As the coolant gets hot it expands and forces its way through a pressure valve in the radiator cap then passes to the coolant bottle. If the bottle which is not pressurised, fills to capacity it overflows to the ground.

When the engine cools, the coolant contracts in volume creating a vacuum at the radiator cap since the system to that point is sealed. A separate valve in the cap allows the fluid in the overflow bottle to be sucked back into the radiator until the vacuum is neutralised. At all times the water level sensor is under coolant assuming the level has not been allowed to drop below the minimum line so no warning light appears on the dash board. In the event of a catastrophic loss of fluid such as a burst radiator hose, no vacuum would be created, the engine would be without coolant but the overflow bottle would remain full. The sensors would still be covered with coolant so no warning light would appear.

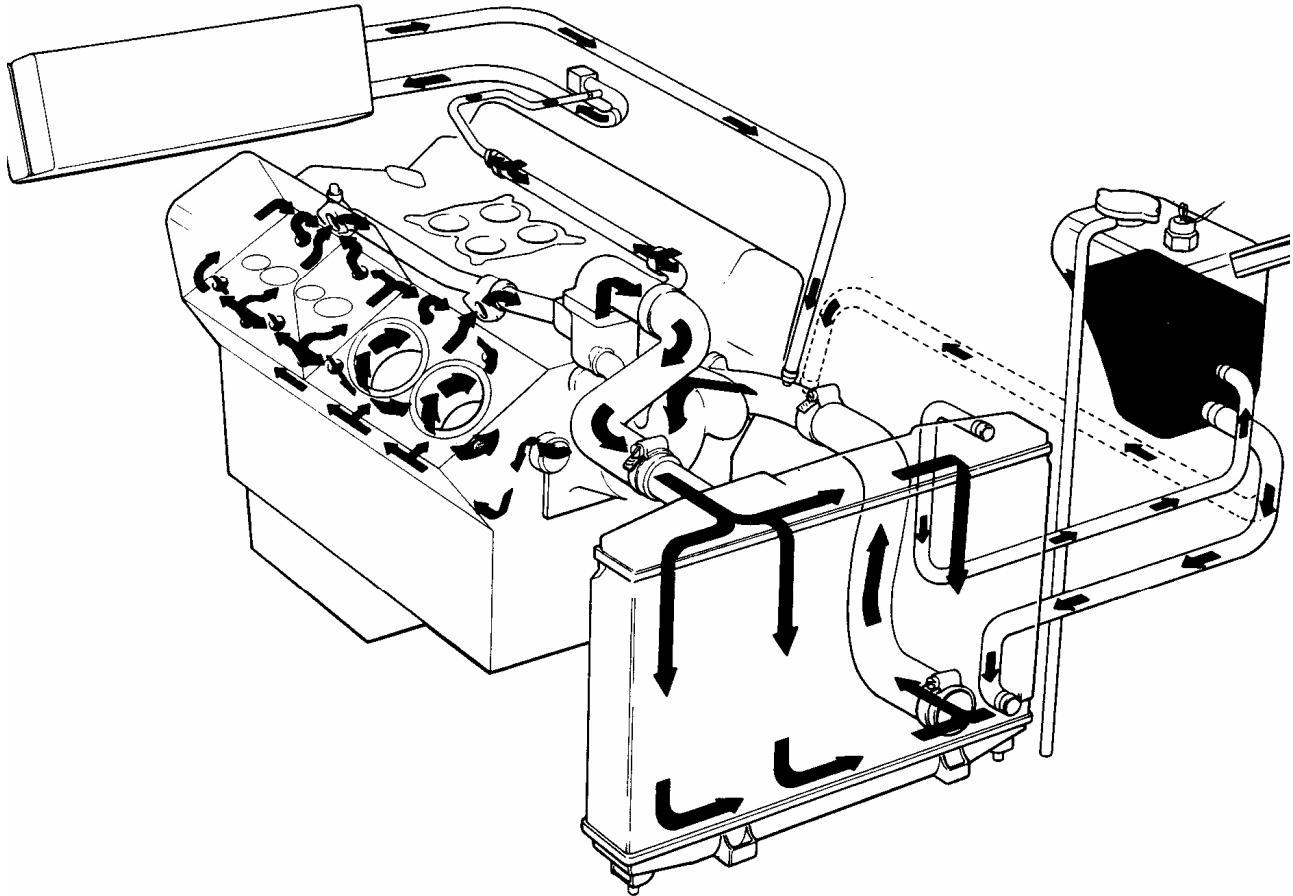
Here the overflow bottle becomes part of the header tank in effect and is itself pressurised. Note that the top of the radiator no longer has any filler cap. In the event of a major loss of coolant the bottle would immediately empty, the sensors would be exposed and the alarm would light on the dashboard. It is probably not practical to upgrade the old system but one solution seems to be to fit the audible alarms detailed in the last Topics. Silver Shadows of course don't have this problem.

Ironically the later system is simply a version of the original Shadow system except that the old brass tank is now plastic and strapped on to the left hand valance which allows the designers to lower the bonnet line.

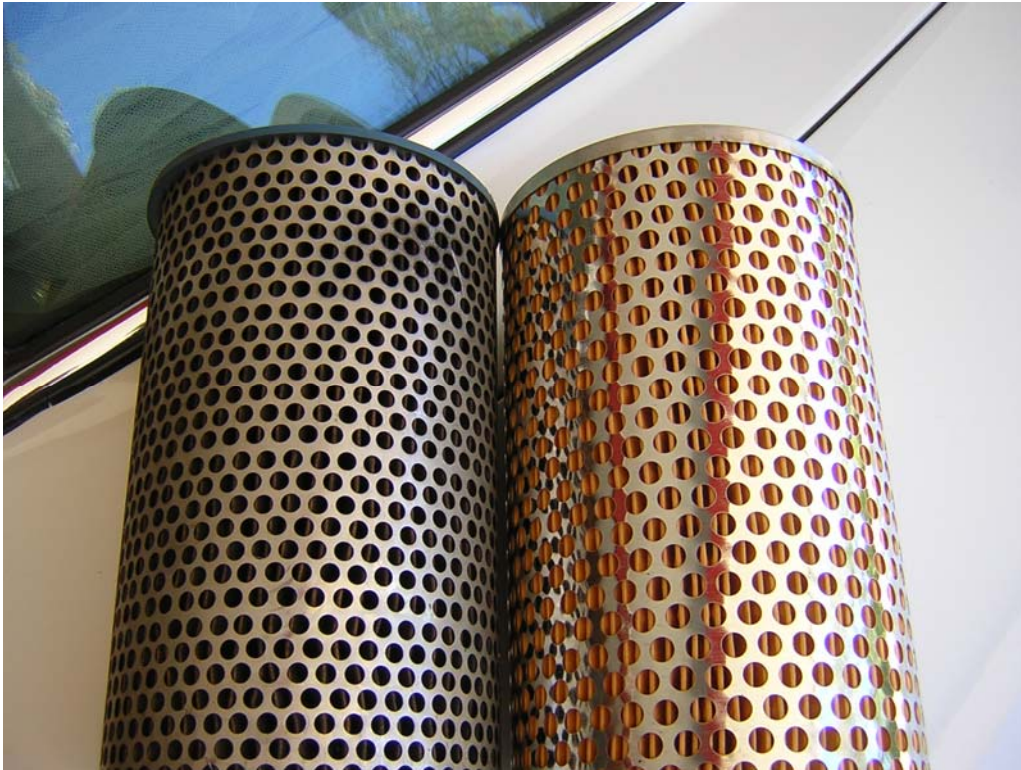
Well here is a before and after picture. Tucked away under the mudguard on Shadows it is often forgotten and even on Clouds undoing the old knurled nut is something that seems we can't remember to do. Considering the muck that we allegedly breath in our cities today, when you think of the comparative volume of air being sucked through these filters, they have a hard job to do.

A blocked filter is equivalent to pulling the choke out on the old cars, which does nothing for the engine or your pocket.

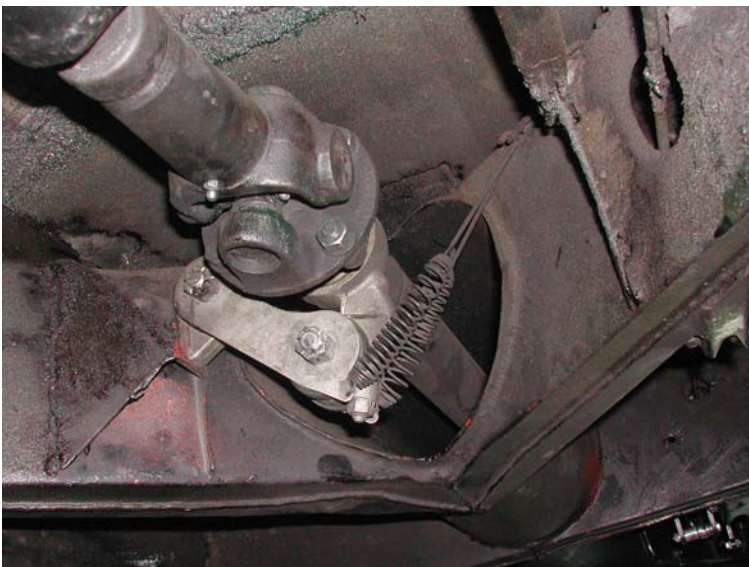
Well I hope you are wiser than before about what most of us take for granted. Actually they can figure fairly prominently in destroying a car if they come adrift or whirl. This happens when the centre bearing seizes or the support fails and the jointed shaft can then swing much like a skipping rope. This is known as 'whirling' in the trade. The total weight of a tail shaft assembly on a Silver Cloud is of the order of 30 kilos and it spins as fast as the engine. I will leave it to you to imagine the energy that would be unleashed.

This is the centre bearing arrangement for all postwar Rolls-Royce cars. The support 'arm' connects to the chassis via one bolt seen high up on the left. Between the arm and the mount there are friction washers and rubber packings. The castellated nuts are done up to a specific tension which holds the support at whatever angle you wish. The springs apparently augment the support but as will be seen above they have been strained beyond their limits.

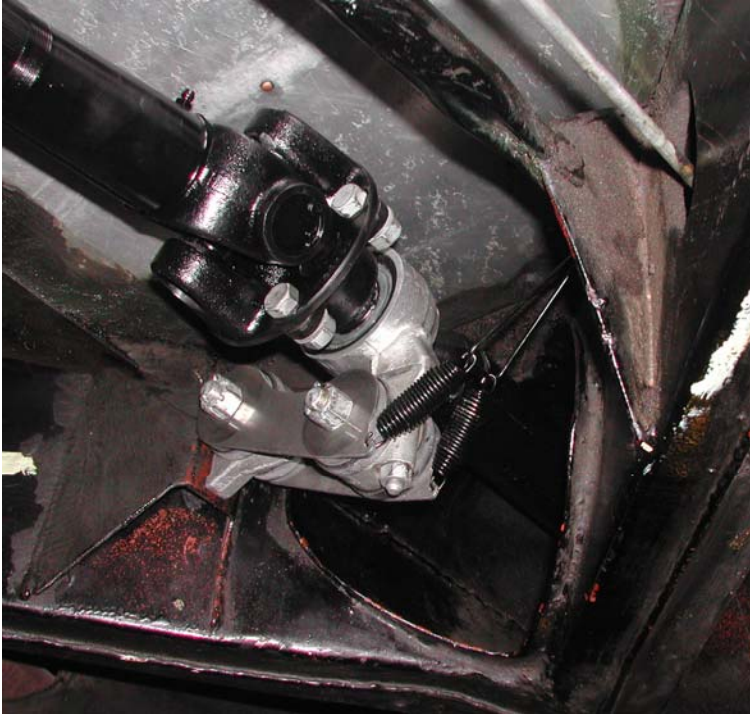
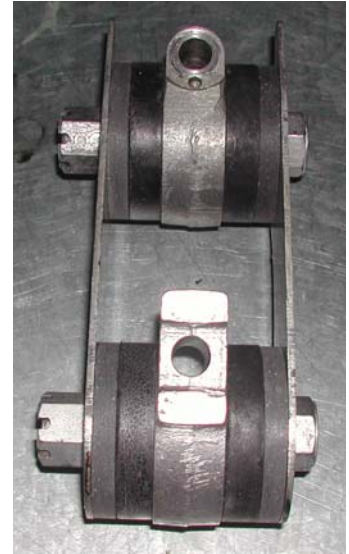
Above is a happier assembly with new washers and springs as well as new carden joints and a centre bearing. Recently I had a nice ride in a dear old 20/25 HP. The owner was reluctant to exceed 55 MPH at which speed there was a very intrusive high speed vibration. The source had to be the tail shaft and this was proved when the car was put in neutral and allowed to coast. The vibration stayed. The cause was probably worn universals and general unbalance.

At top right is a better view of the support arm assembled with new washers. These have not been tensioned yet which is done when the shaft is in position. The finished assembly is sufficiently stiff so that it cannot easily be pulled down but does have a spring in it.
