TEE ONE TOPICS

Number 41 December, 2004

ALL THAT GLISTERS IS NOT GOLD

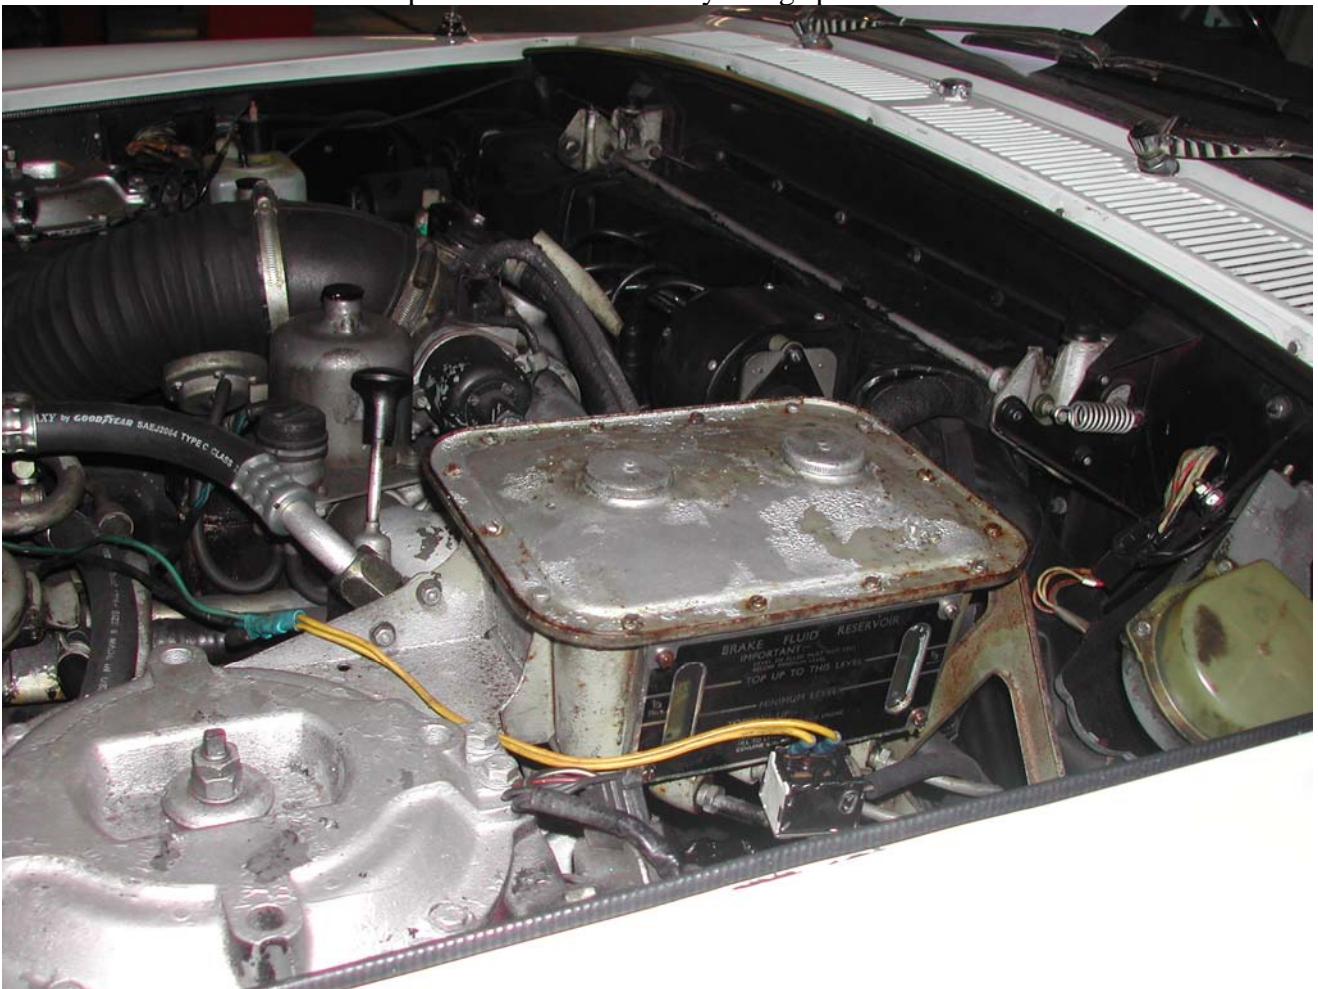
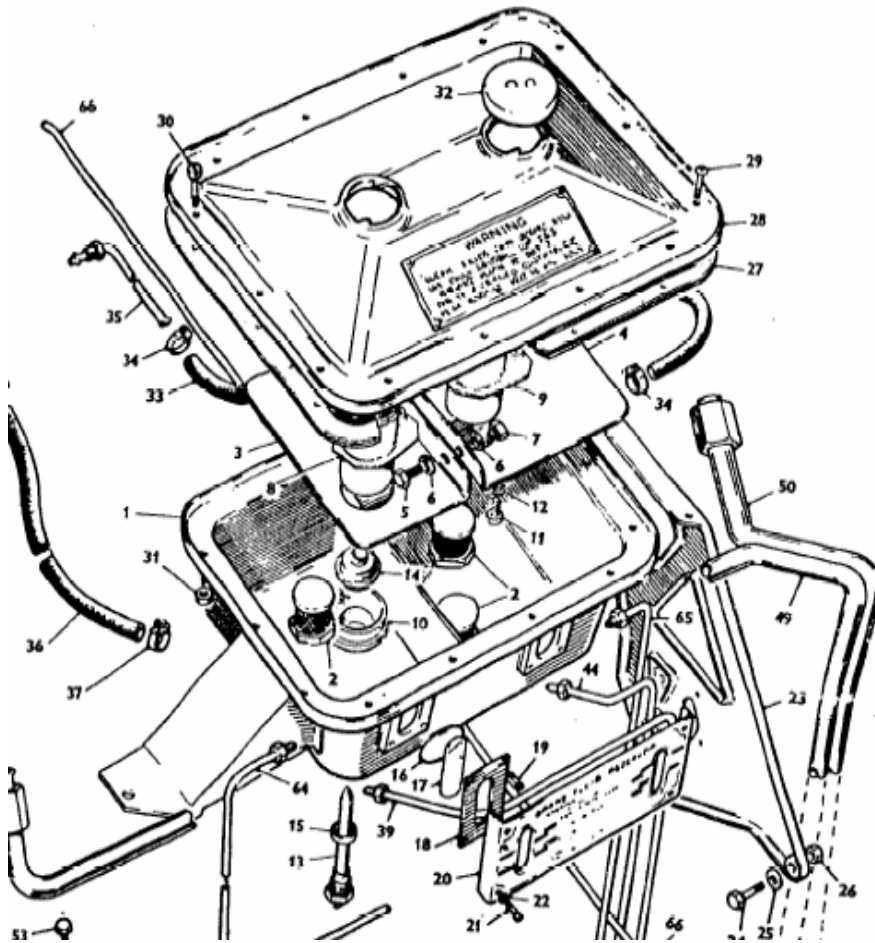
In talking about these bits I am using reference numbers that refer to parts shown in the Spares Book diagram pasted into this story. The main body can be a challenge. There were I think four iterations mainly to cope with dropping the little master cylinder feed (the lower outlet of the two shown at 2 above) and fitting reed switches (13) for the low fluid level indicators apart from changing the mounting arrangements (23). They all had common sight glasses (17) which are literally windows on the hydraulic system. The two glasses are located on 'O' rings (16) in recesses in the front of the reservoir. Two oblong plates with suitable apertures (18) are screwed over the glasses and the 'instruction plate' screws on over them. And here is the last major challenge. The four screws (21) holding the 'instruction plate' (20) usually come out quite easily. The aperture plates beneath them though have four hexagon head countersunk screws (19) that can be quite difficult to remove. If firm pressure with the Allen key won't release them try placing the side of the reservoir over an anvil beneath the screws. Place a flat round punch that just covers the screw head on the screw and give it a belt. This will usually loosen the thread and the little darling will come out. If you have to resort to drilling etc take it to a machinist and have him do it properly. The screws are still available.

Get all the bits except the countersunk screws plated including the remaining screws and bolts and plates. Have the filters (2) repaired if they are damaged and check that the reed switches still have their terminals. Make sure you use brake fluid compatible 'O' rings in the sight glass recesses. If they are not they will swell up and you will see nought. When you are replacing the screws be sure to douse the threads in anticorrosive grease for the benefit of the next poor sod.. Replace the low pressure feed hoses (36) with the correct brake fluid compatible items not fuel hose nor

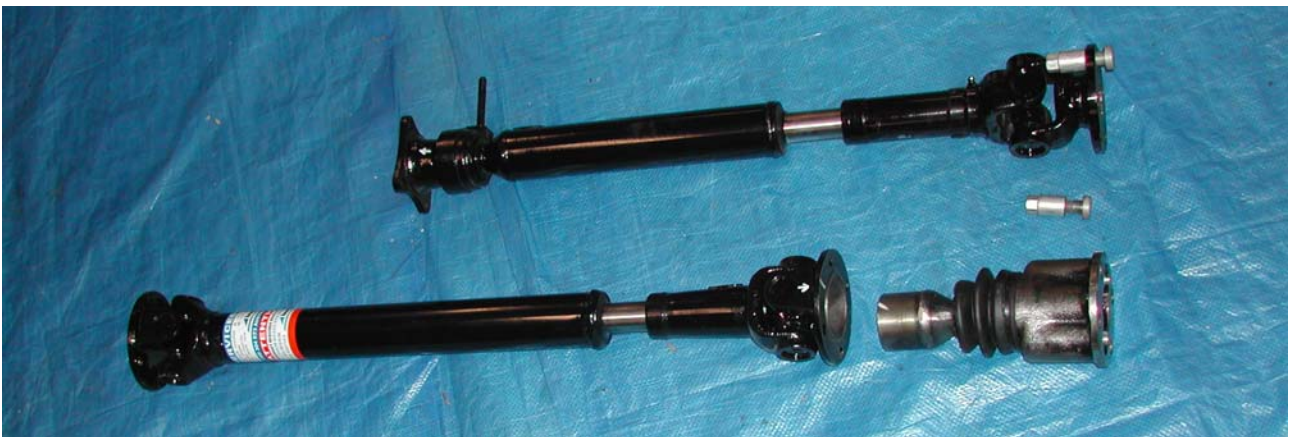
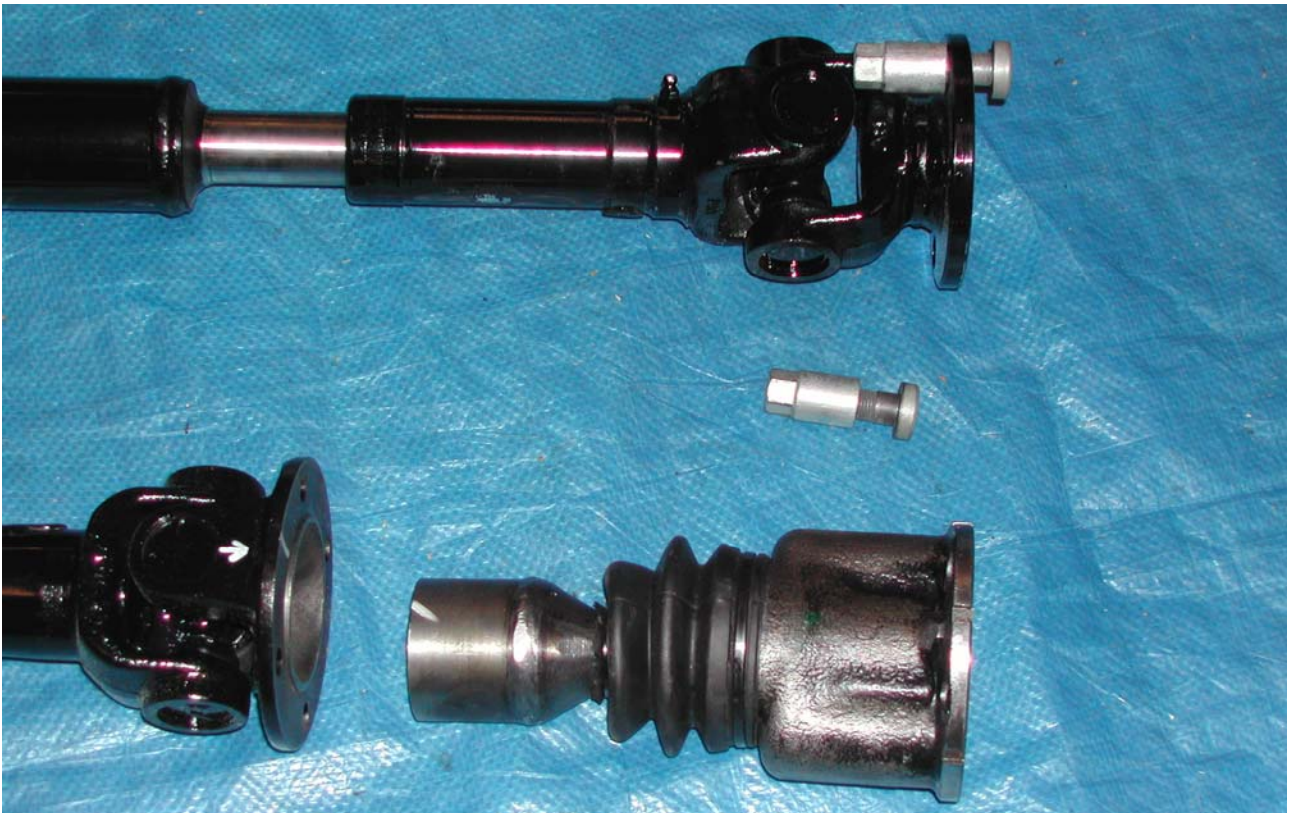
After the last issue of Topics I had a couple of mild scoffings about the damage that can be caused by a tail shaft, propeller shaft, call it what you will, that had got out of control. Just take my word for it and if you are still sceptical feed into your Google Machine tail shafts and see what they come up with, particularly with trucks! Meanwhile we have had a Cloud with a very perished rubber boot on the back of the front CV joint and quite worn universal joints on the rear shaft, not to mention a fairly worn centre support bearing!

The rear shaft shown as the lower one in the two pictures posed no great problem as the universal joints are perfectly standard Hardy Spicer units as is the sliding joint at the front of the rear shaft.

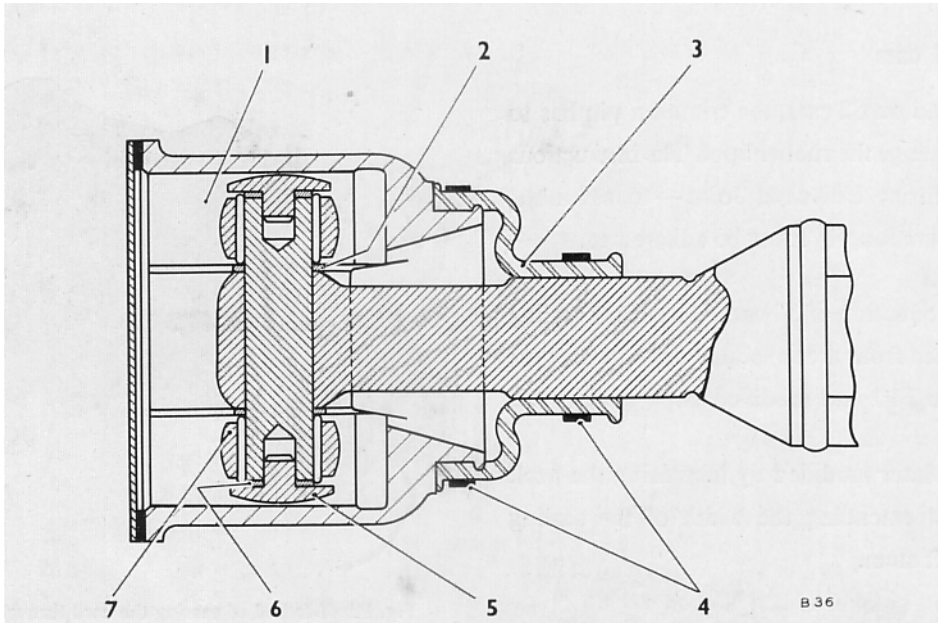
But then we needed to address the front shaft where the Factory fitted a plunge type CV trunnion joint as a means of minimising shaft vibration. As will be seen in the cross sectional drawing below, these not only provide for flexing of the drive but also longitudinal movement. With this car it was found that there was very considerable wear in the trunnion. The severed joint above has had a non standard boot fitted to replace the original item which was perished and broken. If you want

Having found the joint worn I enquired about the replacement cost of the trunnion (1 in the drawing) without the associated pin rollers and buttons. It was apparently \$3600 and since we couldn't get one the colour we wanted (joke) we decided to scrap the

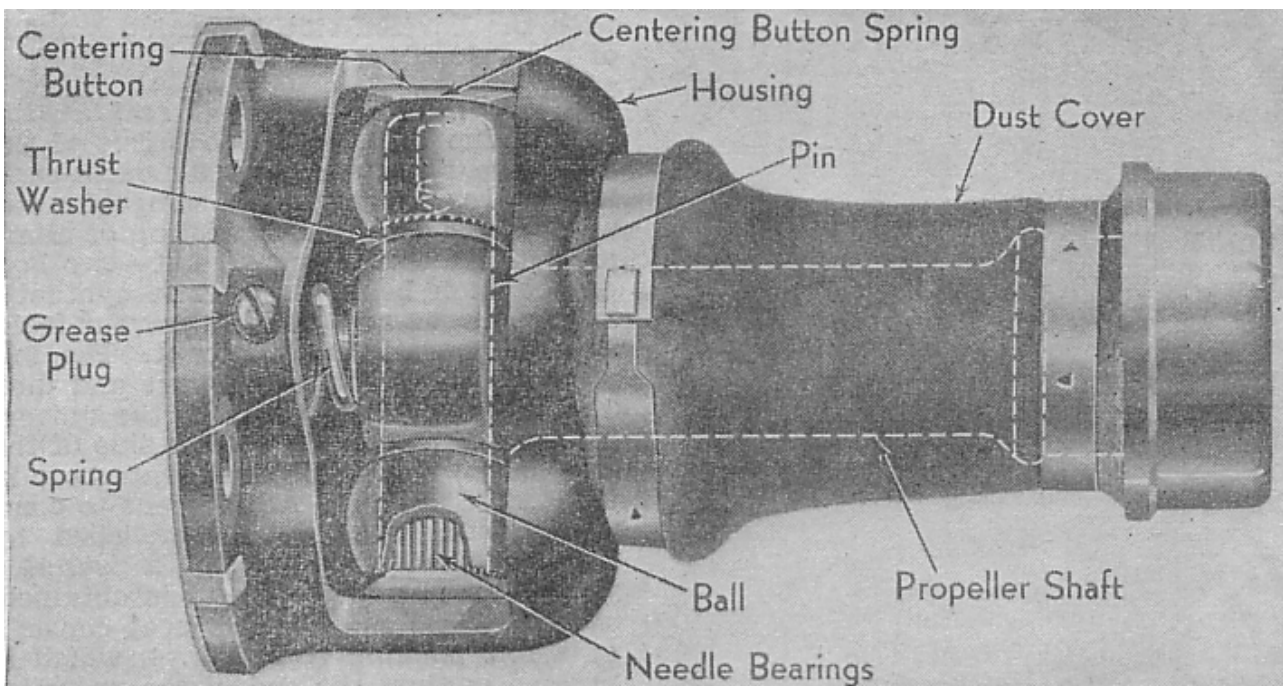
design. The alternative universal and slip joint is shown fitted. This is the standard approach to this problem I am advised and having had it applied some 20 years ago to a local S2 Bentley with complete success, I have no doubt this latest application will be similarly successful. What is important is the subsequent balancing of the two shafts AS A UNIT. This of course has to be done by specialists who will paint correlation marks on the adjacent joints as they were setup in the balancing machine.

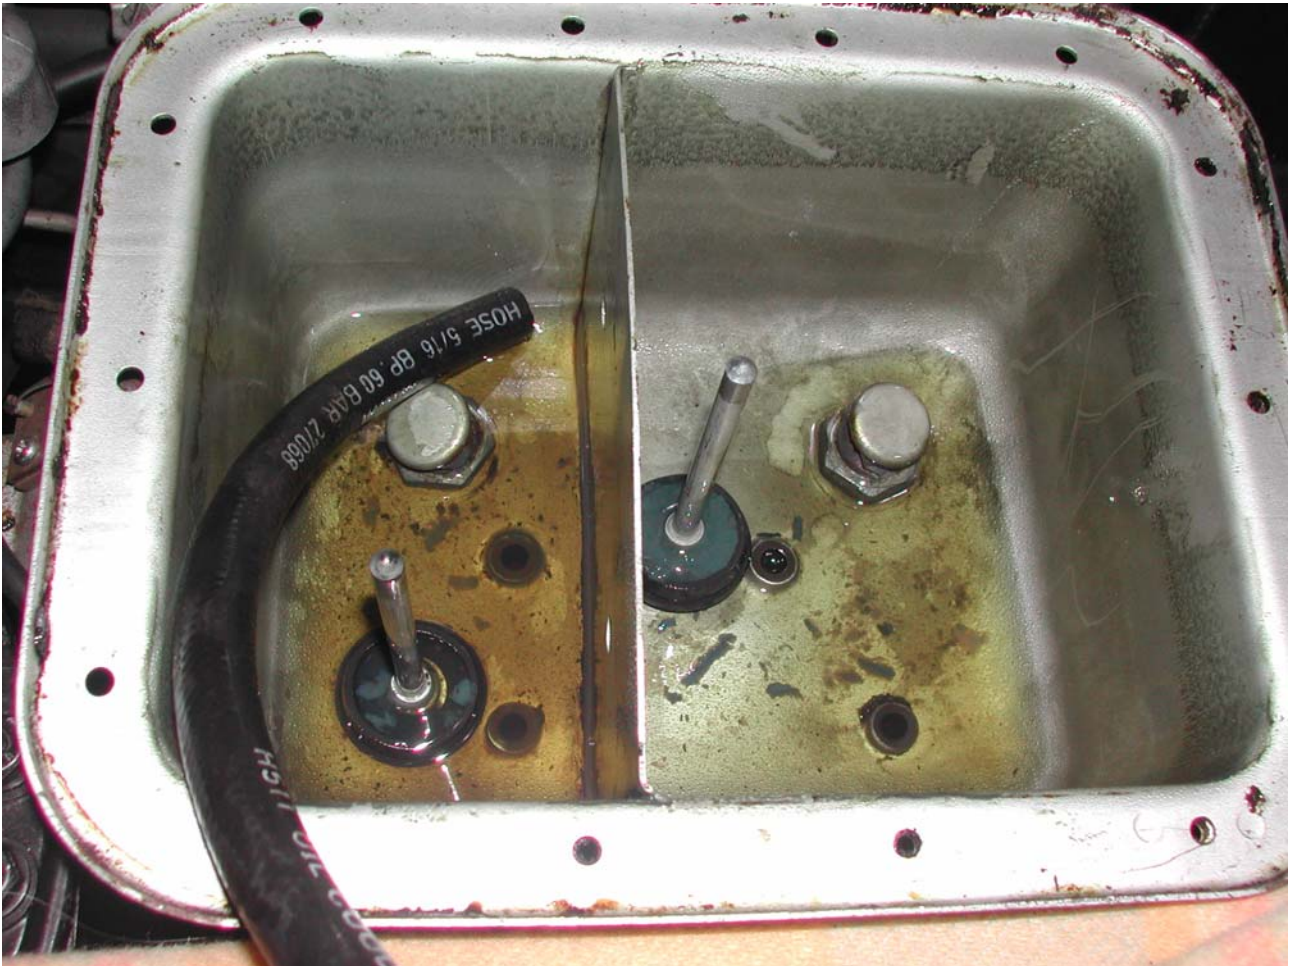
Back to reservoirs and here is a first hand example from an otherwise immaculately maintained Shadow II. This car had all its brake hoses replaced 12 months and some 7000 miles previously. Needless to say the system was thoroughly flushed and refilled with the old version of RR363 not that the latter category would deteriorate any faster than the new stuff. At any rate the muck seen above accumulated in that short time. After cleaning out the reservoir some 8 litres of the new RR363 were flushed through the system and it will be interesting to see the bottom of this container in another year!

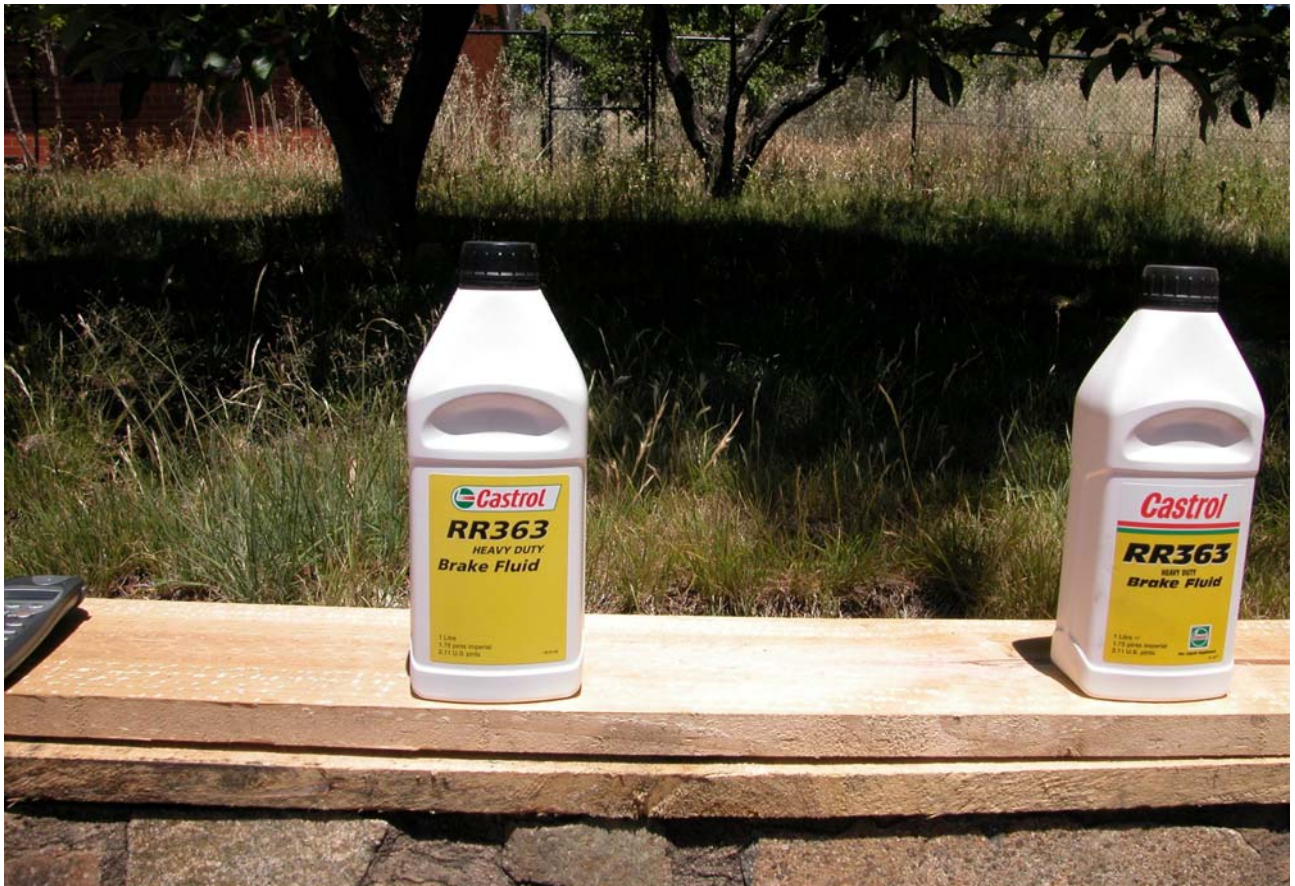
IT'S HERE!

After seemingly interminable argument, diverse intelligence, hearsay and anecdote the 'new' RR363 has arrived on the shelves of your nearest Castrol outlet. The only supplies I was aware of previously were from the local Bentley Dealers at \$24 a litre. The new supply is the same price as the old at \$12! The one on the left with the special logo at the top of the label is the 'new' one.

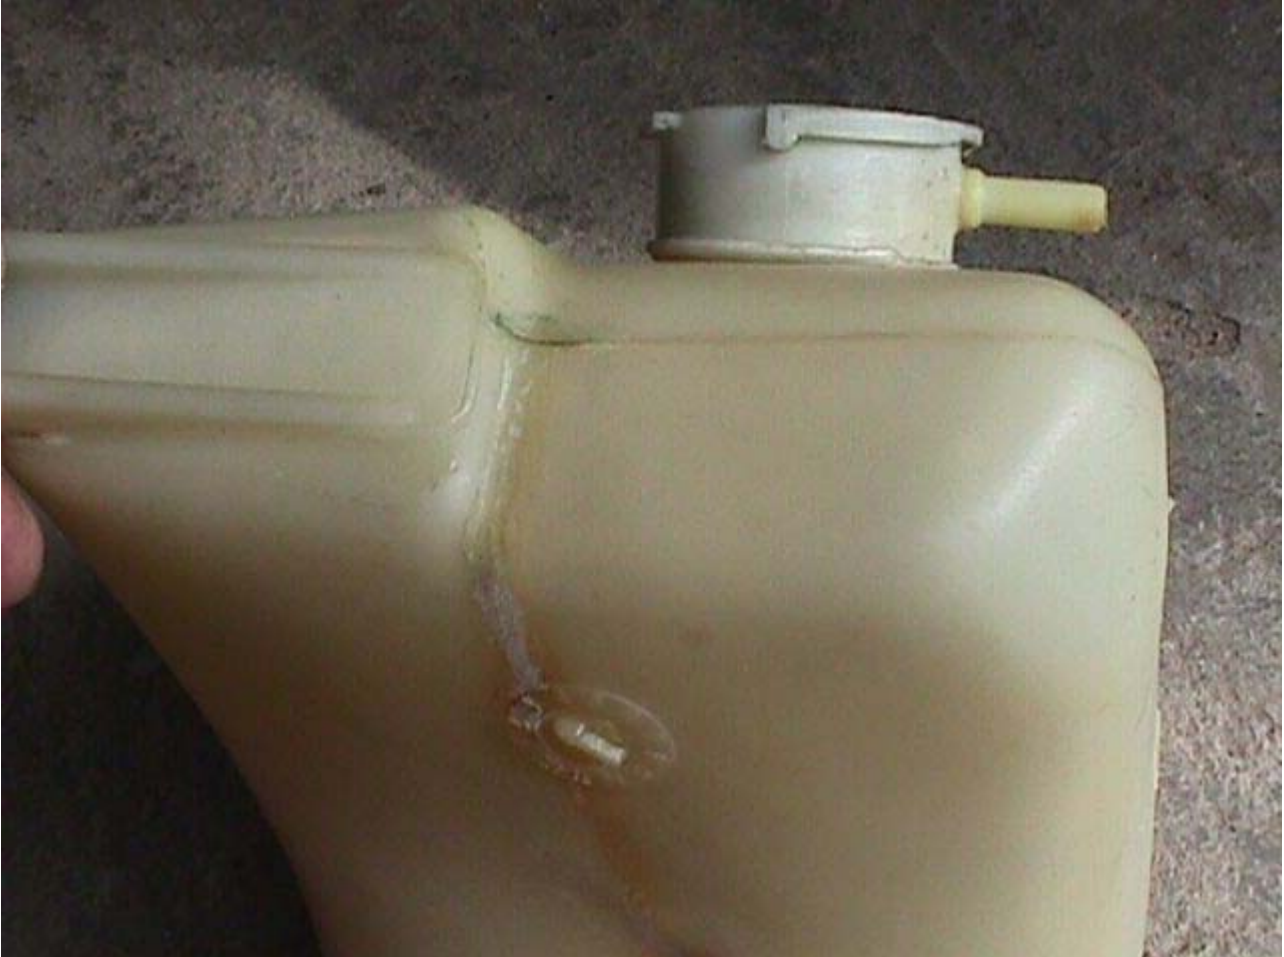
installed the Turbo R's coolant bottle last night after work and here are the pictures of the failed unit removed. One is, as we would more readily recognise it and the other, a close up, shows the staining from the fracture in the seam weld almost at the top of the unit, well above the high mark for the coolant. While almost no loss of water has been detected during my two years as custodian, there was however, no pressure in the system it would seem. This only became evident late last month, the day we had a rally to Palm Beach via the northern beaches of Sydney. It was a very hot day reaching about 40C. In really heavy traffic the temperature gauge climbed to the extreme high end of normal. I turned off the air conditioning and drove with the windows down which was rather pleasant, along by the beaches. Once the traffic thinned and a decent speed was attained, the temp gauge returned to normal. I thought it was the electric fans not working but all was normal in that department.

I would think that an annual pressure test by one's friendly radiator man might be good practice as well. As you might well imagine, if the fracture had been a little further to the left it would have been obscured by the wiring loom. I will be testing the car on the next "Stinker" and duly report the results. Hopefully it will be good news.

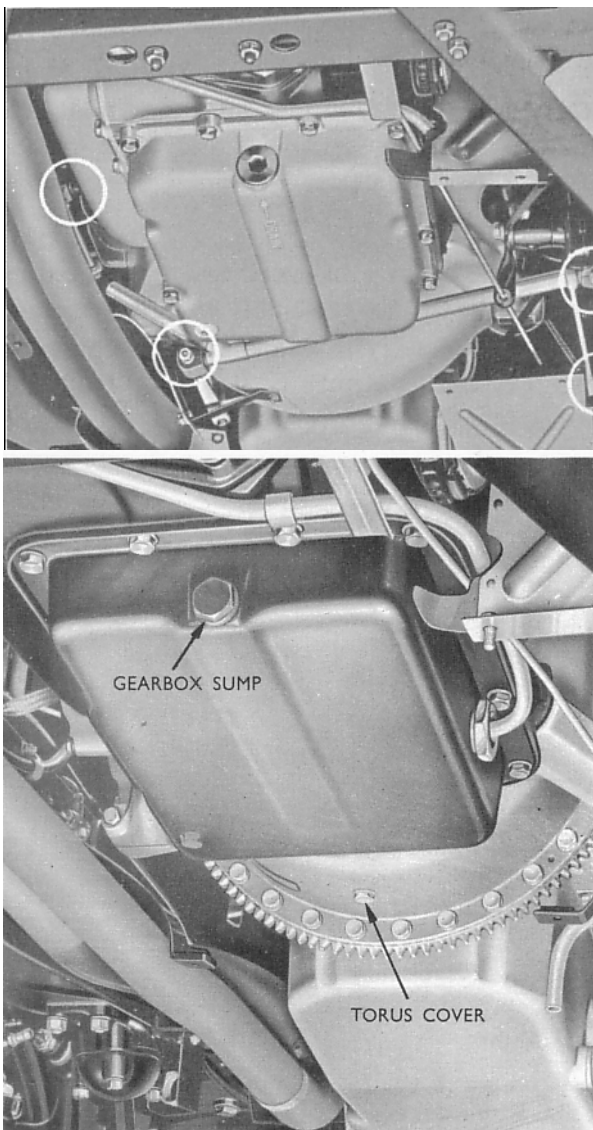
Preferably this is done at the same time as draining the sump. The catch is that it involves more work and disturbing some more bits. The circled bits to the left are the disconnection points for the gear change mechanism. This is also a good time to clean these joints out and if necessary fit new boots, grease the joints and adjust them so that there is just no play. Having got the levers etc off the next step is to remove the torus cover just ahead of the gearbox sump.

The picture below shows it all. Obviously you will have to turn the flywheel round with your hands to get the drain plug to this position. The little plug in the cover has a very small thread so should you drain the torus be very careful to just nip the plug up preferably with some nice Loctite on it to stop leaking and coming undone! Modern torque converters are virtually undrainable so an oil change in one of the later boxes is always going to leave a bit of the old stuff behind. Given that only a pint of oil is left behind in the torus in the early boxes, it hardly seems worthwhile risking stripping the plug and/or having to take off the levers etc.

The more observant of you will identify the chassis in these pictures as that of an 'R' Type Bentley. That is because my manuals on this box in that model are the best. The pipe seen coursing around the sump in the lower picture is for the hydraulic ride control used in the pre-Cloud days! And
