TEE ONE TOPICS

December 2005

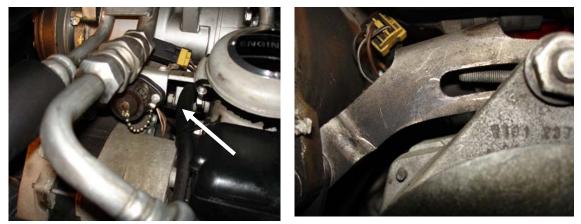
I have doctored the drawing with blue call-outs to show where the adjusting points are. Fortunately they have provided screwed adjusters given the tensions needed to drive these things. The extra large arrow on the lower mount of the air-conditioning compressor is a hexagon head bolt carefully placed behind the compressor belt. It is very very tight and will

need a long Allen key chucked in a holder and turned with your favourite ratchet to remove it. Next down is a picture of the rear lower mount for the compressor (arrowed). Note that you are working with metric spanners here. The nut is approached from under the compressor from the other side.

If you have a seeing-eye Gerbil to help you, you should avail yourself! Incidentally the bath plug and chain cover is the first of the engine management system diagnostic ports. You just plug your box of tricks in there and it will tell you everything! To the right below is the adjuster for the alternator.

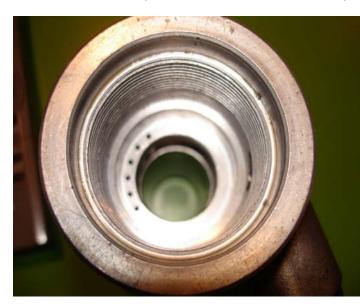
A not particularly good picture looking from the business end of the master cylinder on a Silver Cloud. The bridge piece that wears is seen with half a dozen replenishment holes in it and the end of the sleeved cylinder can be seen behind it

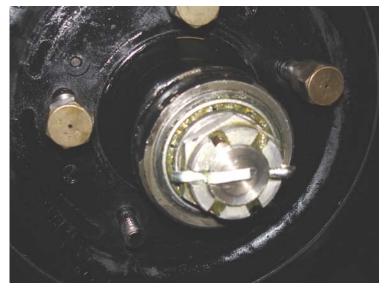
And here you see the set up. There remains a problem in that the nut that holds the wheel on needs to be locked to the axle with a split pin. And this is what some cretins do!

Clearly the head of the split pin has to enter one of the slots on the nut but then the legs of the pin can only open along the axis of the stub axle as above.

The solution is to twist the pin before inserting it by clamping the split end firmly in a vice about an inch from the head and

using a small adjustable shifting spanner turn the head through 90 degrees.

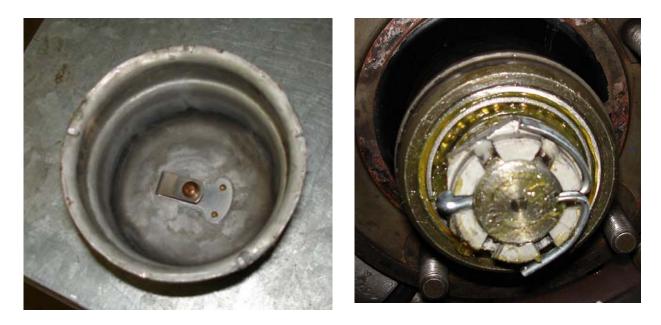
Put this modified pin through the hole in the axle and the pin will then fold nicely around the nut. The purists would want to tuck the end of the pin into the slots. The size of the split pin by the way is 5mm at least 4 inches long which you can buy at specialty fastener places. When you find out where to get replacement earthing terminals and rivets let me know.

So having followed these instructions you should retain the terminal in your cap seen at the left if you splay your split pin as seen on the right!!!

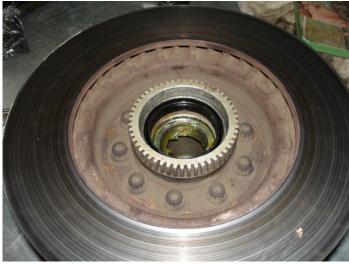
And here is the notched wheel referred to above known as the phonic wheel. Technical designers must struggle to come up with names for their gadgets. I went off to Mr. Oxford to check once again whether my etymology was suffering through age and confirmed that the word phonic is still linked to sound. But there is no sound here just magnetic fields! You can also see the freshly greased up inner wheel bearing its retainer and two seals to keep the innards clean

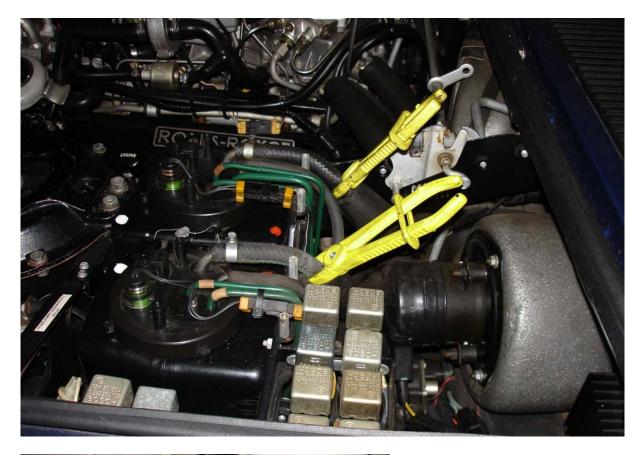
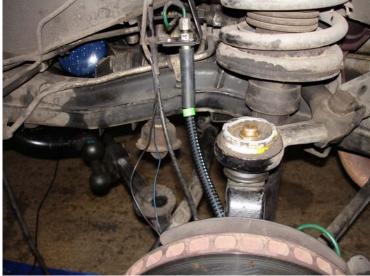
The job is not difficult and well within the capabilities of the gifted amateur! Although you will be changing all the brake fluid as a matter of good maintenance, you don't want the stuff dribbling all over you while you work. So clamp off the supply pipes on top of the those quaint reservoirs. Note that unlike earlier cars these syphon the fluid out of the reservoirs rather than dribble it out from their bottoms.

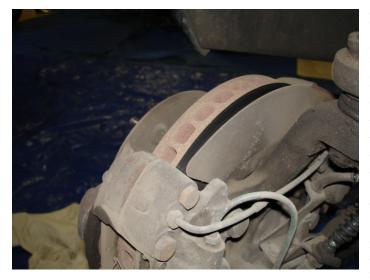
One of the early shocks you will have is to find that you have only one brake hose to your wheel. This was dictated by the ABS system. The ABS sensor wire can be seen paralleling the brake hose and the other wires are for the pad sensors!

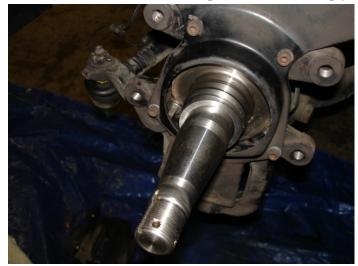
A view of the cleaned up stub axle and baffle plate. The ABS sensor now de-frummed can be seen lurking behind the baffle looking for its phonic wheel! On the stub axle is a very important spacer that all Rolls-Royce axles have which allow the inner wheel bearing to settled where it is going to sit in the assembly. Sometimes, the unwary drop these spacers in the kerosene and forget to put them back causing seriously furrowed brows when the hub goes back on!

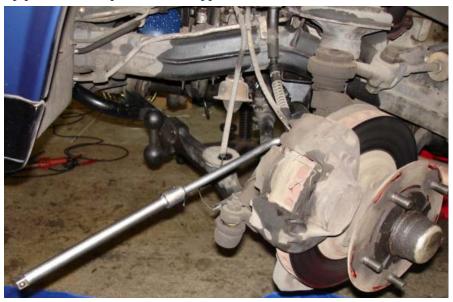
Unbolt the calipers. These are held on by two fitted **metric** bolts that were not only well tightened but having been subjected to heat and grot so are very tight. Use a socket

and long bar to save your temper, knuckles and the surrounding machinery. The calipers should just lift off. If at this stage you find a substantial lip around the edge of the rotor, find a visiting machinist who will come to your car and grind the rotors flat, removing the wear lip from the periphery. This is probably preferable to removing the rotors and having them machined on a rig. In situ the rotors finished relevant to the car. This man will also measure the thickness of the rotors since there is a minimum dimension for safety which is stamped into the outer rim of the rotor. If this has been exceeded wash your hands and go out and drive taxis for a month or so to pay for the new rotors.

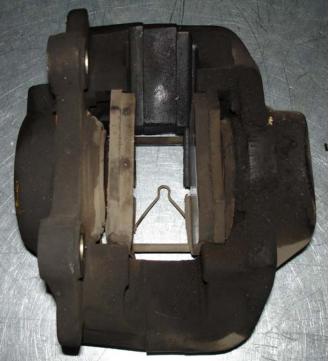
And here is one very dirty calliper. Note there are two halves with metal spacers between. Every instruction you pick up tells you NOT to break the

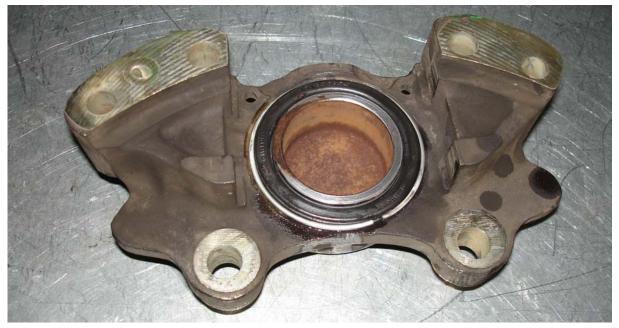
And here we have the piston, all cleaned up and a new dust seal fitted to the top lip. Using your mineral oil brake fluid in this case lubricate the piston and inside the cylinder and press the piston into the calliper. Don't force it. It has to be exactly square toft and two thumbs pressure is the maximum allowed for entry. Push the piston right to the bottom of the calliper and the dust seal will fit itself nicely around the top of the piston. You can then expand the dust seal retainers

And press them right down to the calliper face as below.

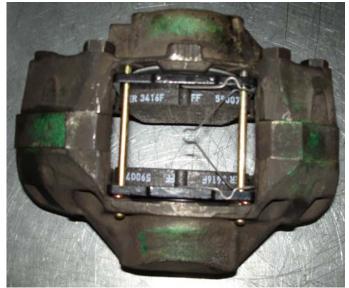
And here we are all together. The spacers between the two halves can be clearly seen together with the new pads. The anti-rattle spring is a bit fiddley to get in. There is one in each calliper and note that the nipple shaped 'pointer, points in the direction of normal rotation of the wheel. Put the pad retaining pin through the pads and the spring before you try and insert the legs of the spring into the holes drilled in the centre of the pad backing plate. Without stretching the spring, slide one half back along the pin just enough to get the leg in the centre hole. Then repeat for the other side. The pin retaining clips should fit comfortably and not be gouging the dust seals not jamming into the walls of the recess in the calliper. It remains to refit the calliper and torque up the retaining bolts. Try and do one calliper at a time and keep all the bits together. Clean out the reservoir and bleed the brakes. Next issue we should be able to talk about pad sensors and their fittings.
