# TEE-ONE TOPICS

Number 59 December, 2006

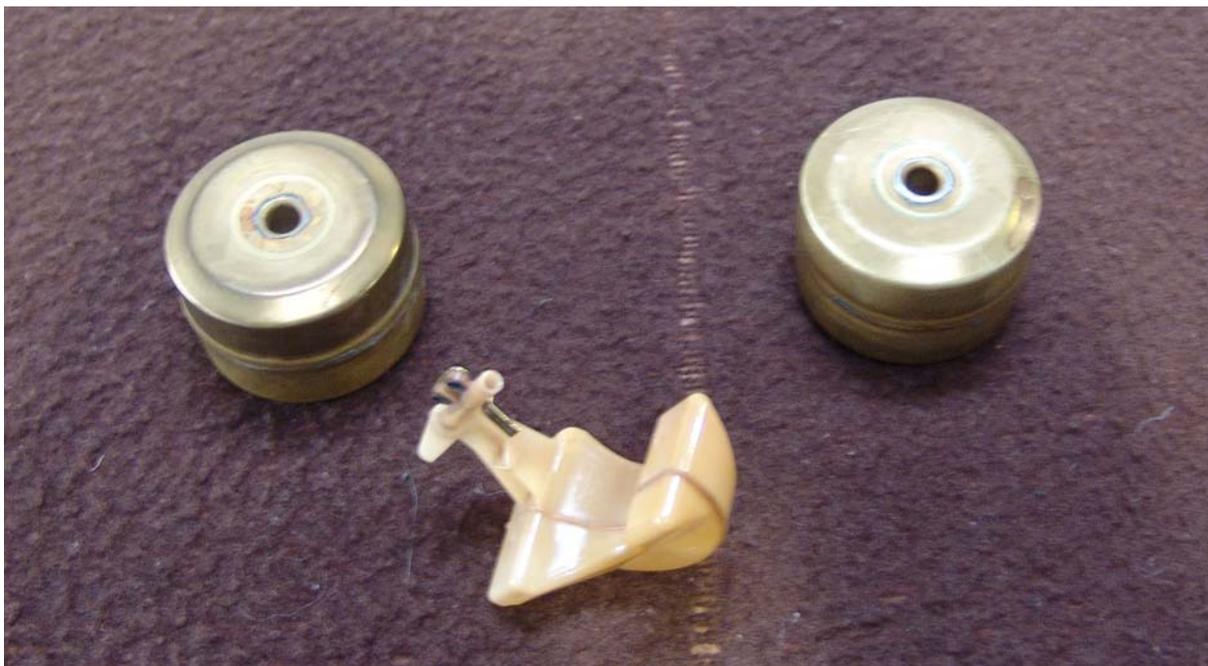
NOT, as modern argot would have it. The copper floats pictured on the previous page came out of an ancient S1 Bentley which staggered up my precipitous drive recently trailing a small stream of fuel. Having confiscated all matches and cigarettes on the property I lifted the bonnet to find fuel running out of the front carburettor from beneath the lid. Ignition off removed the lid and the float chamber was fuller than the family po! The float was however submerged!! First guess before the lid came off was a defective jammed or clogged needle valve. A submerged float however killed that diagnosis.

A couple of dental picks from your local fang farrier are the best tools to draw out the float which usually defies all attempts to grip it! The float out and held to my shell pink ear with a spirited shake and lo the sound of sloshing fuel. The thing had leaked, settled lower and the fuel had to rise that much more before the float could push the needle valve shut. Old hands will tell you they are repairable but if you think about it they are just not worth the trouble. To do it properly you would have to boil the fuel out of the float then weigh it exactly. You can solder the leak hole and then adjust the weight by paring off solder on other joints so that the finished weight is as the original.

Fortunately, I had a couple old floats. To test that they didn't have holes in them I immersed them in boiling water and watched for bubbles caused by the air inside the vessel expanding! No bubbles, popped them in the chambers cleaned the filters in the lids and all was right with the world again. No leaks. The car ran like a spastic nematode and it was very tempting to fiddle with the mixture screws. I didn't. The 'rubber' diaphragms were probably the originals, brittle as glass and any forced movement would have them cracking and leaking!

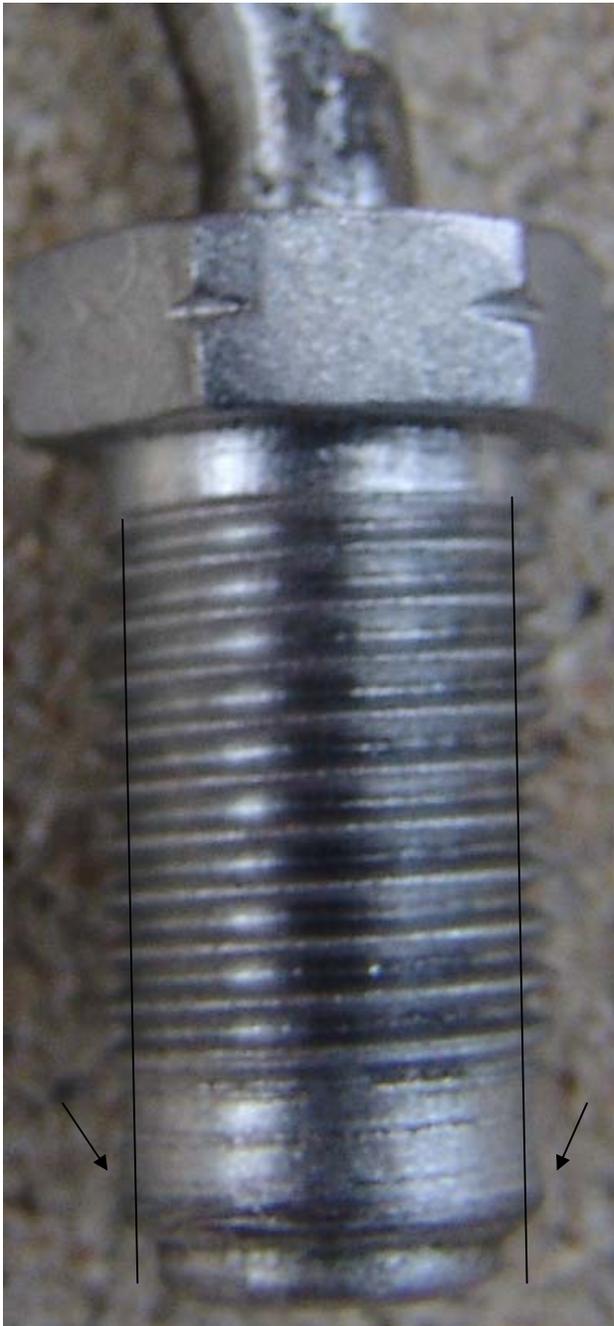
out as can be just seen in the picture. This is often so bad that the nipple can barely be withdrawn from the receiving assembly. The solution ideally is to make up a new pipe and fit a new nipple. Alternatively a little judicious filing around the swollen perimeter should do the job. As to how tight to do them up I nip them up 'comfortably' knowing that some may drip. With full pressure in the spheres apply the brakes or load the rear as needed and gently tighten leaking joints just enough to stop the leak! ✂

My mate Peter mucked around with his incredibly complicated camera to take the photo at left. What we were trying to show was the flaring of the lower unthreaded portion of the pipe nipple. This system of union is used right through the hydraulics of all post-war models and involved double flaring of the pipe.

The outside of the pipe fits snugly into a conical recess in the base of the nipple and when the latter is screwed into the calliper/wheel cylinder/junction block etc the double flared nipple should fit neatly over an inverted cone shape in the receiving assembly.

The nipple pushes the pipe down firmly and the seal should be made. Unfortunately because the pipe is relatively soft there is no obvious 'tight' point at which you can say that's it! So the ham fisted will tighten and tighten. Indeed if he keeps going he will reduce the double flare to tissue paper thickness and at the first burst of pressure the pipe or what is left of it will simply spring out of the nipple and hose all those in attendance with brake fluid or mineral oil!

While this unfeeling Mr Hercules was doing his spannering, the nipple was suffering at the same time through the end of it being flared

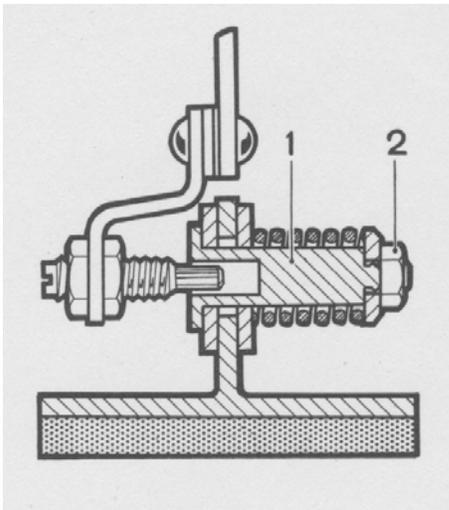
At left is a cross sectional view of the stop showing the spring bearing down on the two washers clamping the shoe web. Note the very small clearance between the adjusting bolt and the sides of the stop hole. It is this distance that the shoe retracts when the brakes are released.

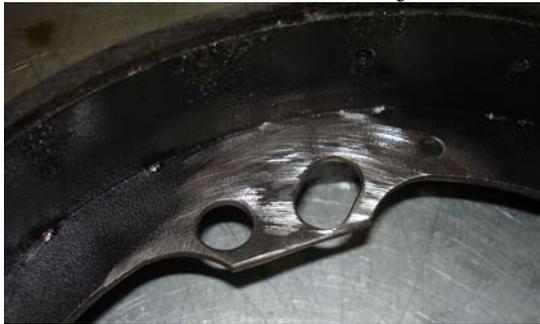
At left the elongated hole is where the shake back stop is mounted. Note the crud generated by the lining bonding process has been removed to ensure the correct grip of the washers on the web.

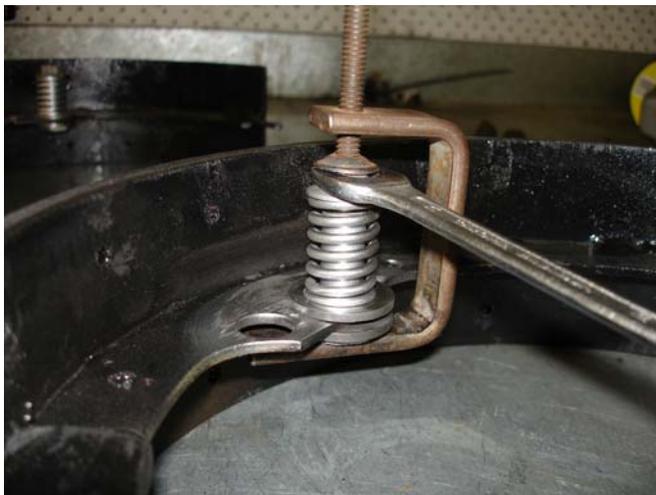
The length of the spring and the thickness of the top washer are so designed that there is just no thread to start the nut. This is one way to do it – very gently ensuring that the nut threads on cleanly!

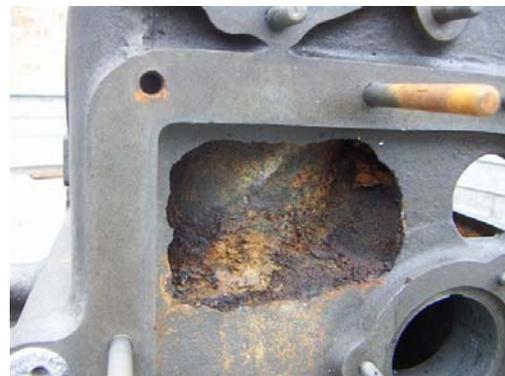
He actually broke open the hole you see in the picture which revealed that the casting thickness had been reduced by corrosion to 1-2 mm! Originally they would have been 4-5mm of metal.

My friend, idly tapping around the block in the manner of the old railway fettler who used to tap railway wheels, noticed a rather dull response from the front of the block – normally covered by the timing case cover. There was a slight crack in the area evidenced by some residual cleaning solution leaching out . A bit harder tapping produced the following.

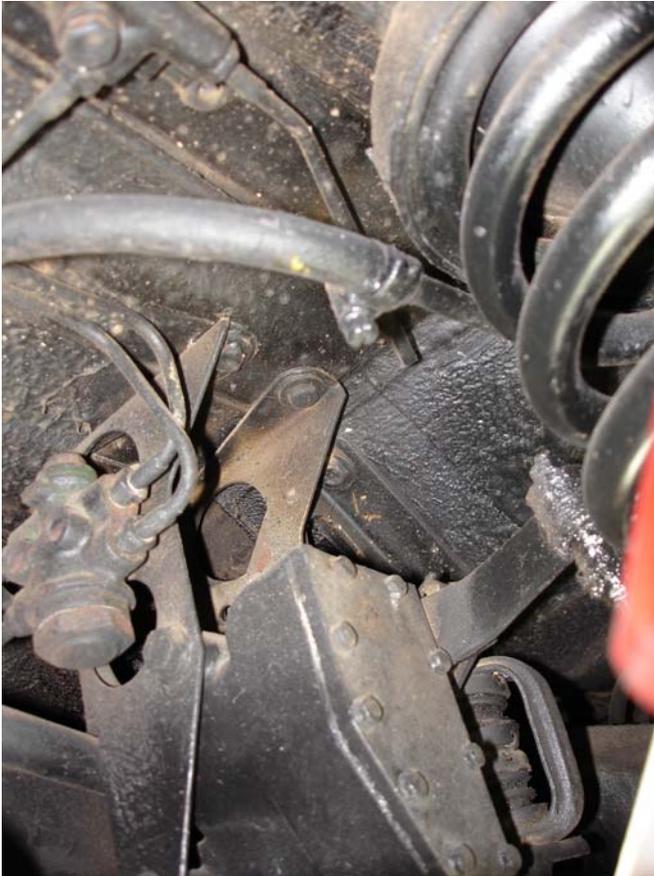
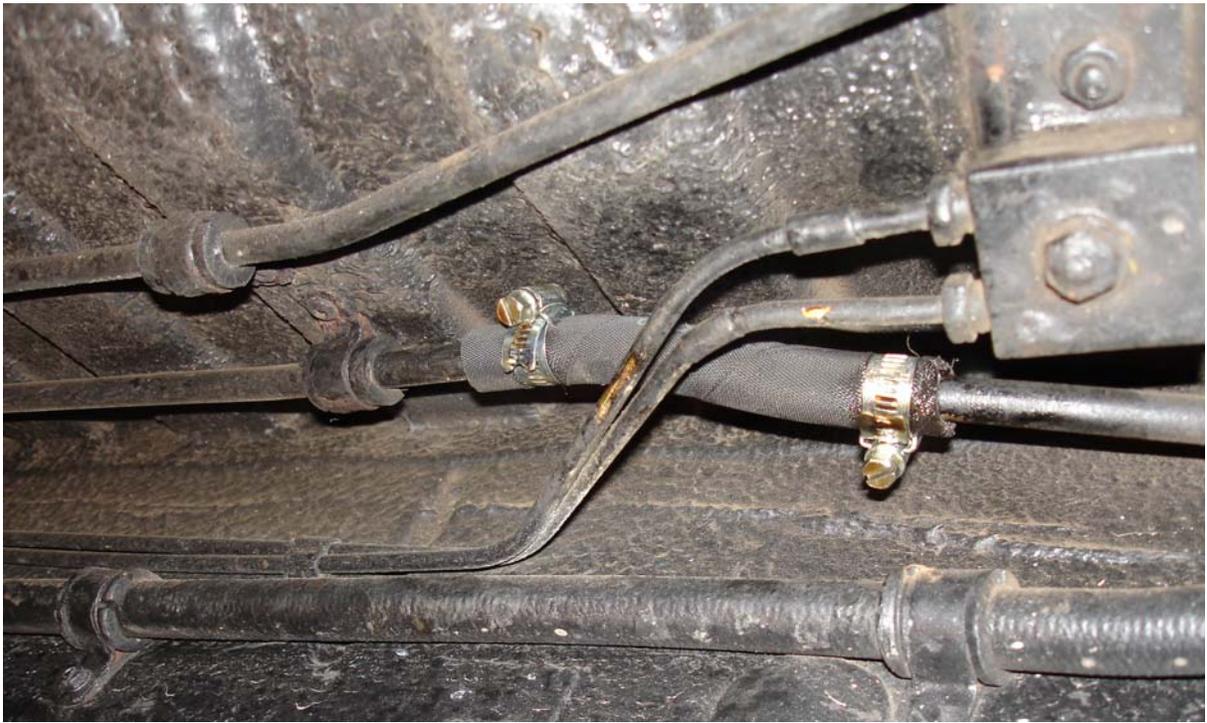
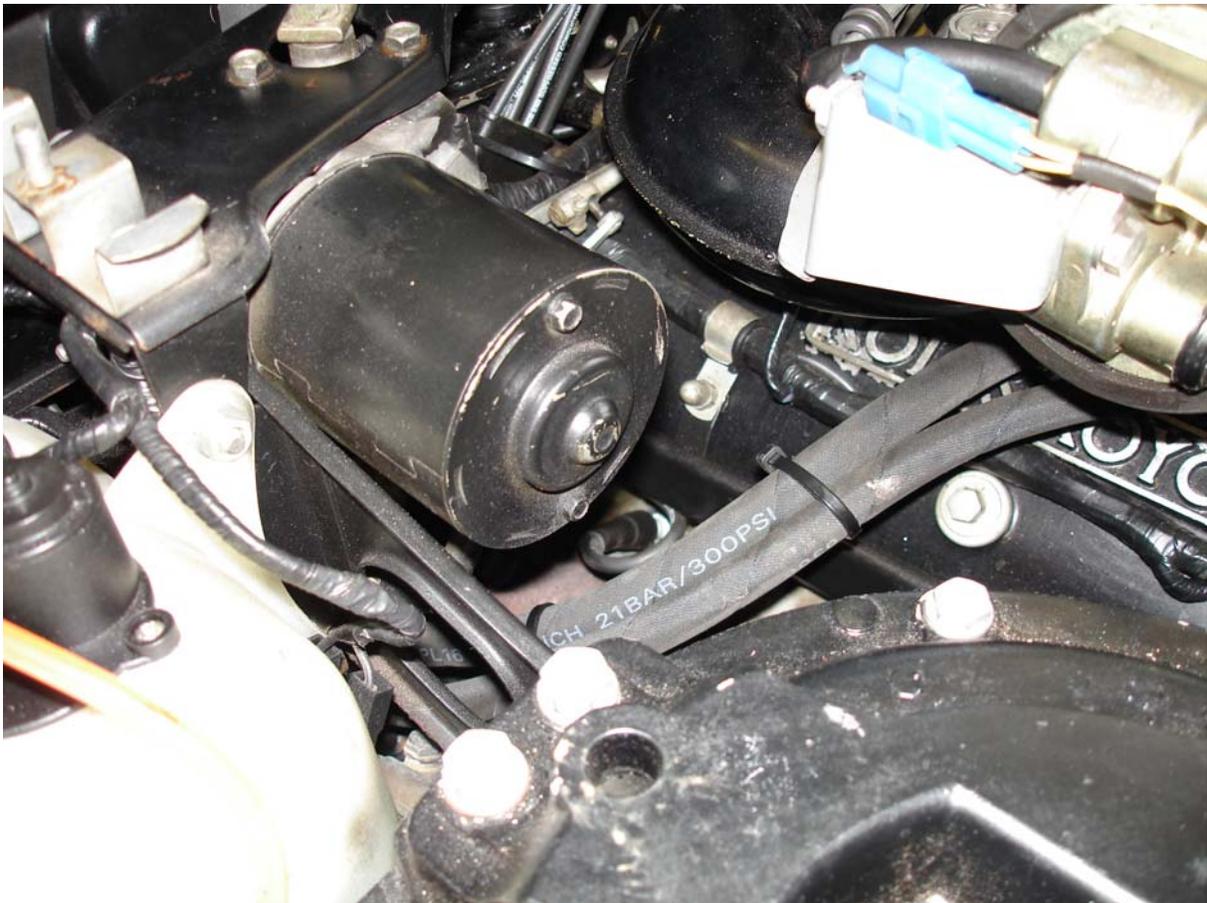
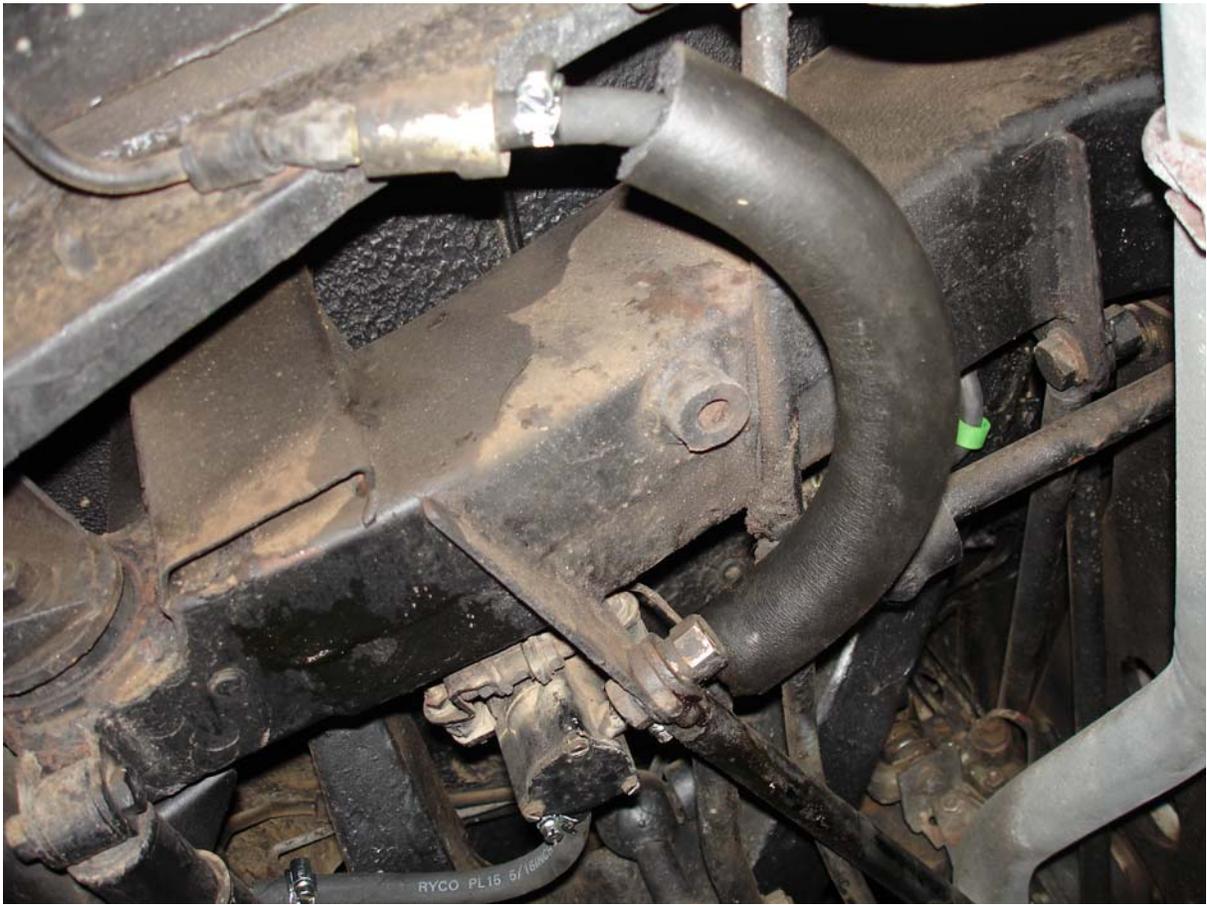
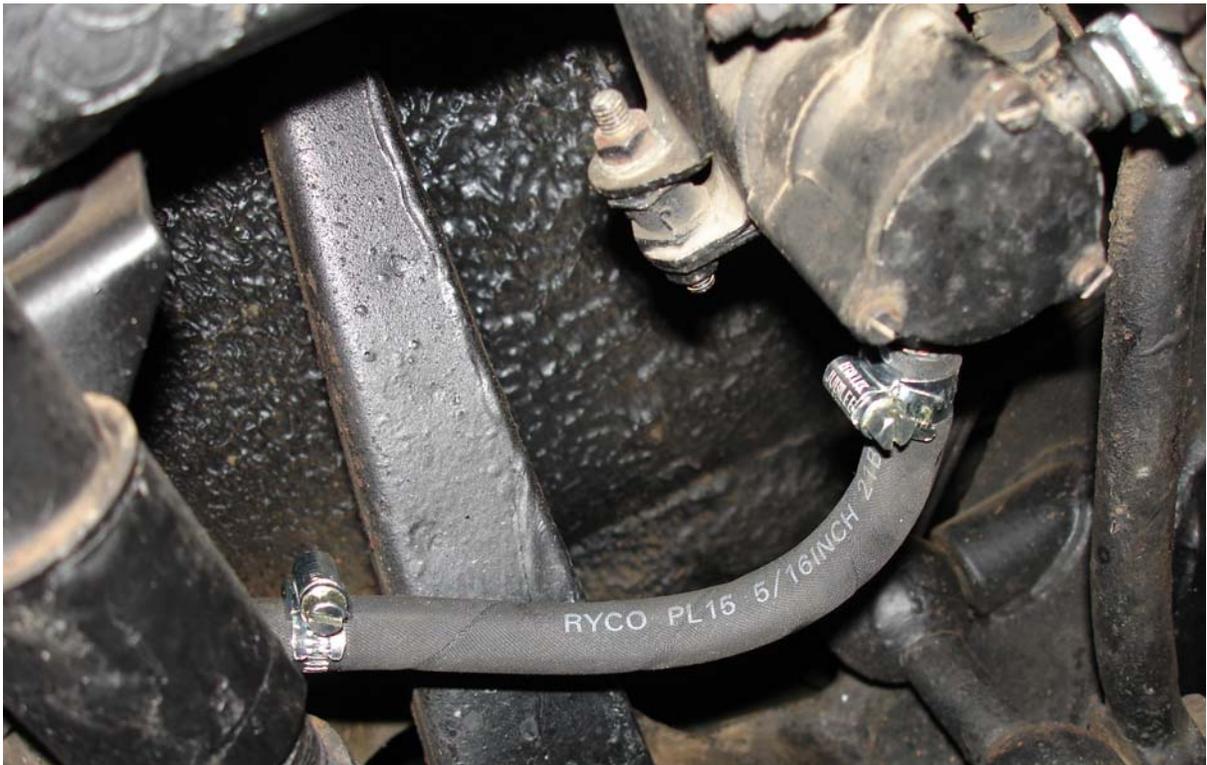
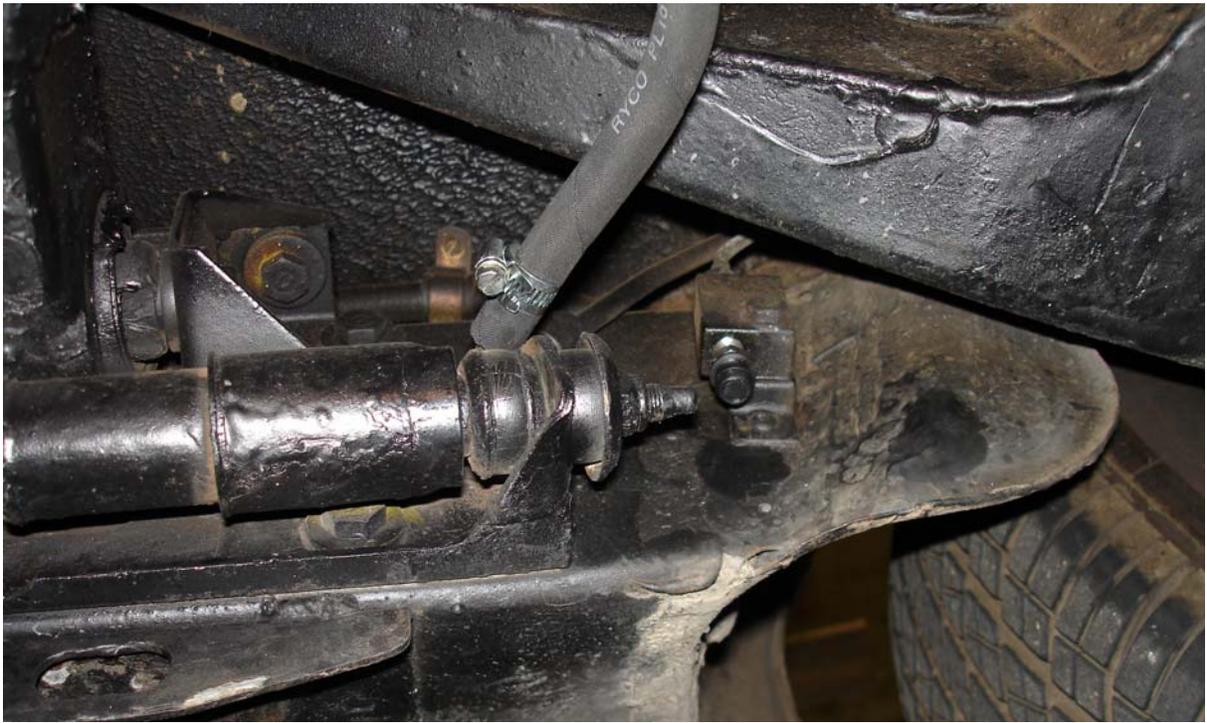
The pictures give some idea of where these rubbers sections are. In replacing them always use new hose clips.

In another place I have been pointing out the likely limited life of the numerous rubber hose connections used on the SZ cars. These cars as you know have a re-circulating system requiring two pipes between the engine and the tank.

To simplify the reticulation, rubber hose is used to join the straighter lengths of pipe. This also provides a barrier to noise transmission from the pump and to some extent the engine itself.

With age this hosing becomes brittle and common sense would suggest that it be changed periodically with the best quality hose available.

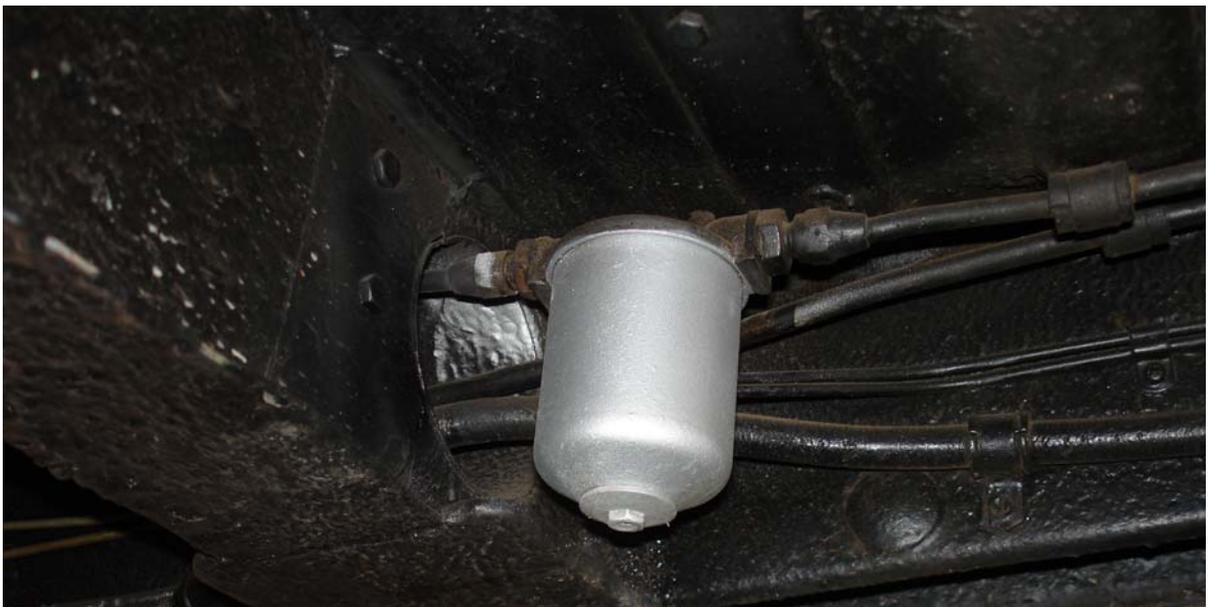
The primary filter below is often forgotten until the fuel pump gives up

trying to push fuel through a gravel pit!
