TEE-ONE TOPICS

Number 60 January/February, 2006

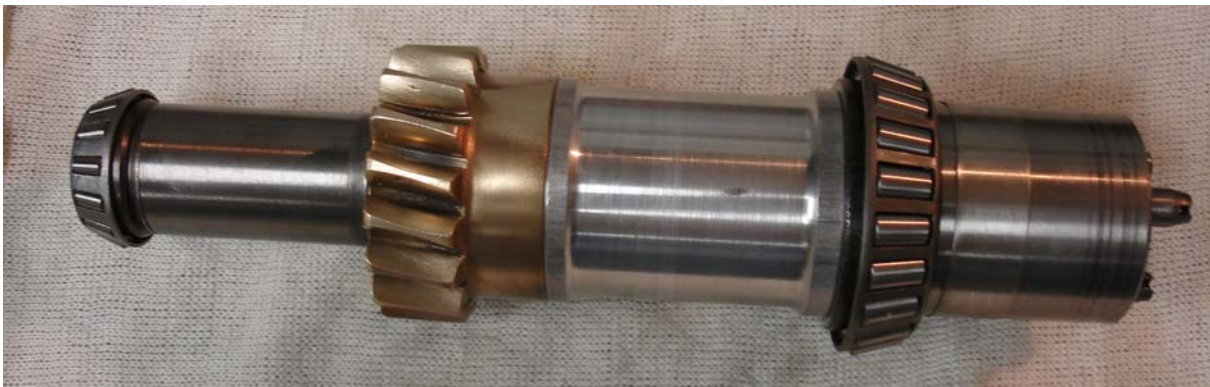
This reconditioned shaft has new bearings and a used gear. Note that the assembly from the large bearing to the gear is pressed against the circlip restraining the latter. If there is need for expansion the large bearing cone can slide on the shaft. The other repair on this shaft is the installation of a 'Redisleeve' where the lip seal runs to overcome wear grooves.

By now everyone will be aware that the bronze drive gear for the brake servo shaft on the Cloud and earlier Phantom series, wears. Thirty years ago particularly with the weight of the Phantoms V & VI working in city traffic, these little gears worked until they eventually sheared. The problem was sufficiently serious for the Company to issue a bulletin detailing a method of testing for wear in the gear without having to remove it. A copy of the Bulletin is in the Technical Library. The procedure involves knocking up a device for holding a pointer on the head of the bolt and moving the pointer to and fro will give an indication of the amount of backlash between the driving and driven gear or if you are lazy simply hang a 9/16" AF spanner on the head of the retaining bolt and wobble it.. Since it is highly unlikely that the steel driving gear will wear, the result will refer only to the bronze driven gear.

Replacing it does not require a degree in rocket science. Just drop the under-diaper, remove the servo, open the drain plug on the servo housing, drain out the good oil and unbolt the servo shaft seal housing and slide it off catching the bearing spacer if fitted as you do! Wiggle the shaft and it should slide out. Do this gently because on the end of the shaft is a dinky little taper roller bearing all neatly held together by the usual cage. The latter wears to the point where with little difficulty the little rollers will simply drop out. If that occurs and the rollers drop out while you are withdrawing the shaft contact me for a glossary of invective. Finding them should not be too difficult with a magnet – at least you will know how many to look for!

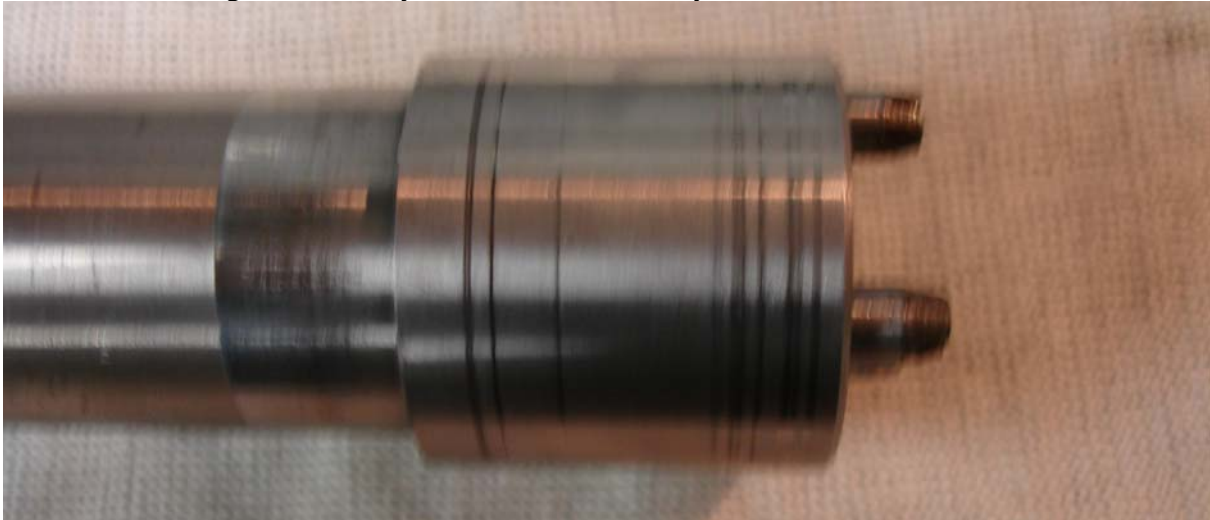
The inevitable wear marks on the output shaft before sleeving. On this shaft an early adoption of a double lip seal shows in the groove pattern. Again note that the large bearing does NOT butt up against the greater diameter of the shaft.

Building up a new shaft is straight forward. You will need an appropriate puller to get the little bearing off the end and a press with suitable collar bits to push bearings on and off. Again follow the instructions in the Manual available in the Technical Library.

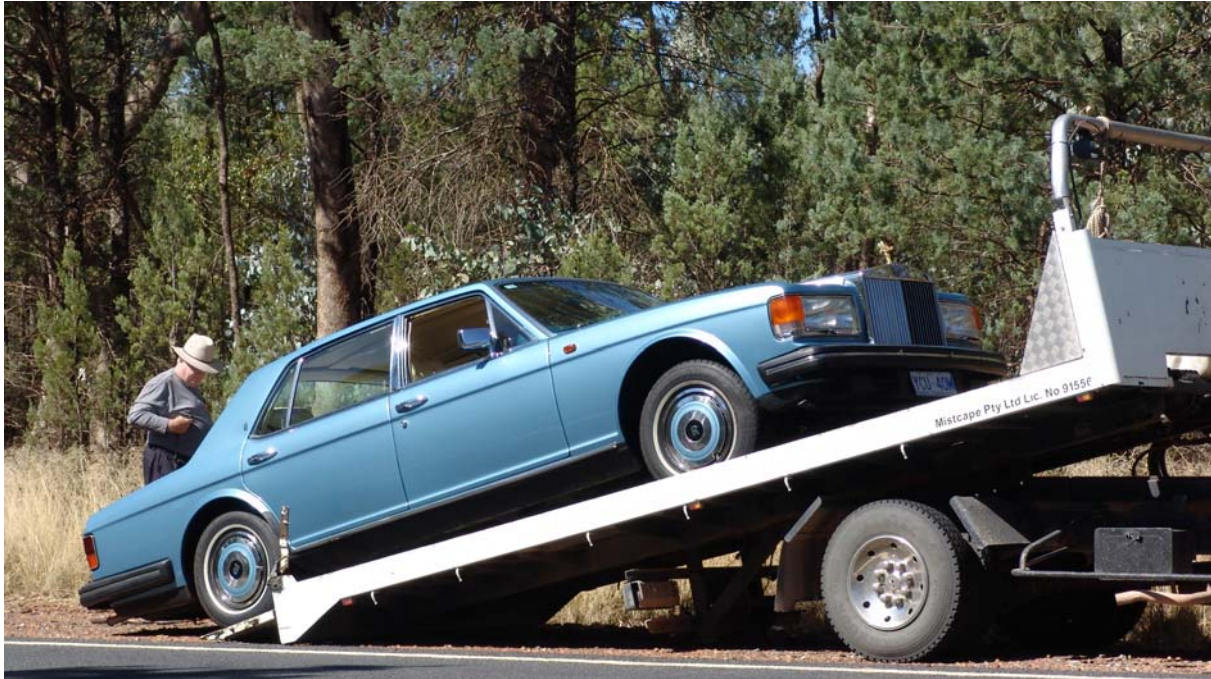
Well I had to put it to the test didn't I??? This is the scene last rally 12 miles from Parkes. All was well with the world when suddenly no go from the right pedal. Fuel pump failed! Car was trucked back to Orange some 100 miles, a brand new hire car was presented and extra accommodation offered. I was very smug about my membership from there on!

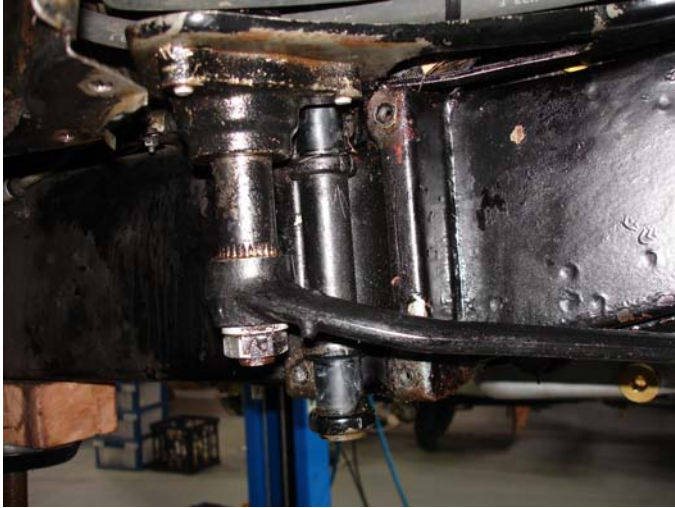
At left the old bushes have been removed and the whole assembly pulled away from the chassis. I find dishwashing detergent the best lubricant to slide the new bushes up the holding fixture.

Replacement is easy and well indicated usually by shards of bush hanging down in full sight behind the front wheel. Four bolts hold the box to the chassis via clamps. These removed, the whole assembly can be judiciously sprung away from the chassis, the bushes cut off and the new ones after liberal coatings of detergent can be slid up into position. The front bush which enjoys a spacer is

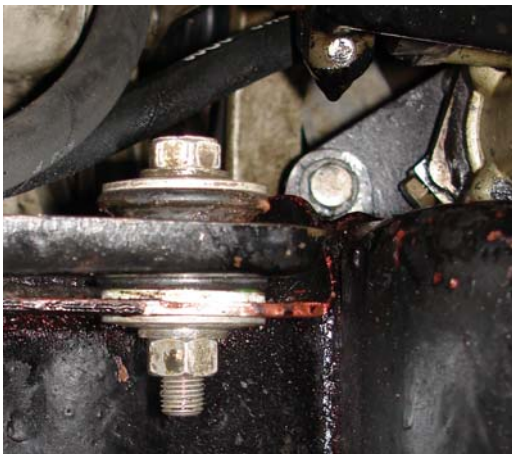
At right is the rebushed assembly. Note in this case the newly fitted replacement hoses. Since these are usually incredible to access, if there is any sign of deterioration and you have temporarily better than normal access – change the pipes. They are readily made up by high pressure pipe repair firms.

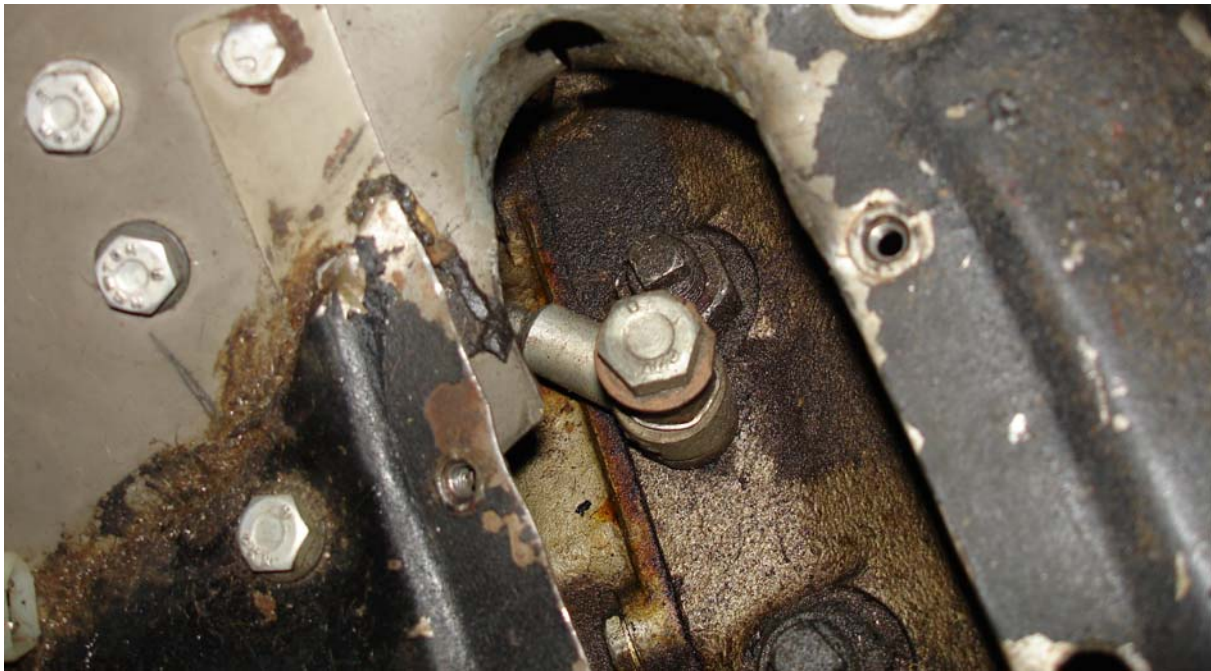
This is a picture of a not uncommon problem of the coachbuilder not talking to the chassis builder. For those that have not been down there what you see through the inspection hole in the floor of a Phantom VI from top to bottom is the front band adjuster the take off for the oil cooler and the rear band adjuster. As the lock nut requires a fairly hefty tube spanner it requires a fair bit of access, clearly apparently, not available under the original juxtaposition of front band adjuster and the front edge of the hole. It appears that the above modification with a dolly and sledge hammer met the requirement. What is more interesting is the oil cooler take off for the heat exchanger. This is normally where pressure tests are taken and the hole bunged up with a suitable grub screw. There is a school of thought that although this takeoff is constricted, because it taps into the pressure side of the pump circuit it deprives the servos of some oomph they could well use.

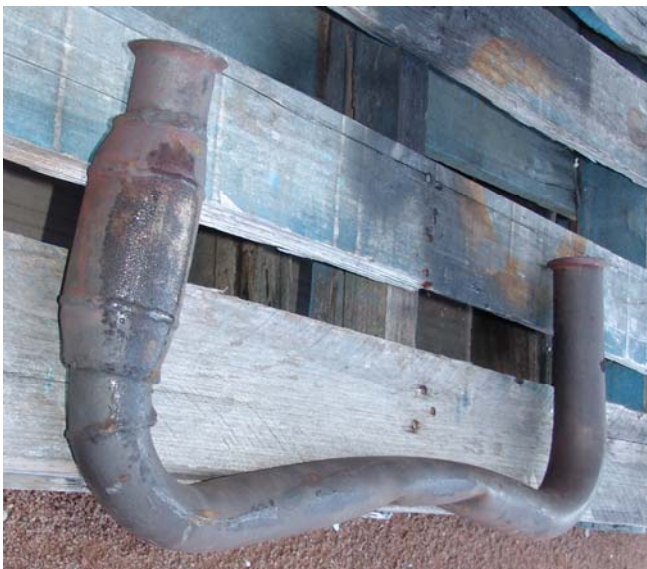
This is nominally the crossover pipe that connects the two exhaust manifolds on a Bentley Turbo so that the combined output can be directed to the turbo turbine. The first observation is don't use the pipe as a jacking point. The reduced diameter in this case brought one side exhaust down to about 30%.

The bulge is of interest – a small catalytic muffler – apparently installed by the Factory to get down to the required emission standard for this car!

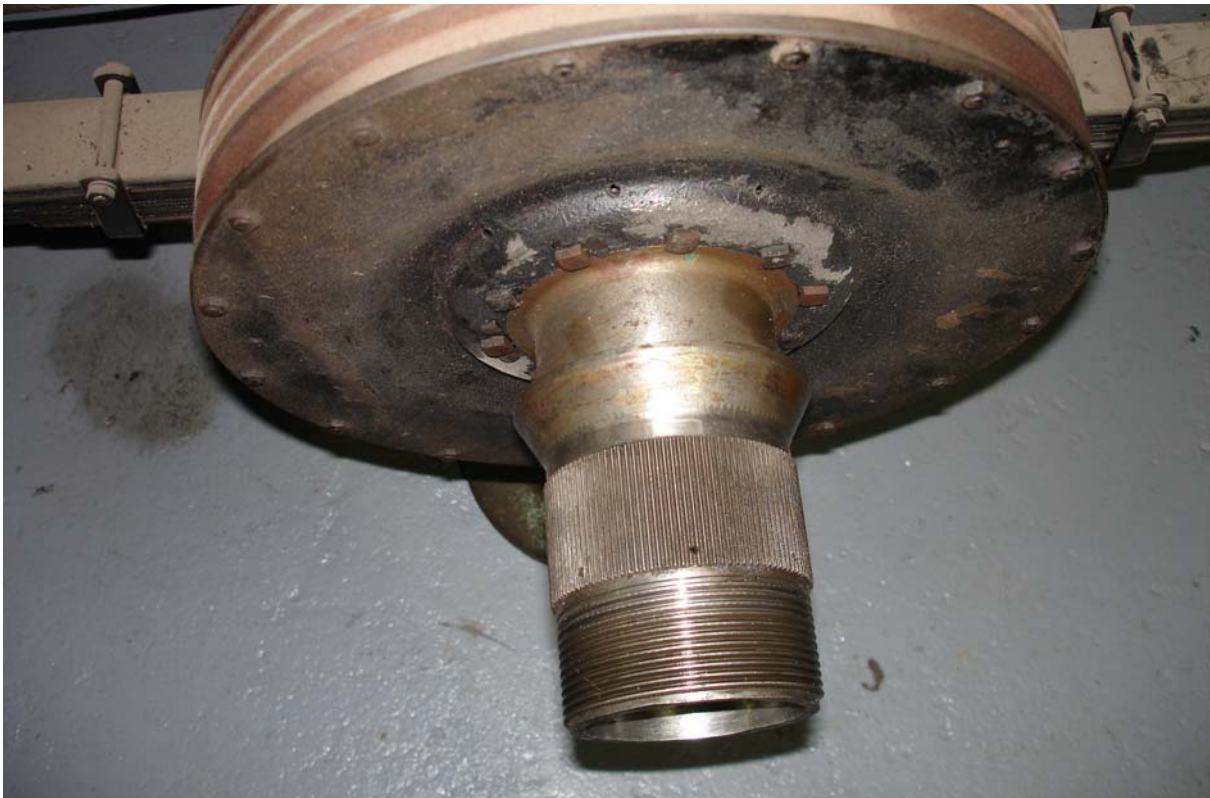
I talked about this elsewhere but it is amazing how little is known about the old centre locking wheel retaining systems. The nub is that while it is desirable to lightly grease threads and splines it is highly undesirable to lubricate the conical section behind the spline. It is on this area that the interior of the wheel hub is pressed, the resulting friction being the means that holds the wheel tight on the axle hub.

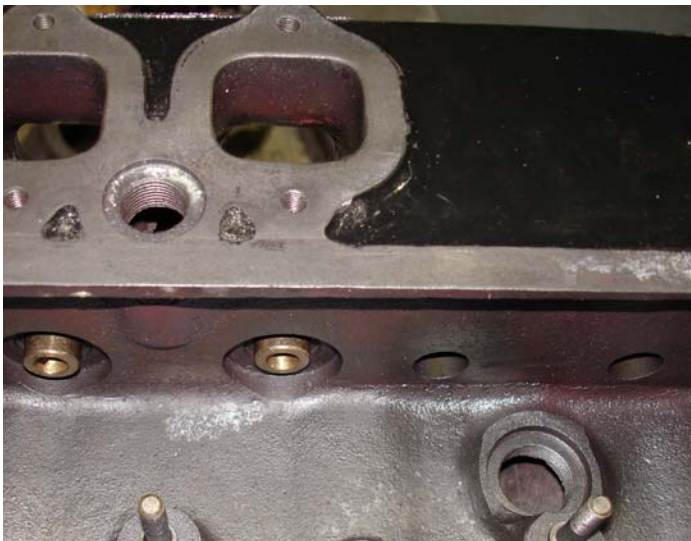
Somebody called these things Welsh Plugs in my day. The original arrangement was a bowl shaped heavy steel pressing that was jammed into a smoothed out hole in the cylinder block or head. These have worked very well for nearly a century with just the odd one popping out or in later times holes rusting through them. Rolls-Royce went one better, threaded the block and screwed in plugs with aluminium washers under the heads. Their purpose is to allow the casting sand to be removed after the foundry had finished

their bit of the job. During overhaul they should be removed when the block is cleaned, the threads cleaned and preferably new plugs fitted with new washers and sealant.

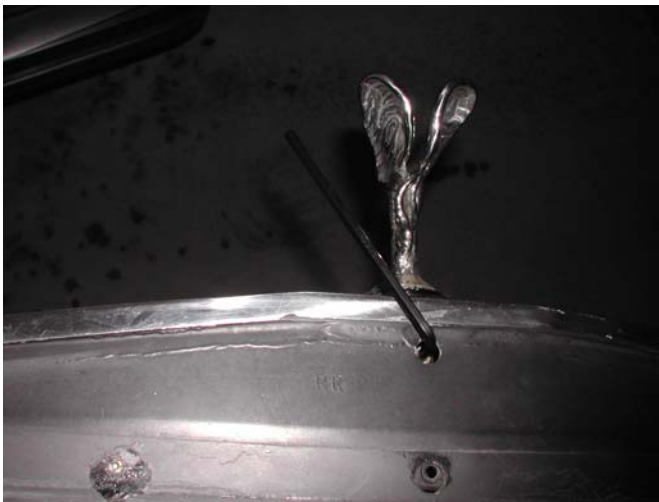
The Shadow produced a very nice little insert which approximated to a parking cap used previously on earlier models. These were dropped into the mounting hole after the mascot was removed and secured with an Allen Head grub screw seen at left

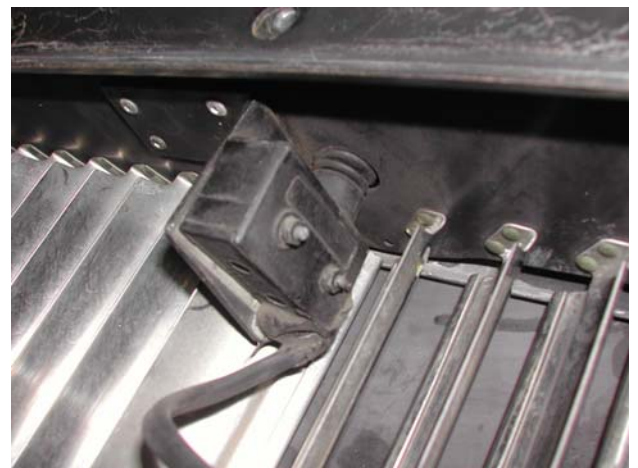
The alarm switch at right is a simple adaptation of the plunger switch used on the Clouds at the base of the steering column to isolate the starting circuit and switch on the reverse lights. This installation operated a separate loud horn installed under the bonnet. The assembly was an option for the Shadows.

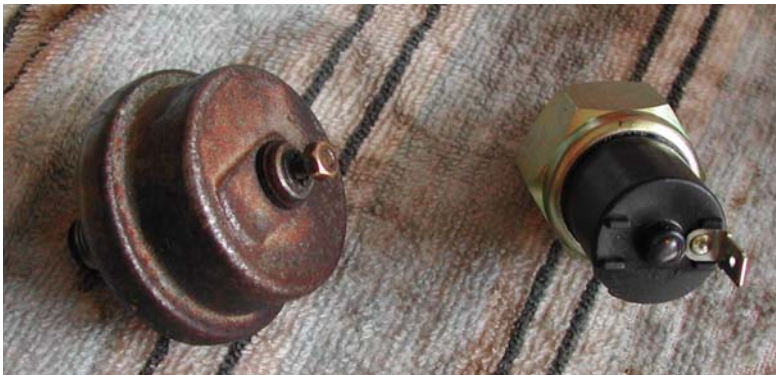
They seldom gave trouble and gave a good enough reading for many years. A replacement has been found consisting of a metal base crimped around a 'Bakelite' core that presumably contains the mechanism. The old and the new are pictured left. Unfortunately the new item is prone to leaking between the 'Bakelite' core and the metal base. Cases have also

been known where the reading obtained from the new units is too low. Fortunately the faulty units have been replaced so far by the dealerships. Note that the sender units are specific to the gauges. If there appears to be a problem you should remove the gauge and the sender and have an instrument fitter attend to them.

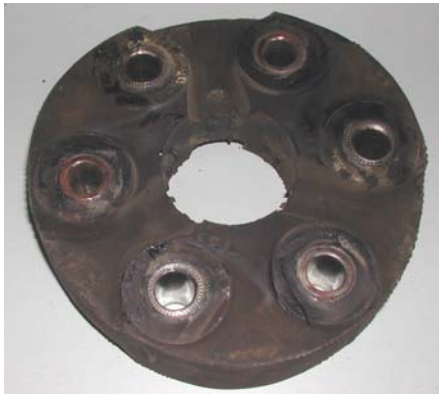
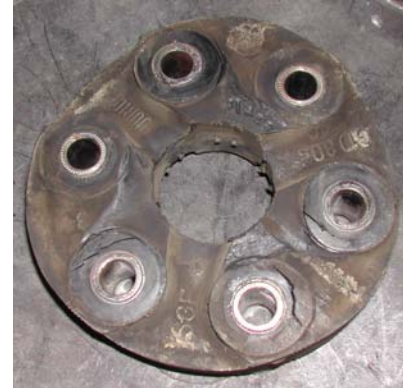
Another initiative was the use of rubber flexible joints, pictures of one preparing to fail, appear above. To calm your paranoia even if the joint completely came to pieces there is a safety spike through the whole assembly that prevents the tail shaft from dropping off either the rear axle or the back of the transmission. In any case the failure of these things always tends to be gradual. The cracks seen in the above examples produced the merest fine vibration at certain speeds which did not seem to be like unbalanced wheels due to the frequency. The cause was discovered by simple examination.

The joints are held together by special bolts and nuts which have heavily serrated undersides to grip. These are done up very very tightly. Even so it is good practice to periodically check that the bolts and nuts remain very very tight!

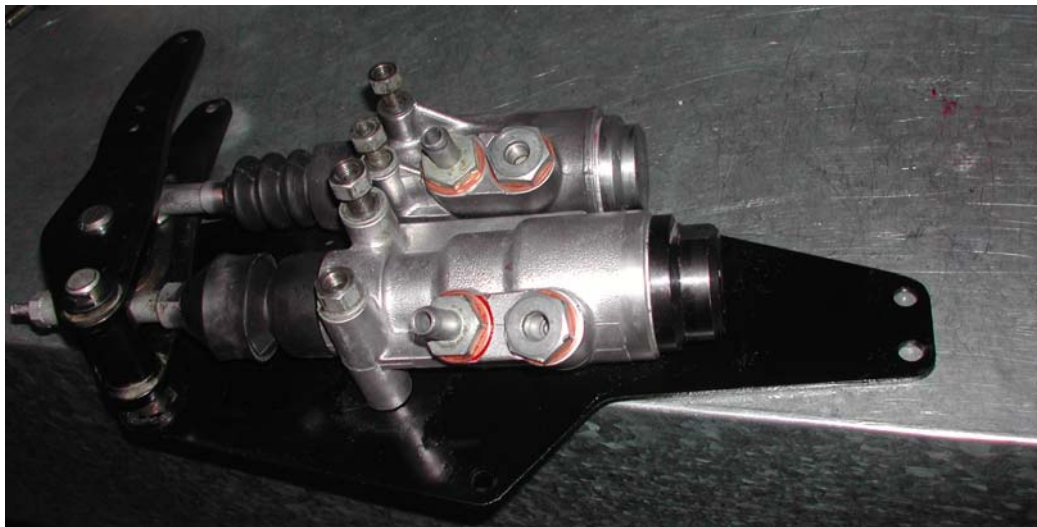
Examples are still turning up of master cylinders that have only been partially sleeved. The problem only shows up when the car is being held stationary with the footbrake on a steep slope.

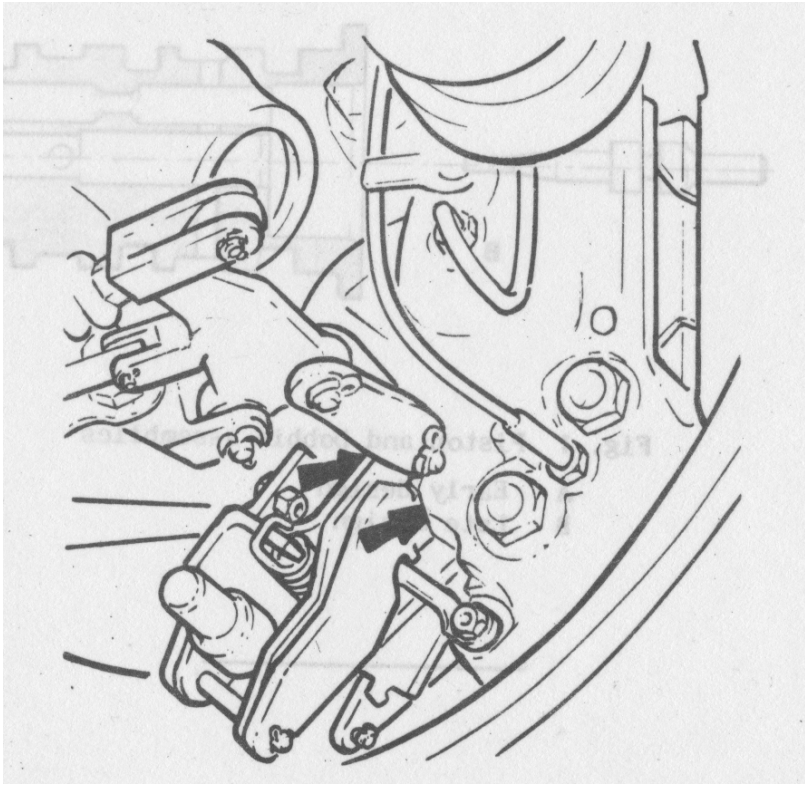
This little diagram turned up in a 1970 Service bulletin. The mechanism to squeeze those rear brake rotors is an exercise in lever proliferation and bearing points. The latter of course need lubricating. The ones you can see present no problem but the ones you can't, if neglected can bind up, shear their fasteners and render the whole system useless.

The Bulletin recommended using WD40 the good old penetrating spray with the precaution of avoiding spraying the friction pads or

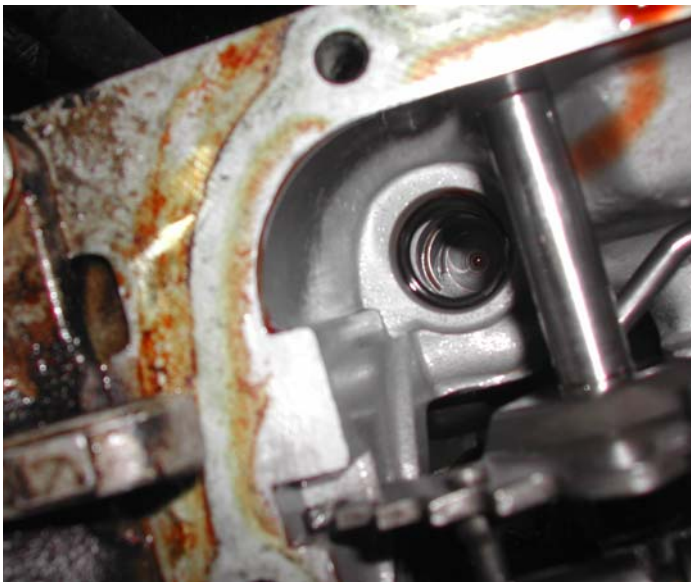
So you have been brave enough to drain your GM400 transmission on your post-Cloud car. Next step is to clean the floor, wipe your face, have a shower and put your clothes in the washer to soak. You drop the filter after removing the special retaining bolt then go back to the manual to reassure yourself that the filter should be a floppy fit. You clean everything in sight, poke the pickup tube up into the intake seen at right, put the whole thing together, fill up with oil and go for a

The answer is simple you left the 'O' ring out of the box where the pickup tube goes and seen nestling in the hole in the picture. The pump in the transmission picks up a lot of oil from the sump but also a lot of air from around the tube. This gets into the gubbins, is compressed somewhat then backfires into the sump blowing a large quantity of transmission fluid out the dip stick all over the hot exhaust manifold!!
