TEE ONE TOPICS

Number 6 September, 2001

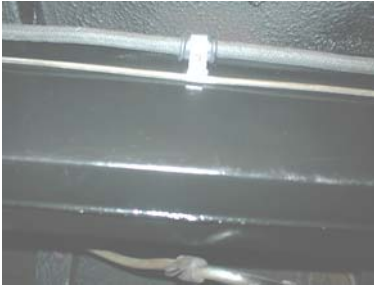
Detail of the chassis mounting of the mail battery cable and brake pipe in the Silver Cloud

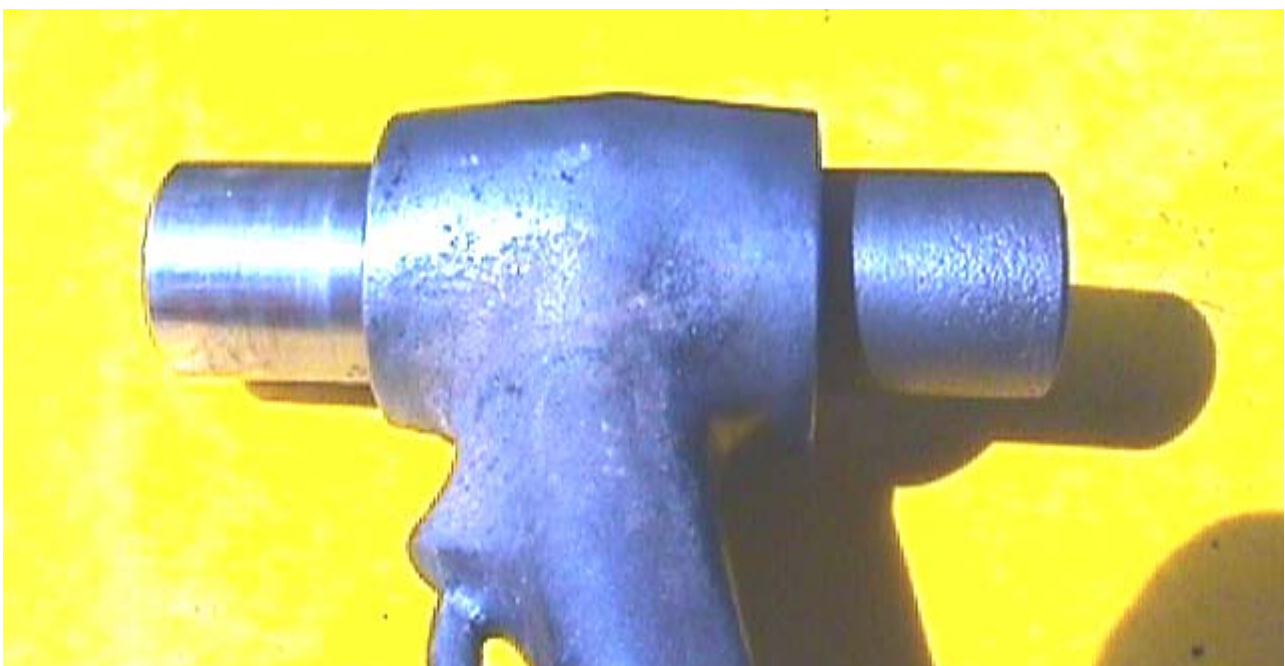
All the very best case hardening did not save this expensive pin from the ravages of corrosion. The right hand end as pictured sitting in a blind bush and not getting enough oil at some time quietly rusted, lost dimension and gave rise to significant lost motion in the steering. Prior to the S2 and associated Silver Cloud, chassis from the factory were lubricated by oil pumped around the structure through various tubes one of the ends of which can be seen above. Once the Cars dispensed with manual gearboxes, the only downside of over-pumping of the central chassis lubricating pump was a dirty garage floor. Degreaser is cheaper than a steering relay pin.

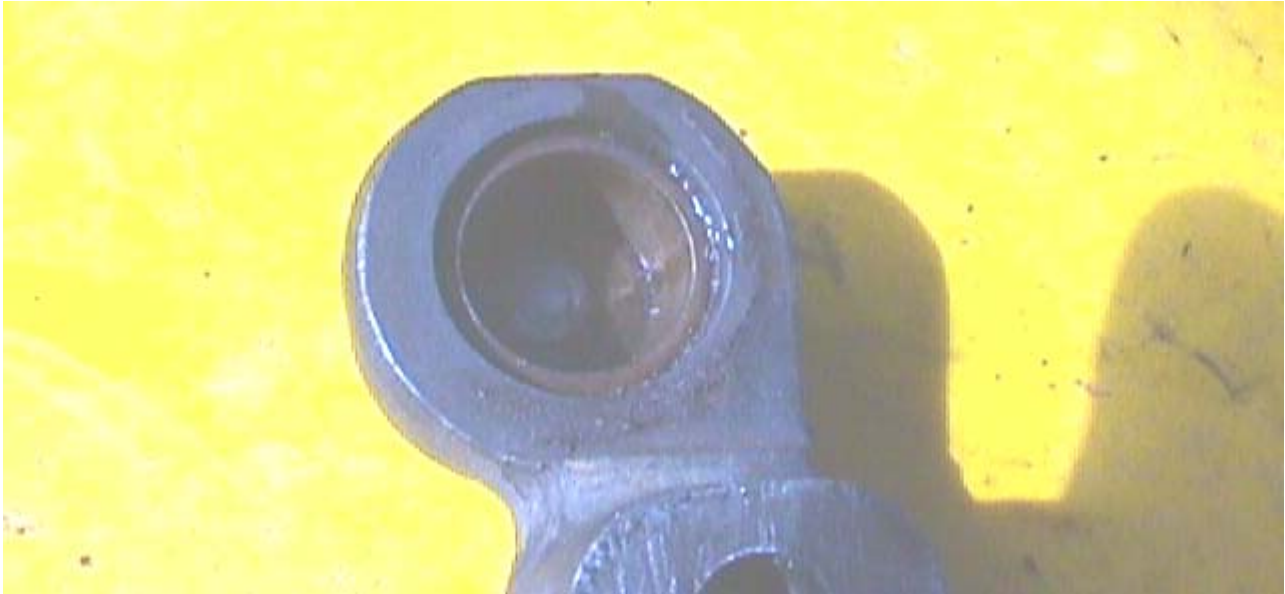
The blind bush in which the damaged pin sat. If it is not full of oil it is a prime target for retention of water. The recess above the bush is designed to hold a felt washer which is the last bastion against the ingress of water. Removal of these bushes for fitting of re-manufactured items can be a problem. One technique is to pack them with grease and hammer the pin in and use the hydraulic action generated to force the bush out. The last resort is to drill them carefully and split what is left behind.

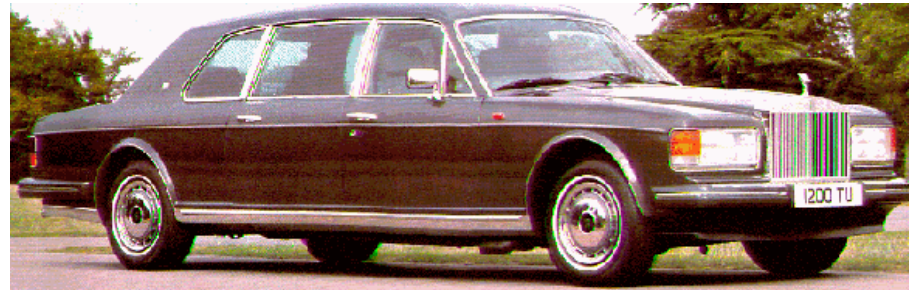
There is a 19 year old somewhere on the net displaying pictures of the cars of his family this is 'The Old Folks'. The above bespoke cars are made under contract for Rolls-Royce with the demise of the Phantom.

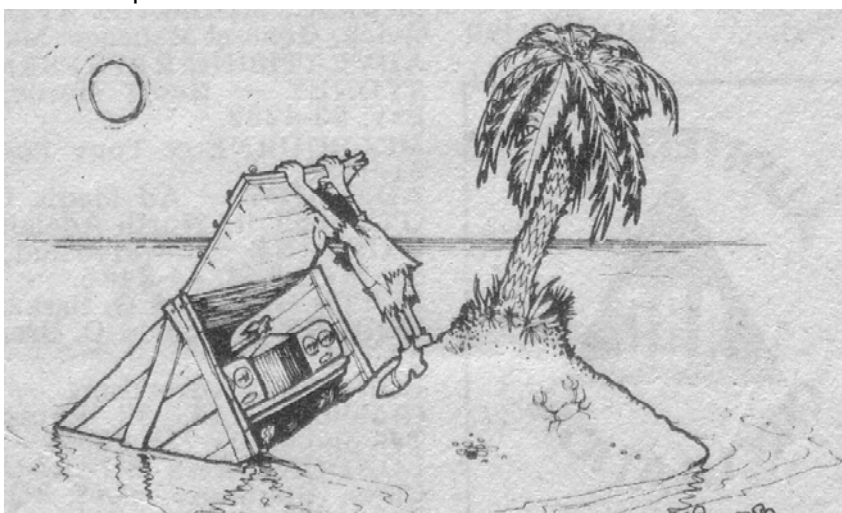
This skill and care is equally evidenced in the detailed marquetry inlay of the Spirit of Ecstasy to the car's waistrails,

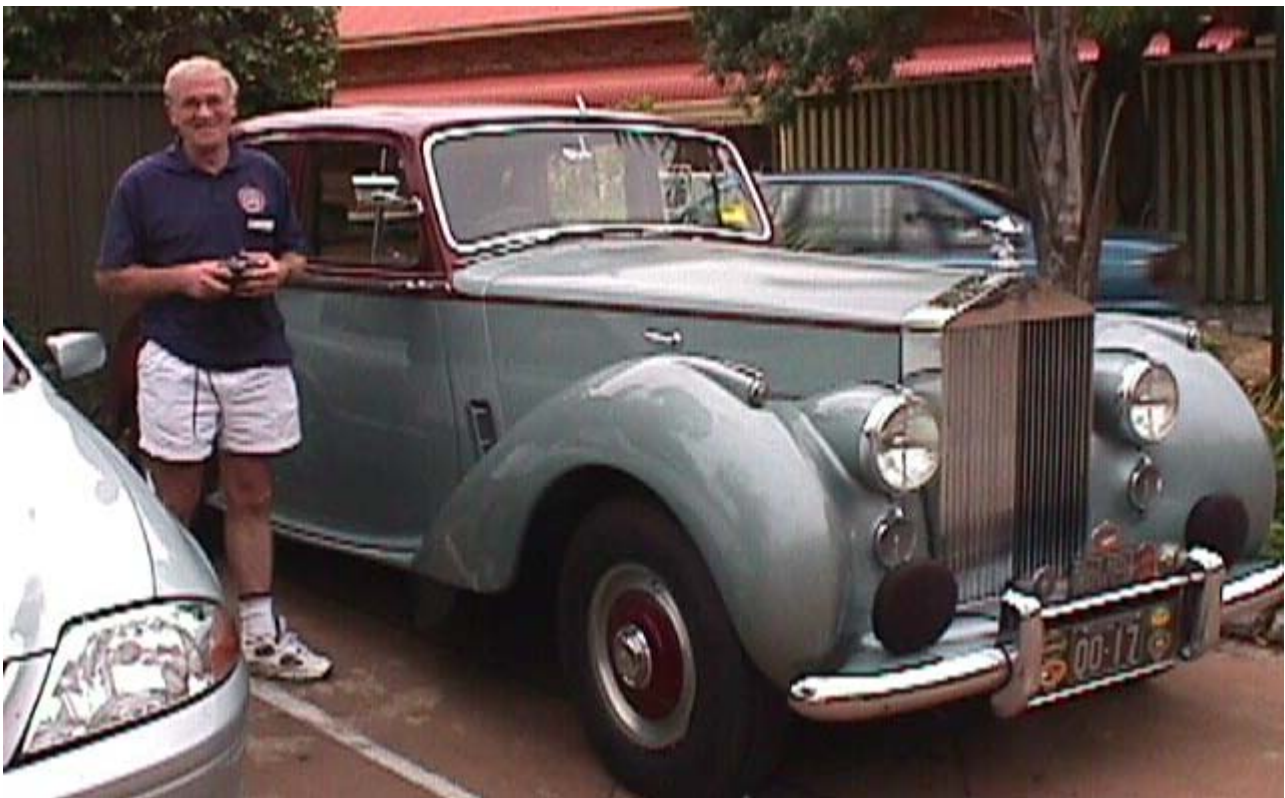
Lloyd Missen the new Registrar for the Silver Dawn and derivative clan. Lloyd among other pursuits than the presentation his of his very desirable chariot has done some most interesting work in the post-war exhaust system design. Hopefully he may share it with us.

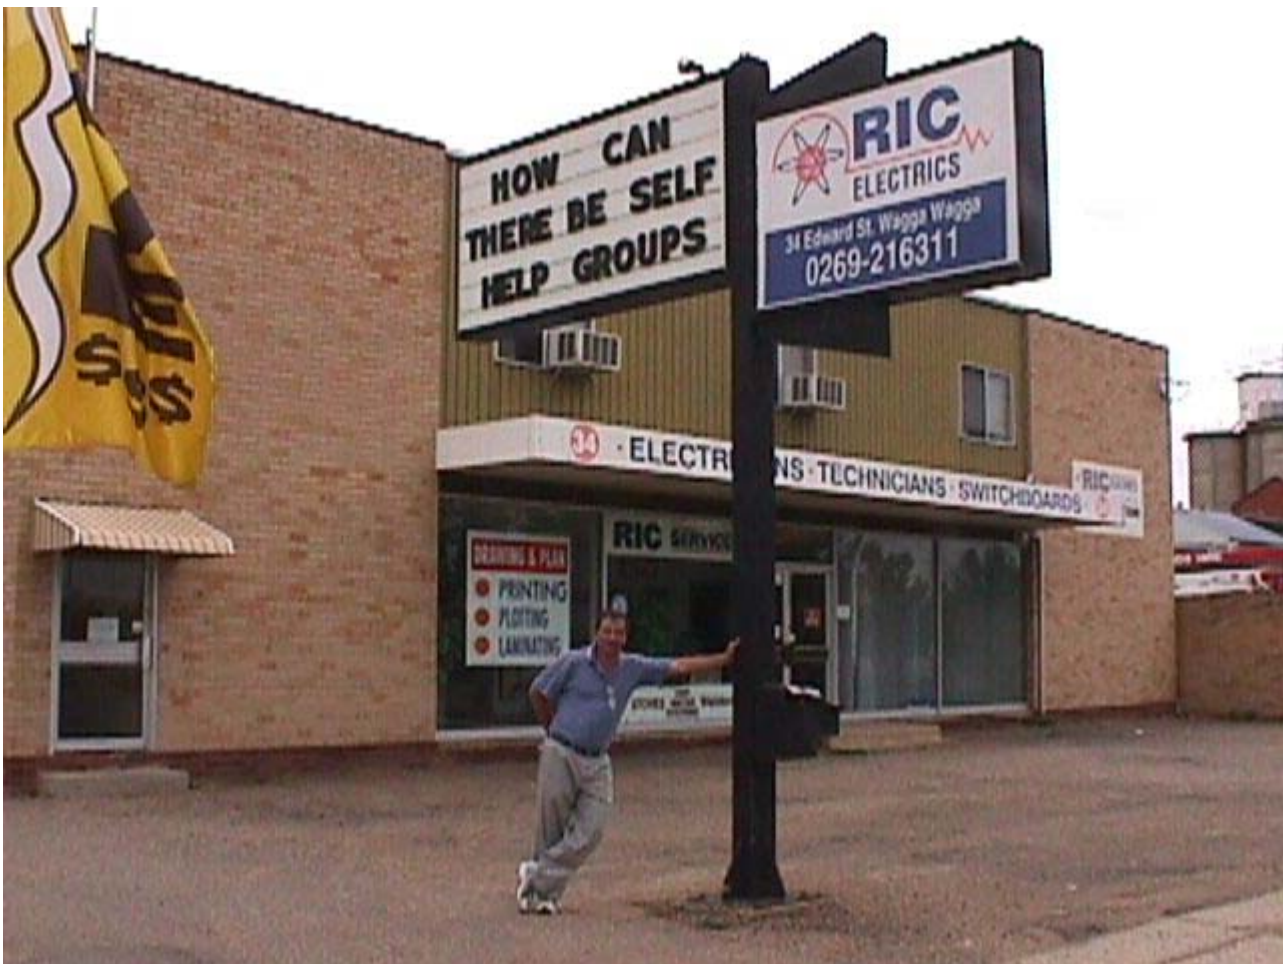
George contemplating the logic of a sign we found on our travels

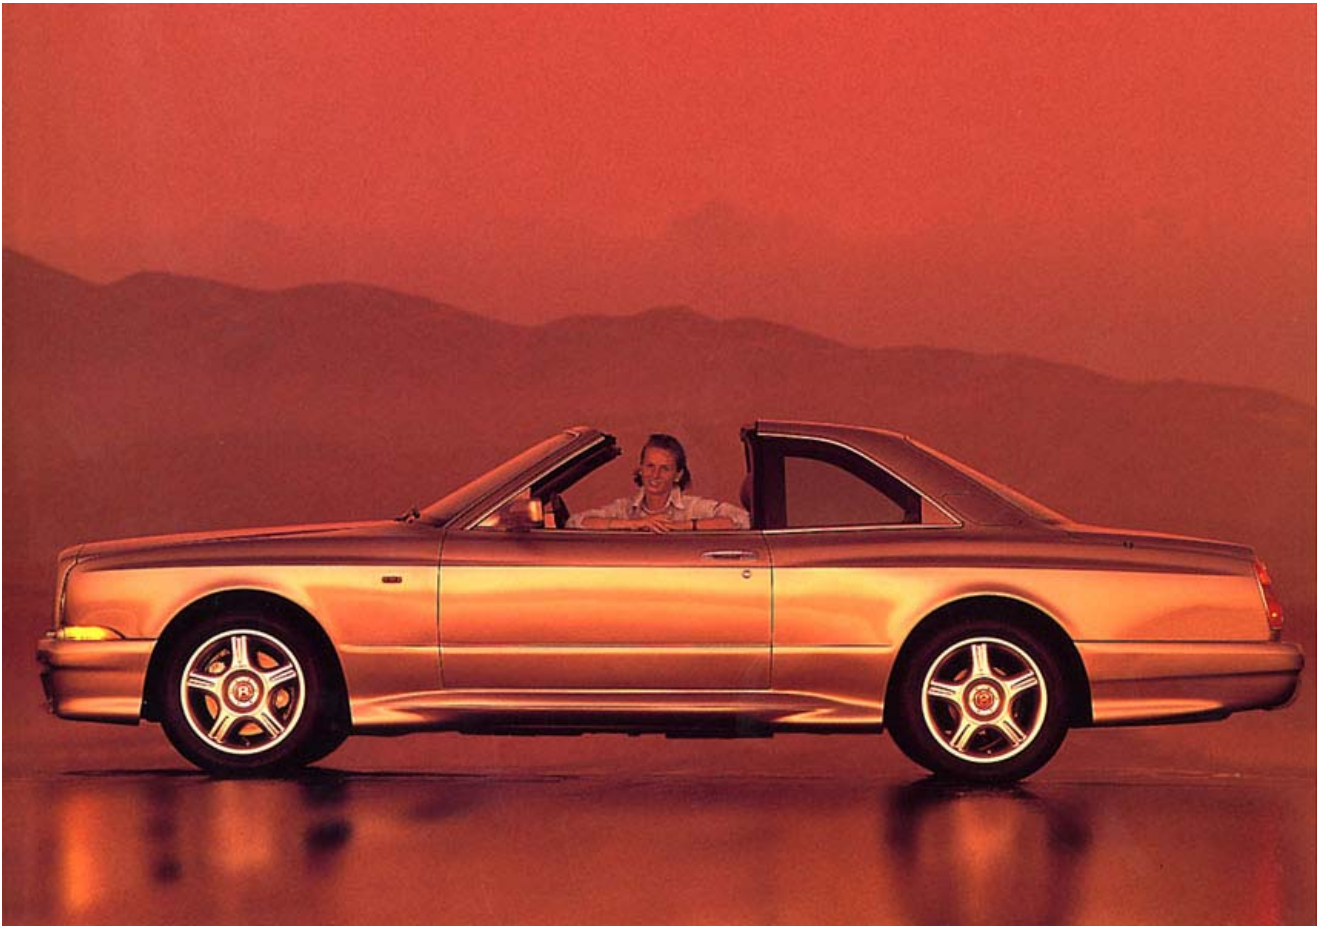
There is at least one of these Continental Cabriolets in Australia in a dark green. Drooling is permitted
