TEE-ONE TOPICS

Number 75 May 2008

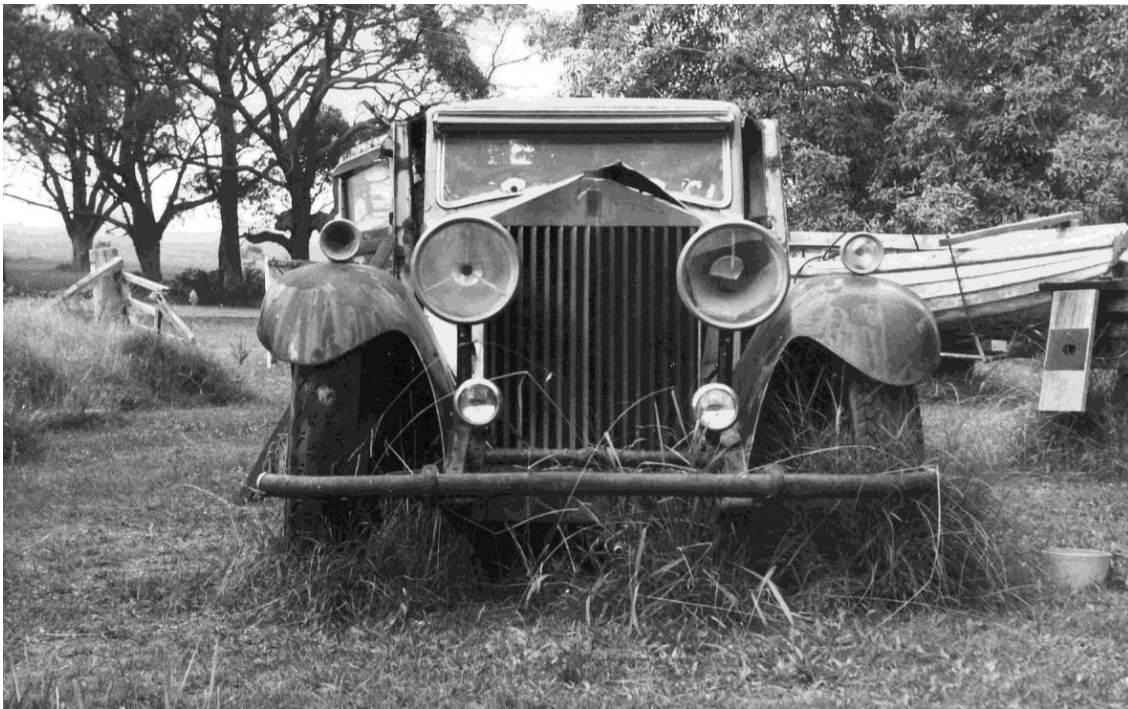
Rummaging around I found this photo which must be 30 years old. It was taken in Australia but beyond that I know nothing. Most of us are profoundly shocked to see this neglectful destruction particularly with the older cars, yet it seems that there is a continuous procession of post war cars to the yards of wreckers. The only dividend here is a supply of parts but it is a self destructing exercise. Hopefully owners and enthusiasts are taking an increasing interest in the Marque beyond parading around in the cars. If anyone knows the story of this car please let me know.

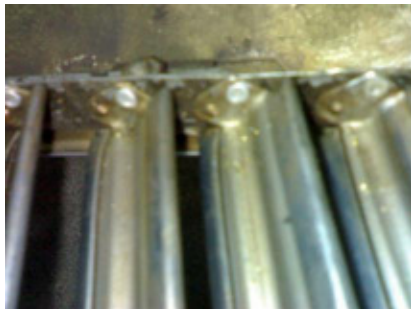
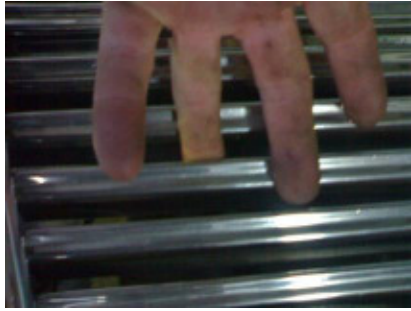
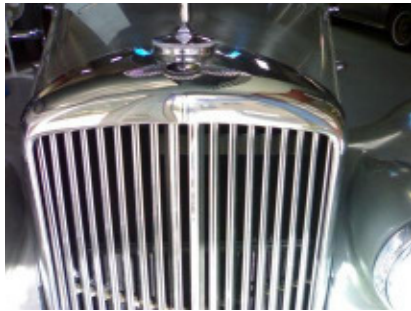
One solution offered was to speed up the water pump which also speeded up the fan being on the same drive shaft. A smaller pulley was offered to achieve this. This of course produces more fan noise which conflicted with the image of the car! But one solution that had very little publicity was allowing more air to actually get through the radiator grille. The suggestion to de-rivet the grille vanes and swivel them to open the 'slots' was made in a passing Service bulletin. Many of the cars that have survived have either had this modification or the problem is largely ignored given that few owners would attempt high speed runs in century plus heat these days. Apart from the cars the owners would be hard pressed to survive! This little chutney of pictures covers a recent long overdue modification on a very well kept example.

As to how much to swivel the shutters the only advice the Factory offered was 'consistent with reasonable appearance. The Silver Dawn it seems did not have this problem and the Silver Wraith of course enjoyed the extraordinary Calorstat that opened the shutters as far as they could swivel. I remember seeing a picture of the front of the Queen's Phantom IV. The car was parked behind what appeared to be a marquee presumably being warmed up before collecting its owner. I remember being somewhat startled at the extent that the Calorstat had opened the grille shutters which clearly were at right angles to the radiator core.

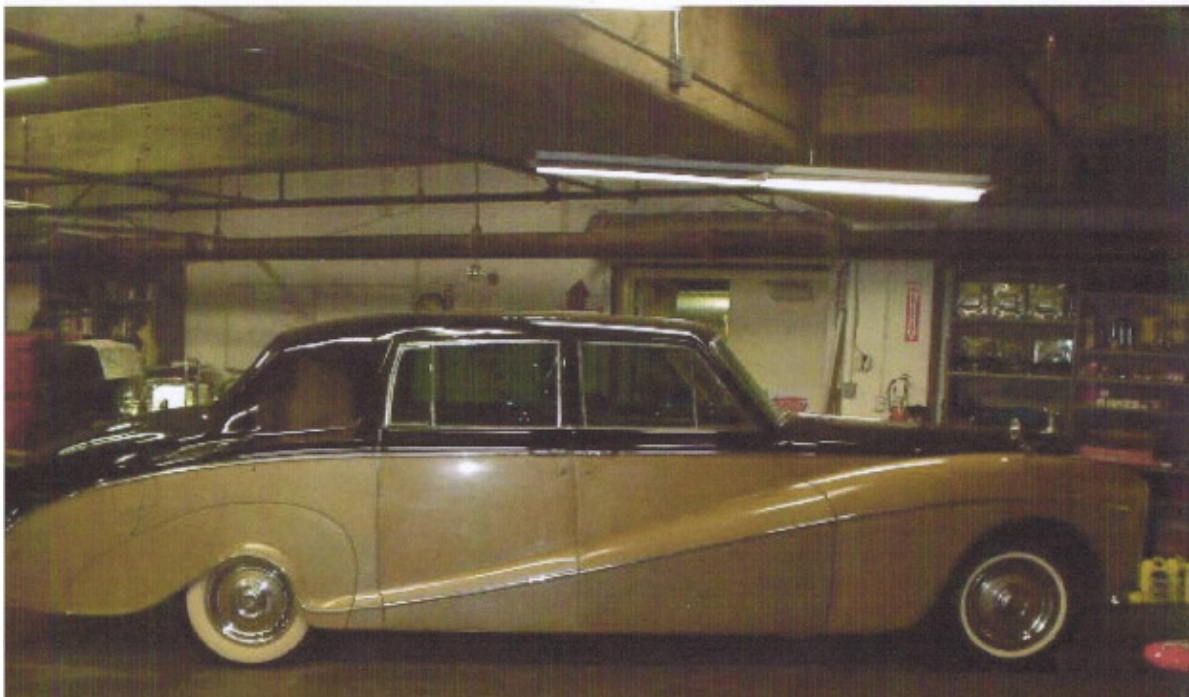
A very rare photo of the unique Henri Chapron Phantom V chassis number 5 LAT 4 allegedly stored in an air conditioned vault in the United States.

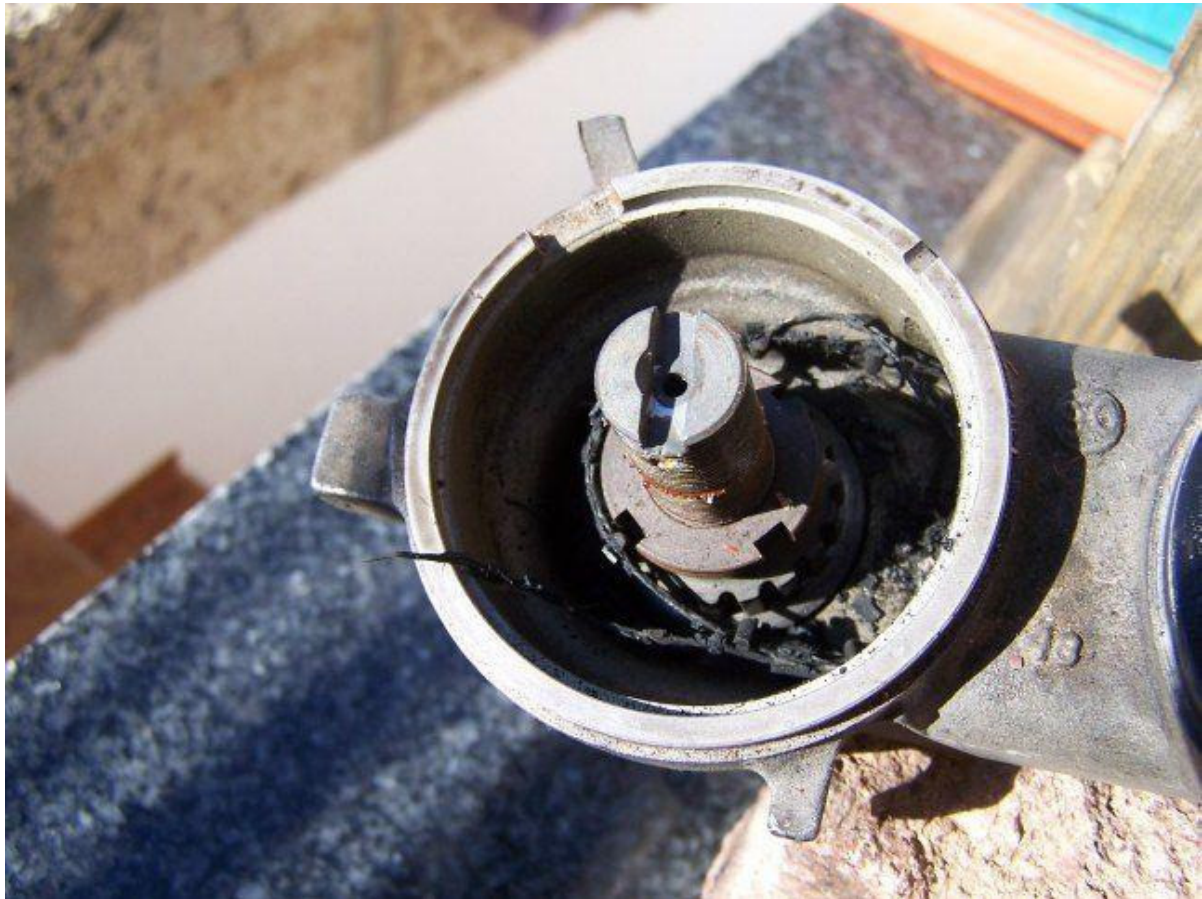
Service schedule for distributor drive belt

With the introduction of fuel injection came electronic monitoring of our engine's performance and fine tuning of components that for generations we have taken for granted. One of the latter has been the replacement of our well tried distributor with a dual unit. This happened on SZ cars from the 20,000 series (say about 1987). The good old distributor with eight wires coming out of it to our spark plugs was replaced with two distributors each with four wires. I imagine that each distributor then only had to work half as hard and could take more care in getting the right spark to the right plug at the right time! This is not entirely without precedent in our back yard since the magnificent vee twelve Phantom III engines of immediate pre-war II fame, enjoyed two distributors. Here though the object was to ensure that a spark actually fired in the combustion chamber. Two spark plugs per cylinder were allocated, each belonging to a separate ignition system including separate distributors. Both of these however enjoyed the positive drive of gear and shaft from the camshaft at the front of the engine.

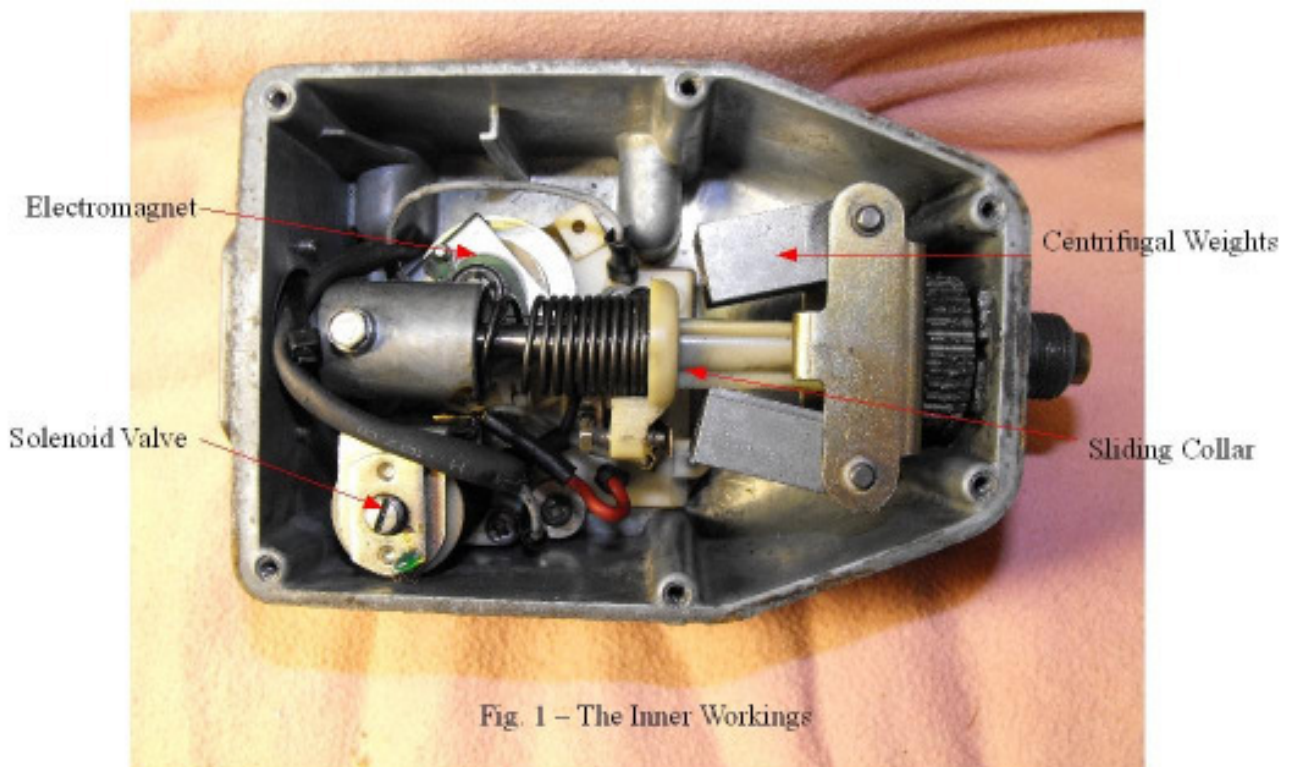
Once on the workbench remove the six screws securing the top cover which lifts off to reveal the inner workings (Fig.1).

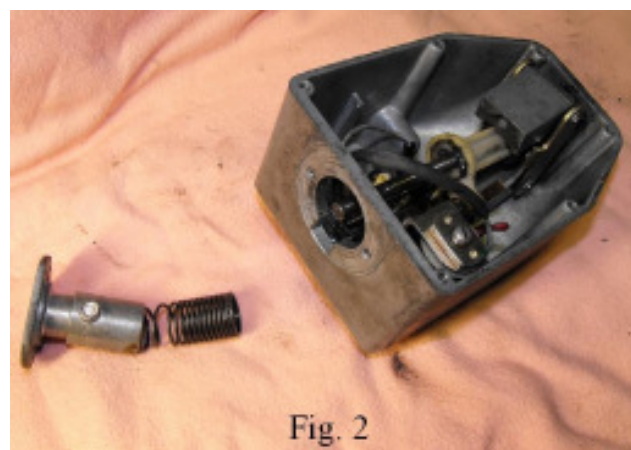
There is a cut-out in the casing so that once the two fixing screws are undone the whole end-cap assembly can be rotated through 180 enabling the it to be removed without undoing the locking screw (Fig 2).

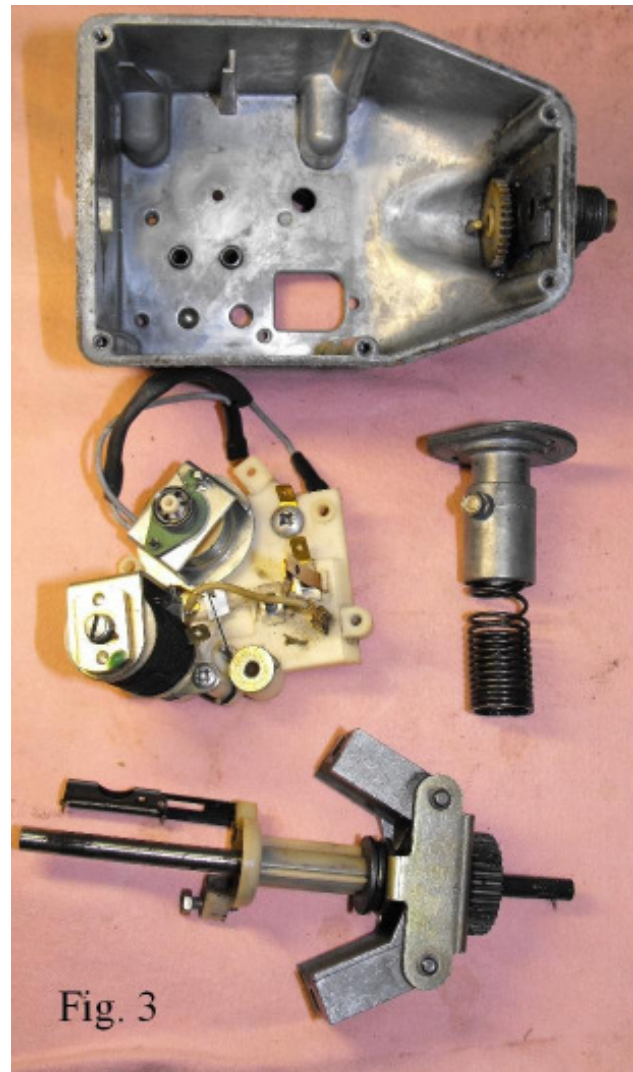
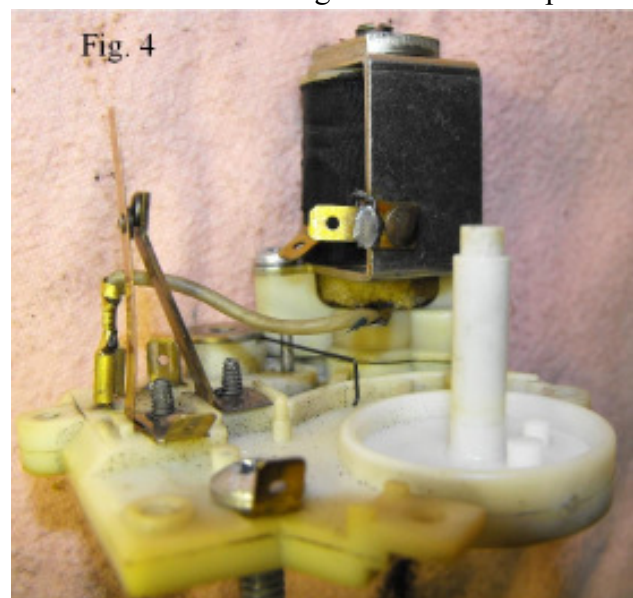
Figure 4 is a close up of the solenoid valve mounted on the base plate. It can be dismantled once the two screws securing it to the base plate are undone. The valve can then be fully taken apart. Figure 5 below shows the constituent parts of the valve. The problem I experienced was that the foam spring that returns the solenoid plunger to the closed position had disintegrated away to

dust. The one in the photo is a piece I cut from a block of foam I keep in the garage for kneeling on. It was the dust from the foam that had been sucked into valve and was caked around the plunger seal stopping it seating properly and thereby leaking air into the system

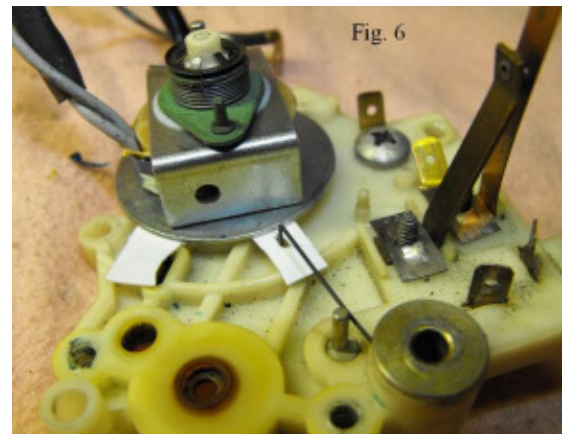
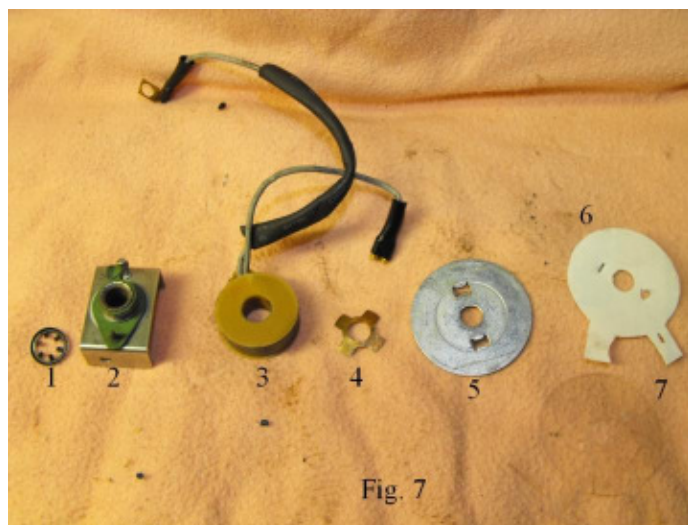
Key	Fig 7 - Electromagnet
1	Crown washer
2	Spring loaded locking plate
3	Winding
4	Spring washer
5	Base Plate
6	Replacement air bleed valve
7	Original air bleed valve

To remove the electromagnet it is necessary to carefully prise off the crown washer. Once this is removed the spindle connector and coil can be removed. Before the bottom plate and air bleed valve can be removed the return spring needs to be carefully disconnected from the cut-out in the air bleed valve. Figure 6 is a close up of the electromagnet and Figure 7 the unit fully dismantled. The flap of the original air bleed valve had become scared and would not seal properly. Being made of transparent plastic it does not photograph very clearly. A replacement was made from suitably thin plastic.

If the plastic of the air bleed valve is damaged a replacement can be made from suitably this plastic; in fact I cut my replacement from the lid of a margarine tub. It is important to get its relationship to the electromagnet base plate, which I managed by roughly cutting it to size but then mounting both it and the original on the base plate. I then used a fine craft knife to sculpt the replacement to exactly the same dimensions as the

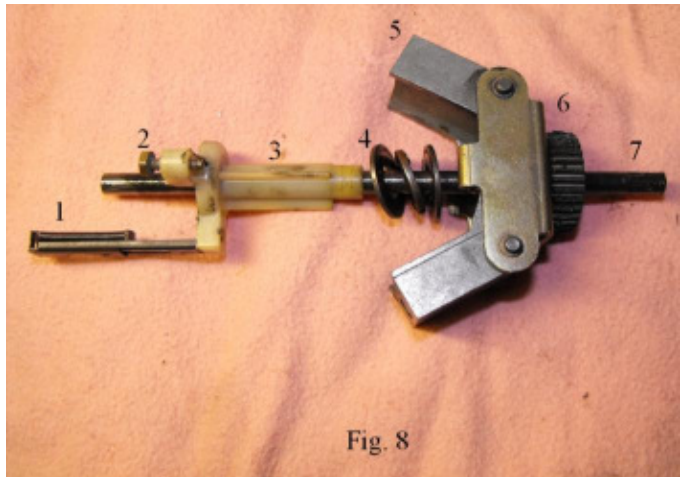
Key	Fig 8 - Spindle
1	Spring loaded slider
2	Low speed points adjusting screw
3	Sliding collar
4	Bearing
5	Centrifugal weights
6	Transfer gear to speedo cable
7	Input shaft for cable from gearbox

Figure 8 shows the components of the spindle assembly:

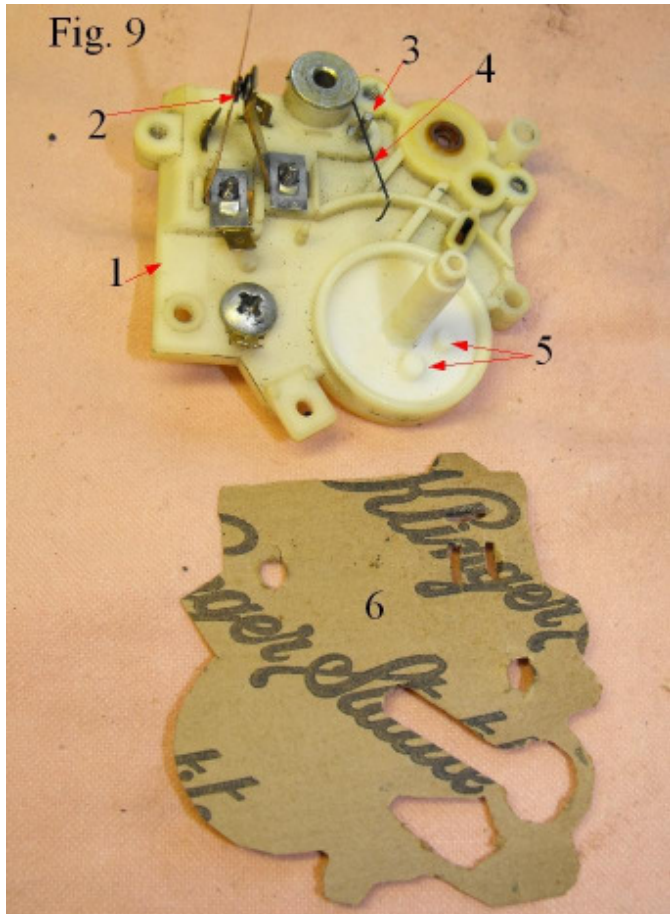
The final piece of the jigsaw is the base plate. The valve seat and other apertures need to be clean and check the low speed points are closing properly. It is unlikely the tension of the Bleed valve return spring will need adjusting, but if it does this is carried out by means of an Allen key inserted in the back of the eccentric

Key	Fig 9 – Base Plate
1	Base plate
2	Low speed points
3	Eccentric for adjusting bleed valve return spring
4	Bleed valve return spring
5	Lugs for tab on electromagnet base plate
6	New gasket cut from gasket paper

Left to its own devices the manifold depression would suck the bellows flat accelerating the car to maximum speed and this is where the air bleed valve comes in. The whole electromagnet assembly is connected to the sliding collar by the spring slide but it has a small amount of rotational movement allowed by the lugs in the base-plate. Once locked, as the engine speeds up the sliding collar moves further to the left causing the electromagnet assembly to rotate clockwise by a small amount. This rotation opens the air bleed valve allowing a small amount of air into the system which releases the bellows which in turn release the accelerator linkage slowing the engine down. If the engine slows down too much the centrifugal weights move the sliding collar to the right which causes the electromagnet assembly to rotate anti-clockwise thereby closing the air bleed valve allowing the vacuum to compress the bellows and accelerating the engine. At whatever cruising speed has been selected the air bleed valve will hold the vacuum to the bellows in balance and will adjust the throttle opening as the car slows down or speeds up when going up or down hill. The air bleed valve will always be returned to its steady state by its return spring (Fig. 9- 4).

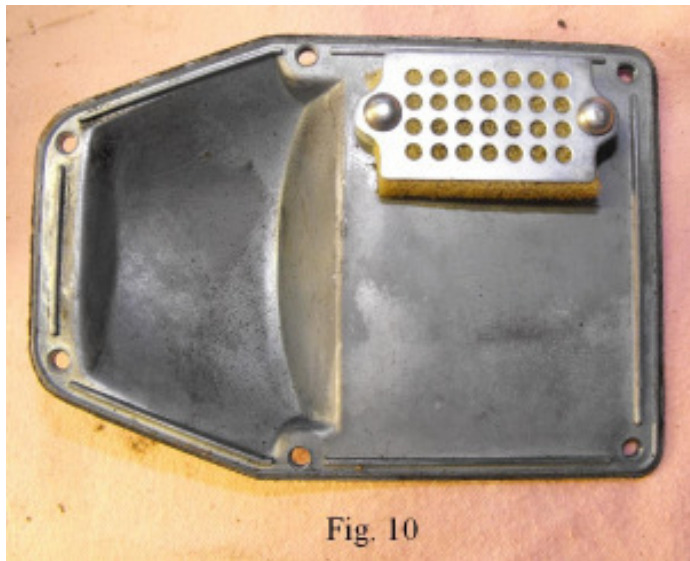
Fig. 10

The cover plate of the Speedostat has an air inlet which also has a piece of foam rubber to act as a filter (Fig. 10). This had suffered the same fate and had disintegrated, no doubt in turn being sucked into the mechanism. Once again a replacement was made from a piece cut from my kneeling cushion.

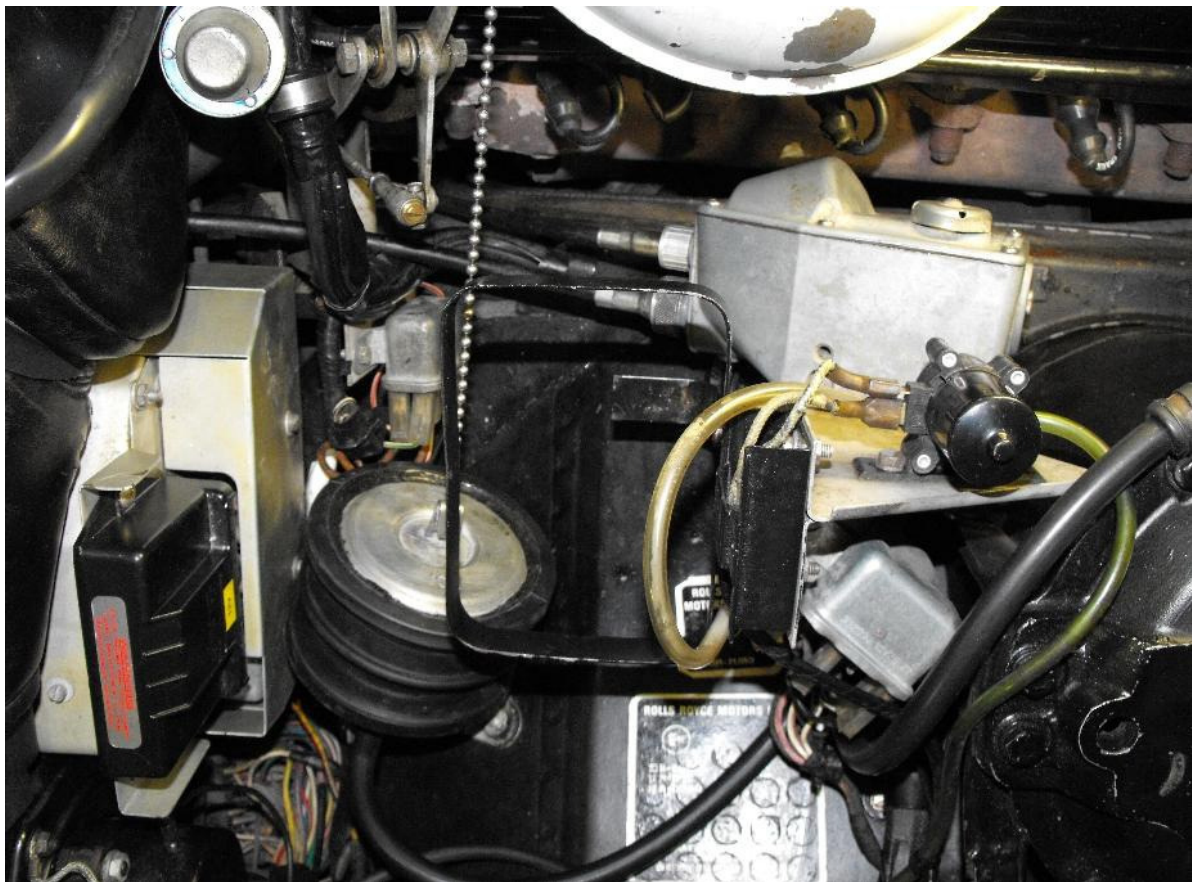
As it is not possible to observe the operation of the Speedostat the following description is my interpretation of its operation based on my observations of the various parts. Therefore, if any of this is wrong, my apologies and I am more than happy to include any corrections (e-mail to andrewsait@aol.com). When switched off the plunger of the solenoid valve is pushed onto its seat by the spring effect of the foam collar thereby closing off the bellows from the vacuum in the inlet manifold. When the car is stationary or travelling at less than approximately 30 mph the sliding collar on the spindle is held to the right of the unit by the spring. At this speed the slow speed points are held open by the set screw in the sliding collar breaking the circuit and preventing the speed control from being used. As the speed increase the centrifugal weights move the sliding collar to the left thereby closing the points and allowing the speed control to be engaged. The Speedostat and bellows in the engine bay
