Phantom II Head Corrosion

(A Slim Monograph by Barrie Gillings)

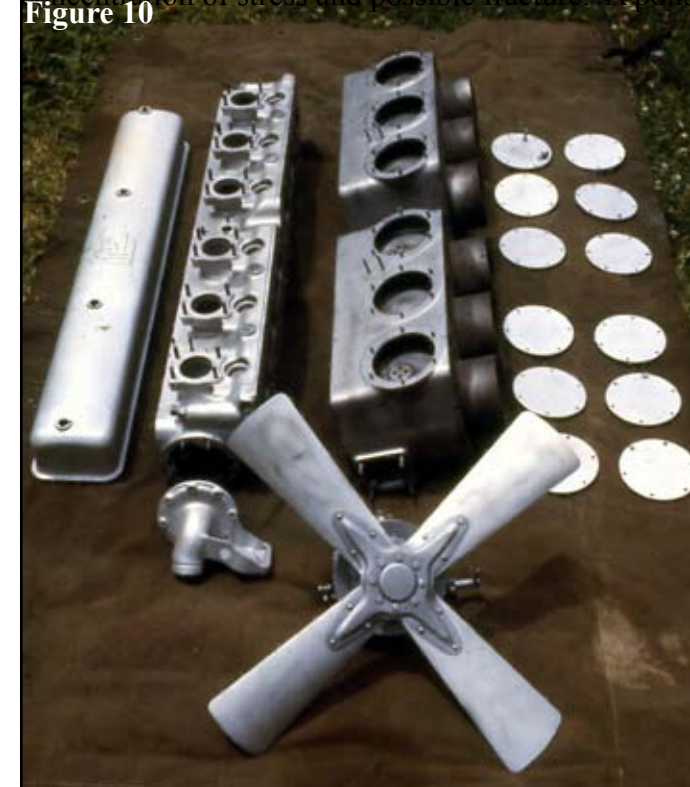
Figure 10

Here are (l-r) a Phantom II rocker cover, cylinder head, the two blocks, the twelve cylinder block cover-plates, then the front head cover-plate and the fan assembly. These have all been chemically cleaned and bead-blasted. When undertaking a cylinder head restoration, the head chemical cleaning and bead blasting greatly assist in identifying any faults and cracks. These are actual or potential causes of fracture or leakage.

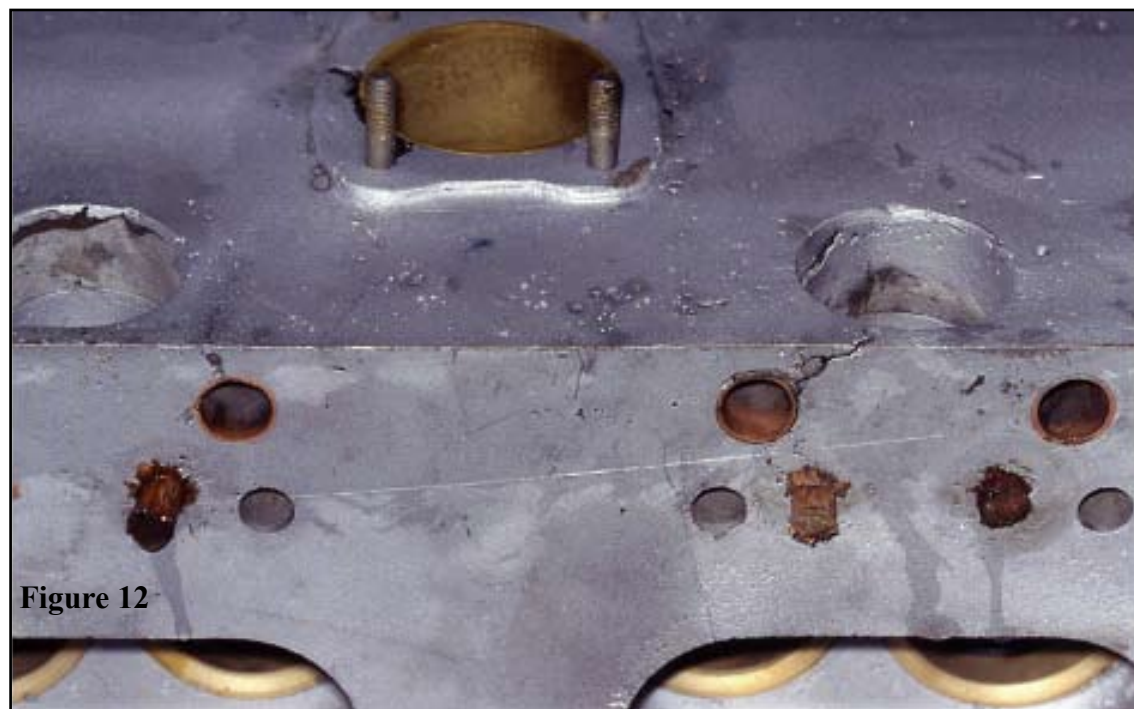
Figure 12

The corrosion cracks in the L and R spark plug recesses are probably the result of deficient welding repairs plus subsequent chemical corrosion. They did not leak. The cracks starting at two of the copper tubes which accommodate push rods are almost certainly electrolytic corrosion. They do not weaken the head, but may leak, as the tubes are sealed into the head by expanding them for a depth of about a centimeter with a tapered drift. (The wooden pegs are to seal head holes to allow for pressure testing.)

After a head has been repaired (welded and shaped), it is wise to chemically clean it, then bead- blast it, examine it for any faults, and correct them. The head should then be dried thoroughly and then immersed in an anaerobic-cure liquid, such as Loctite, perhaps twice. This resin penetrates any small cracks, pits and porosities, and cures in situ because of the absence of air. The surface resin remains unset and is washed off. The process seals off all but the worst leaks. They will show themselves in the pressure test.

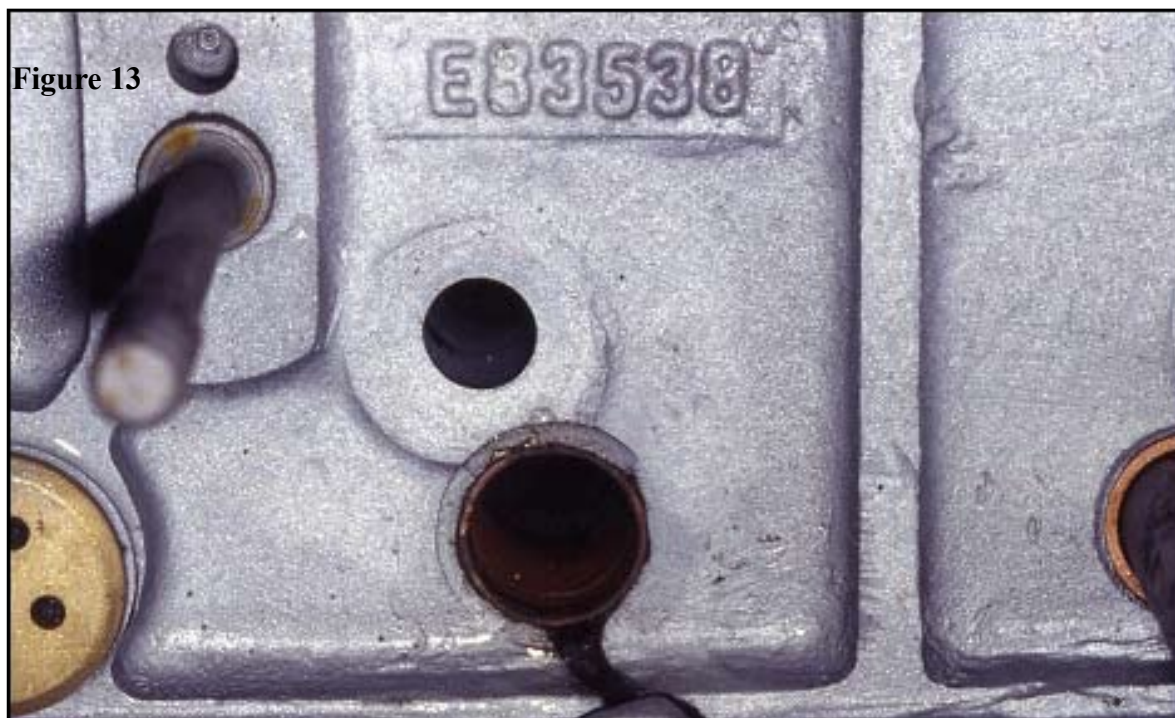
Figure 13

This is a large electrolytic corrosion defect caused by the copper push rod tube reacting with the aluminium of the head. It is much too large to be corrected by anaerobic resin, and welding would require removal and replacement of the copper push-rod tube. Here the space has been repaired with metal-filled plastic resin. The much narrower gap between the copper tube and the head aluminium has been filled with anaerobic resin.

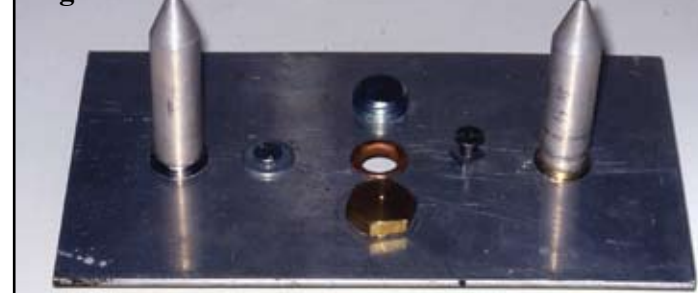
Figure 14

This shows a test panel of aluminium, with two sacrificial anodes, (L and R) and, in the middle; at 12 o'clock, a nickel-plated, threaded steel plug; at 3 o'clock, an unplated steel bolt and square nut; at six o'clock, a threaded brass plug; at nine o'clock, a steel bolt and galvanized steel washer. The hole in the middle of the plate has a copper eyelet peened into place.

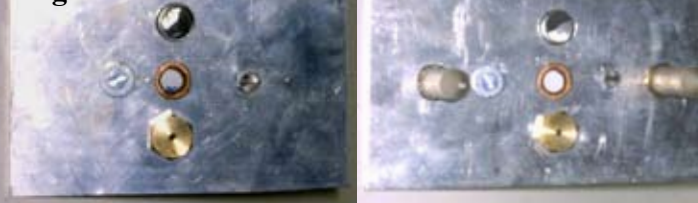
Figure 15

This shows the top view, on the right, of the plate in Fig.14, compared with, on the left, a similar plate with the same combination of metals but without the two sacrificial anodes.

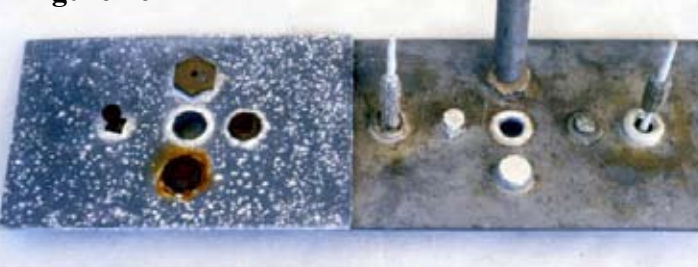
Figure 16

This shows an angle view of the upper surfaces of the two plates after immersion in salted pool water for several months. The unprotected plate (left, no sacrificial anodes) is covered with corrosion spots, probably aluminium oxide or hydroxide. There has been heavy rusting of the nickel-plated steel plug and both the steel bolt and nut, and the steel bolt and galvanised washer have rusted. The threaded brass hexagon plug and the peened copper eyelet are uncorroded. All items show a measure of white aluminium corrosion associated with their contact with the aluminium. The aluminium plate on the right has been completely protected by the sacrificial anodes. This protection has included all the other items. There has been no rusting at all. There is a white deposit on the steel and copper components, but not on the brass. Two of the sacrificial anodes have indeed sacrificed, and lost perhaps 80% of their magnesium. The middle one is a new anode, fitted to the 6 o'clock brass plug (Fig. 14).

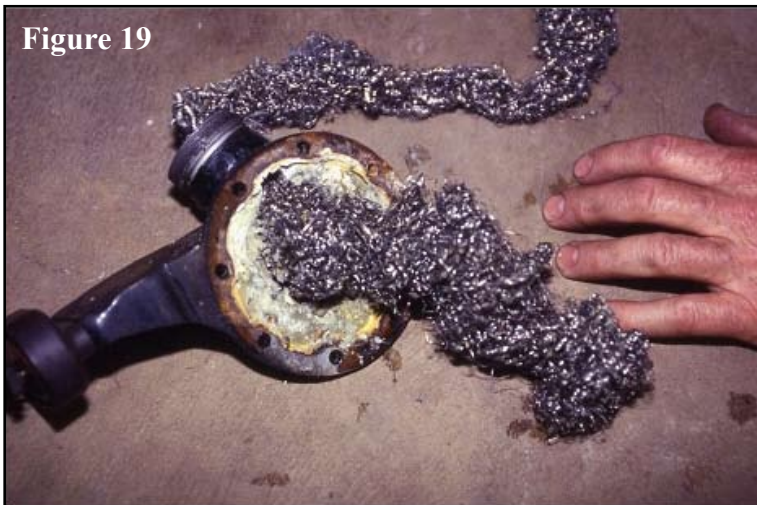
Figure 18

In an experiment conducted to test the feasibility of using sacrificial magnesium anodes to protect the Phantom II cylinder head against internal corrosion, the four welch plugs on the inlet side and the five on the exhaust side were removed and replaced with stainless steel threaded plugs fitted with anodes, as shown in Figure 18. This is their appearance after four weeks of service, using rainwater as the radiator coolant, and no additives. An unused anode (left) is included for comparison. Magnesium loss was greater on the exhaust side, possibly because the temperature in that area was slightly higher, or because of the presence of the copper push rod tubes. It was a surprise to find that the push rod tubes, when removed, were found to be nickel-plated. This may indicate that R-R thought this would suppress their corrosion to some extent.

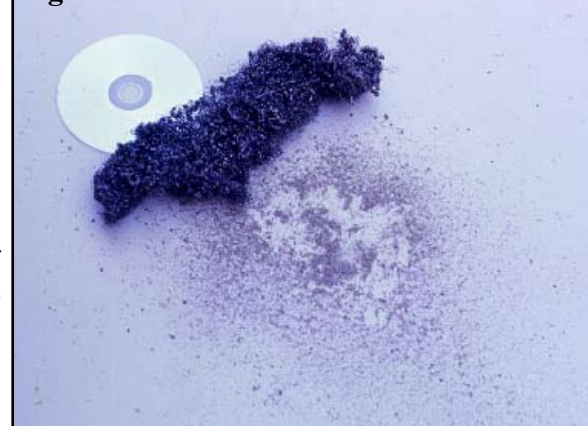
Figure 20

The advantage of using the stainless steel pot scourer as a filter is that it does not corrode, and offers very little restriction to coolant flow, but still manages to trap even fine particulate matter, as can be seen here. The CD is there for size comparison.

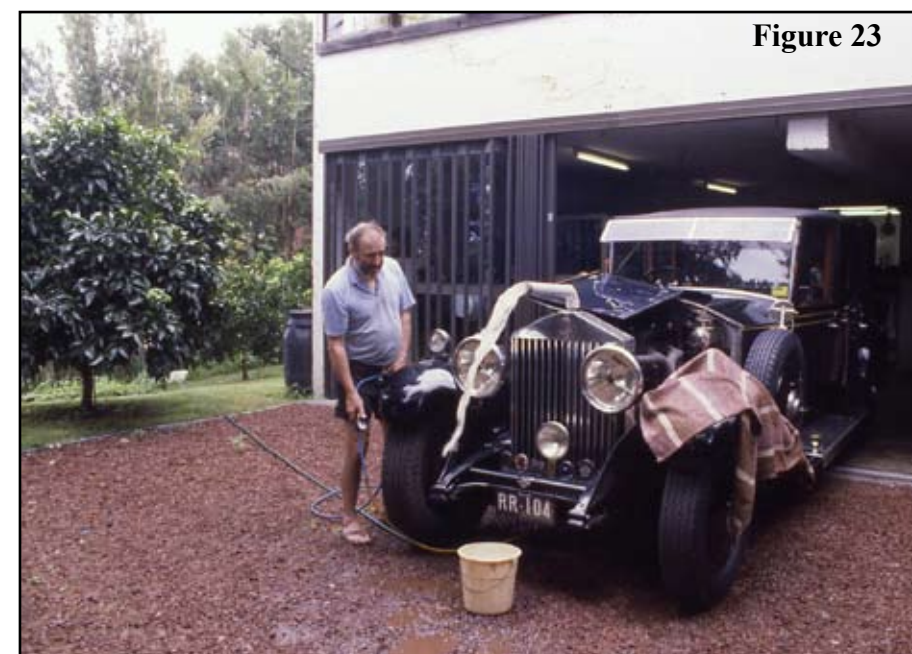
Figure 23

Here you see the back-flushing in progress. It shows the effect of turning on the compressed air after the garden hose has filled the cooling system. The bucket was positioned to collect the ejected water, in order to allow examination of the sludge that was dislodged. The bucket was incorrectly positioned because the force of the water flow was underestimated.

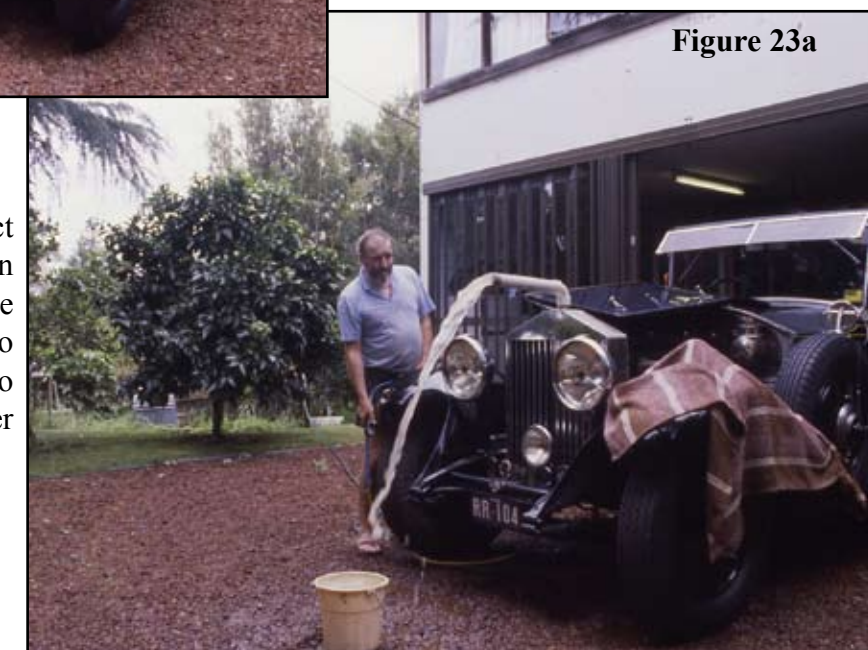
Figure 23a

This shows the bucket in the correct position to collect the ejecta. If you plan to use this system, it is important to make up a plastic pipe and elbow, and fit it to the radiator filler pipe as shown here to avoid splashing dirty radiator water over the engine and mudguards.

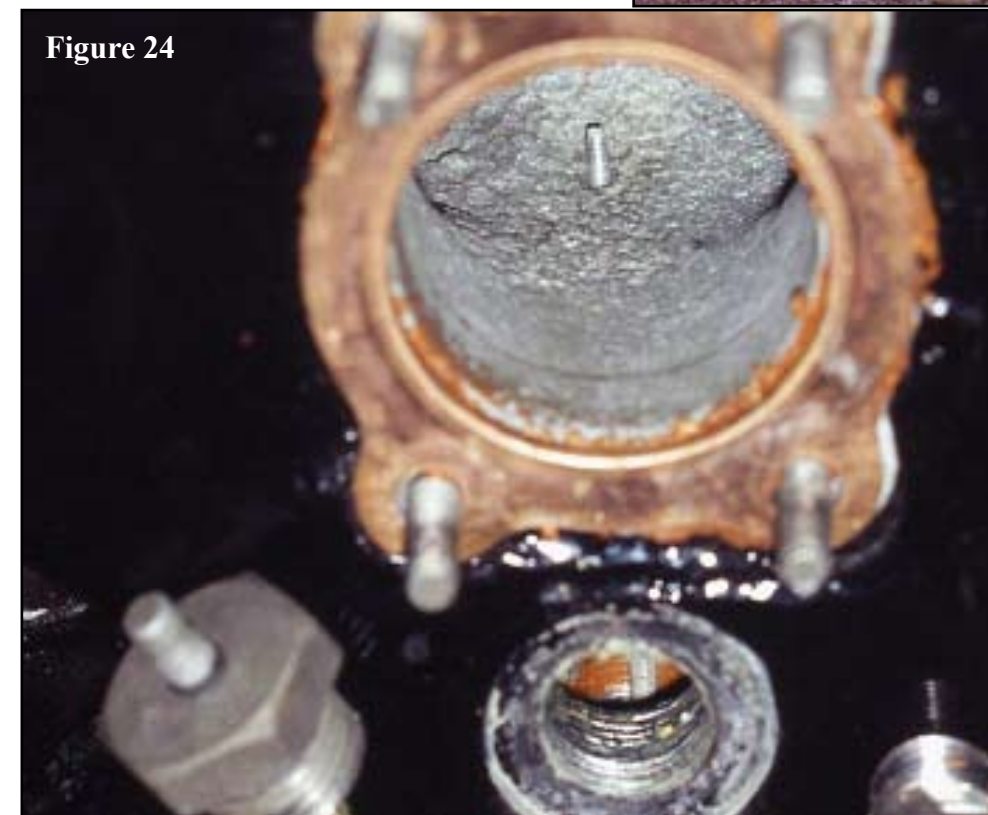
Figure 24

The picture illustrates what can happen if you run your engine with low coolant for any length of time, most frequently a consequence of boiling because of a blocked radiator and coolant loss through the overflow pipes. Head temperatures can rise alarmingly, sometimes so far as to melt the interior of the exhaust ports to produce holes and allow coolant to enter the exhaust system. This will be indicated by water being blown out of the exhaust, as has been the case here. An aluminium wire has been inserted past the welch plug hole and bent upwards to enter the small hole which has appeared in the thinned floor of the exhaust port. This hole must be repaired or the head is useless.

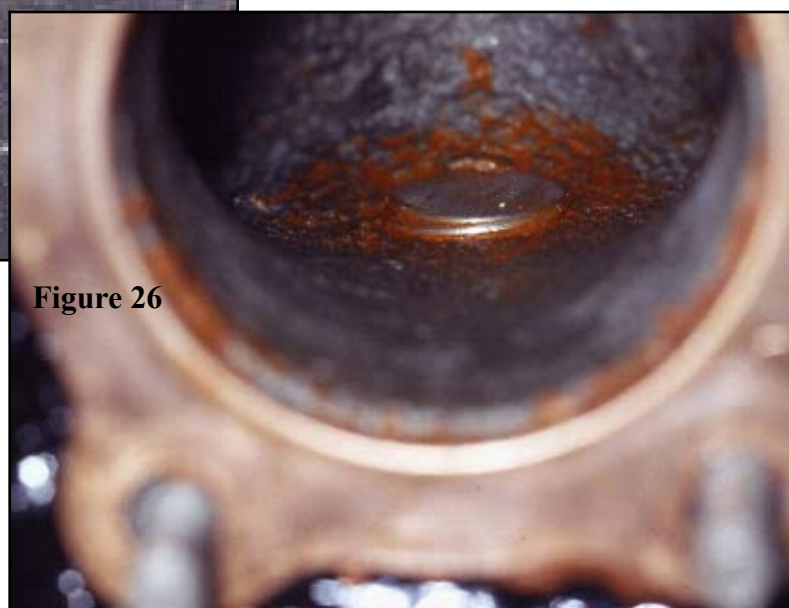
Figure 26
This is the head of the threaded aluminum rod screwed into the centre exhaust port to repair the small hole caused by the melting of the floor of the port, after the overheating of the head because of water loss. The red material is the copper-impregnated, heat-resisting silicone repair material.

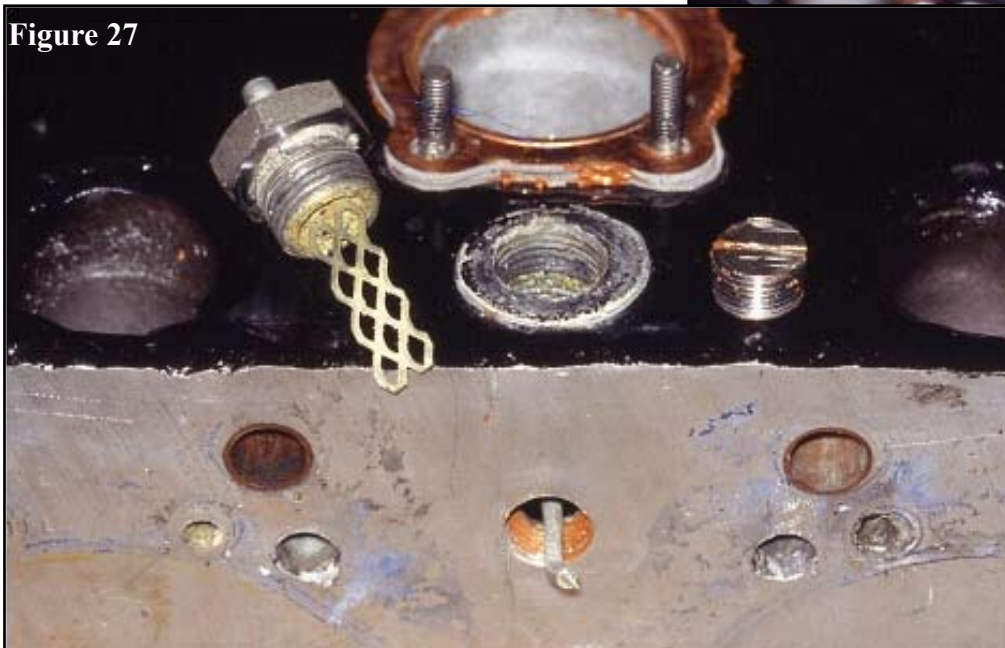
Figure 27

Here you see an angle view of the area shown in Figure 25. The welch plug holding the platinum-plated titanium anode is shown, fitted into and insulated from its stainless steel hexagon plug, which screws into the threaded welch plug hole. Platinised titanium anodes can replace sacrificial magnesium anodes when a small direct current is applied to them. In effect, they reverse the effect of electrolytic corrosion. This system is used on most large ships, and on buried tanks and gas and water pipelines everywhere.

Note also the threaded plug (right and also in Fig.25) which screws into and repairs a hole in the head face. Projecting through the hole is the other end of the aluminium wire seen in Figure 24.

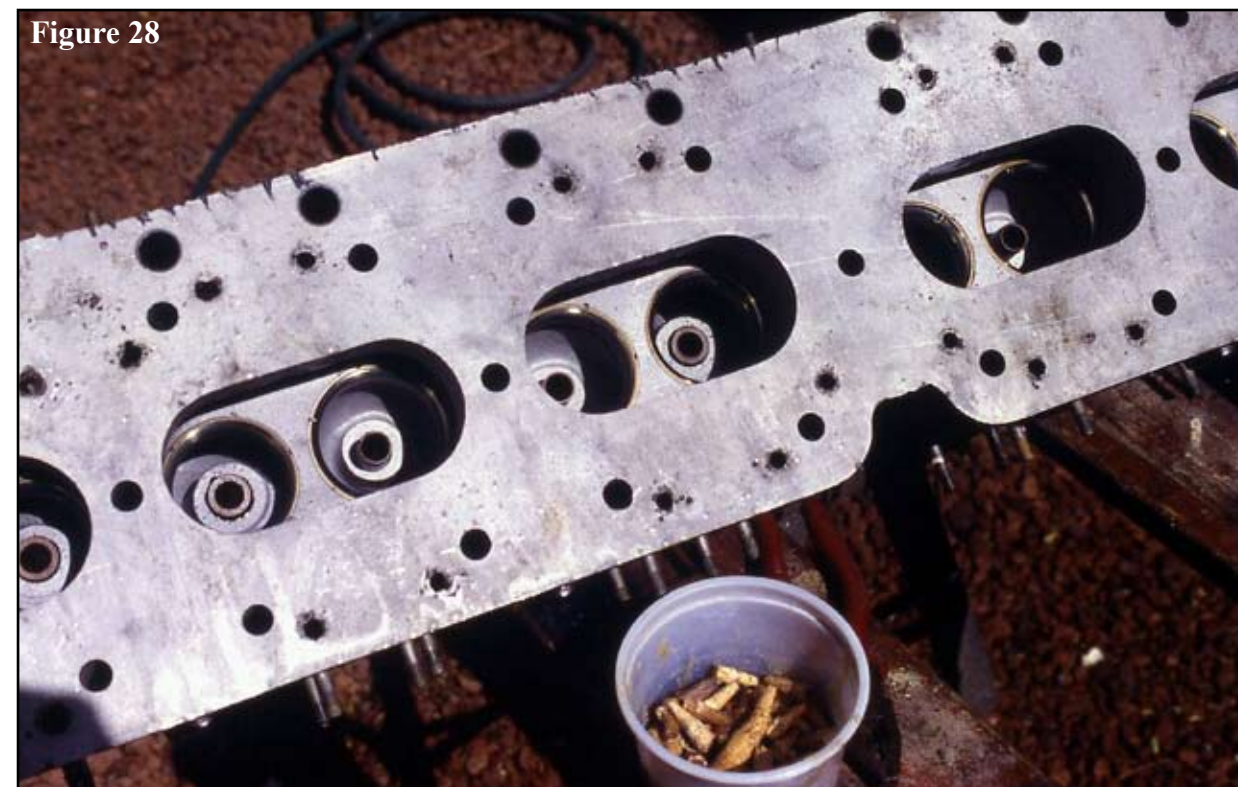
Figure 28

When the cylinder head has been repaired, it must be tested for leaks before fitting. To do this, all holes in the head which connect the inside of the head to the outside must be blocked. This requires the use of many softwood plugs, shaped and tapped carefully into the holes.

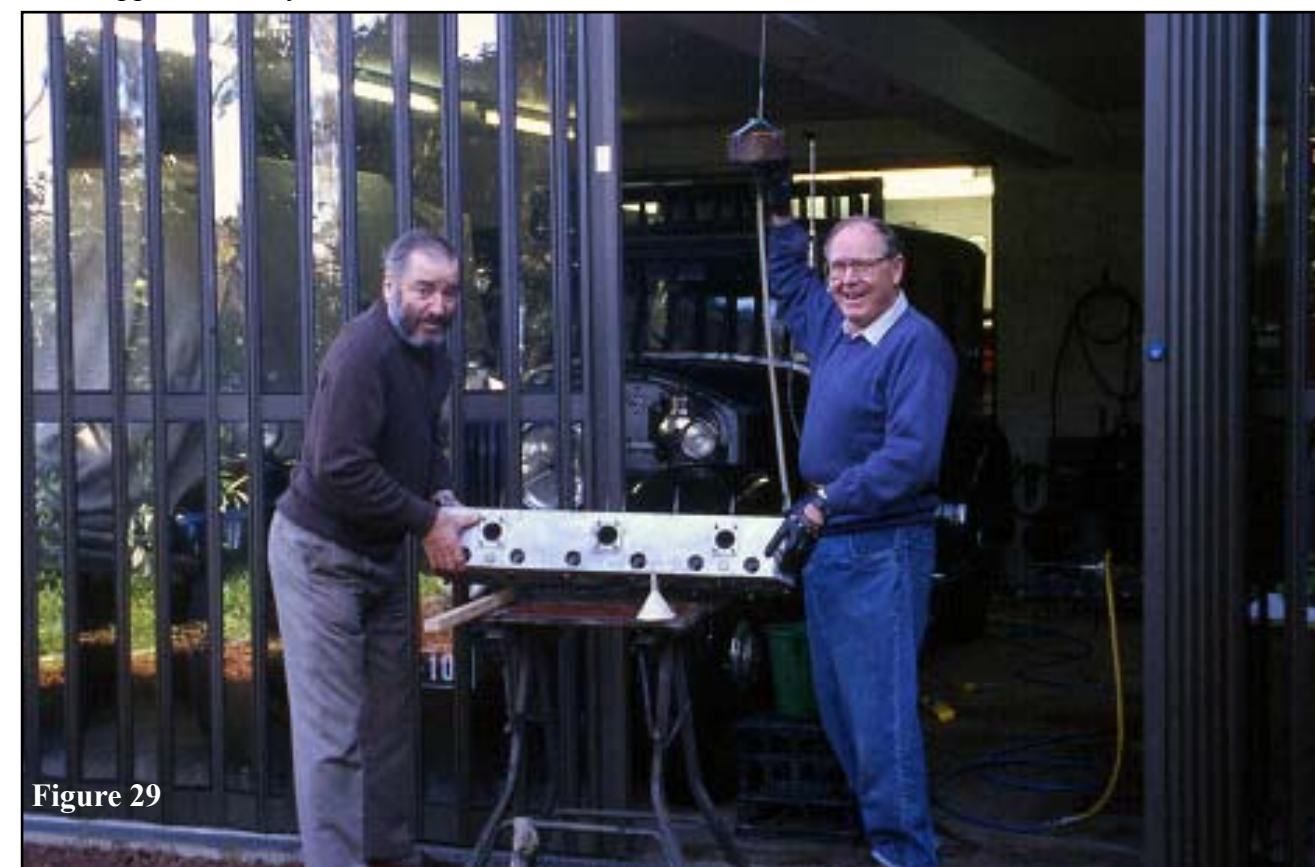
Figure 29

The PII cylinder head is very heavy, and the use of a willing assistant is most helpful for the next process, which is pressure-testing. A water source is required, and is connected to the otherwise sealed head by a hose connected to a small reservoir, here held above his head by James Kelso OAM. This provides very little pressure, here about 15 kPa. But this pressure is probably sufficient for most folk, as the cooling system of the Phantom II is not pressurized. That is to say, it is open to the air in the header tank, unlike modern cars, which usually have a sealing radiator cap which puts the coolant under a pressure of 10 or so kPa when the engine is running.

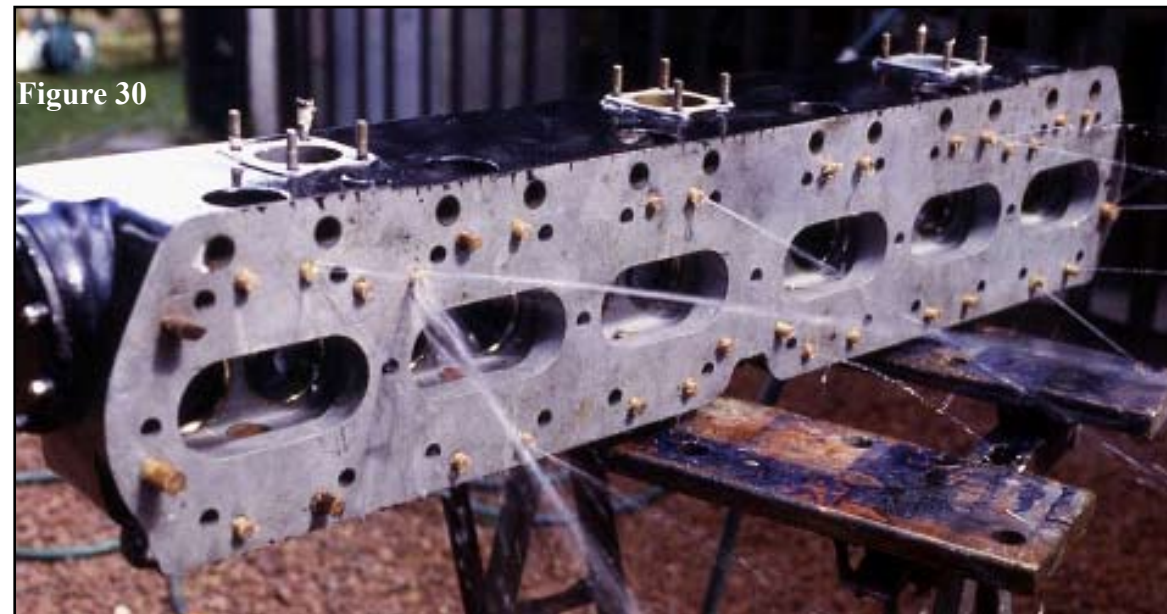
Figure 30

Cylinder head pressure testing does not require the use of an adjustable pressure regulator. It is a simple matter to arrange for an accurate and controllable water pressure for head-testing. On the ground below the cylinder head there is a three-way hose connection. One hose is attached to an inlet connection to the cylinder head (the temperature gauge opening). The second hose is attached to a water tap. The third is attached to a hose which is open-ended and can be elevated to a height of, say, five meters. When the tap is turned on, the water fills the cylinder head, then rises in the hose to five meters, then overflows. This head of water, adjustable by raising or lowering the hose, establishes a pressure of about 10 kPa per metre of hose-end height above the cylinder head. If no head leaks appear with three metres or so of height, the head is sound, and should not leak in service. The photograph shows that some of the wooden plugs did not seal effectively but that was because the holes were not very round as they were corroded. However, the head itself did not leak, and that was reassuring.
