TEE-ONE TOPICS

Number 76 June 2008

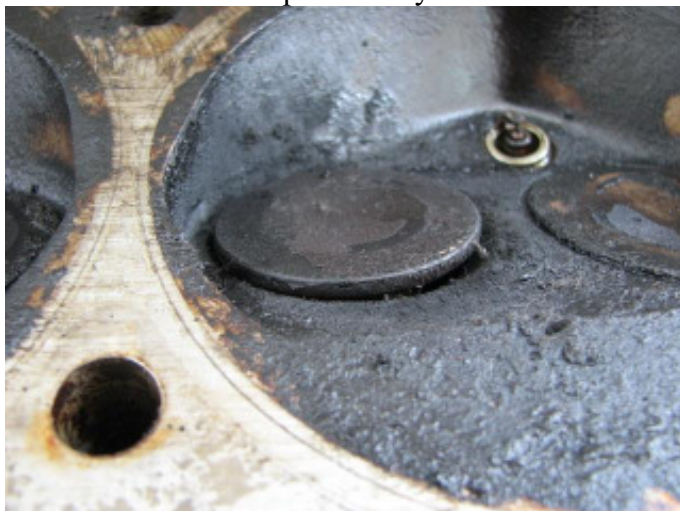
The owner of this engine was proceeding with the rest of his car at great speed when this strange miss and knocking occurred. Such things do little for the lower portion of the driver's alimentary canal! Apparently one of the exhaust valves had seized in its guide and stuck open.

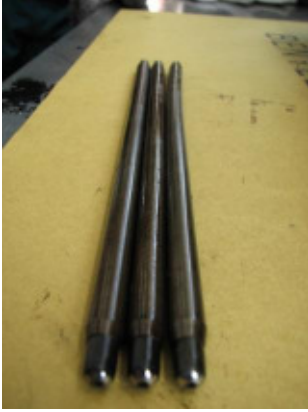
Seen here is the valiant push rod that tried to force the valve open and bent itself in the process.

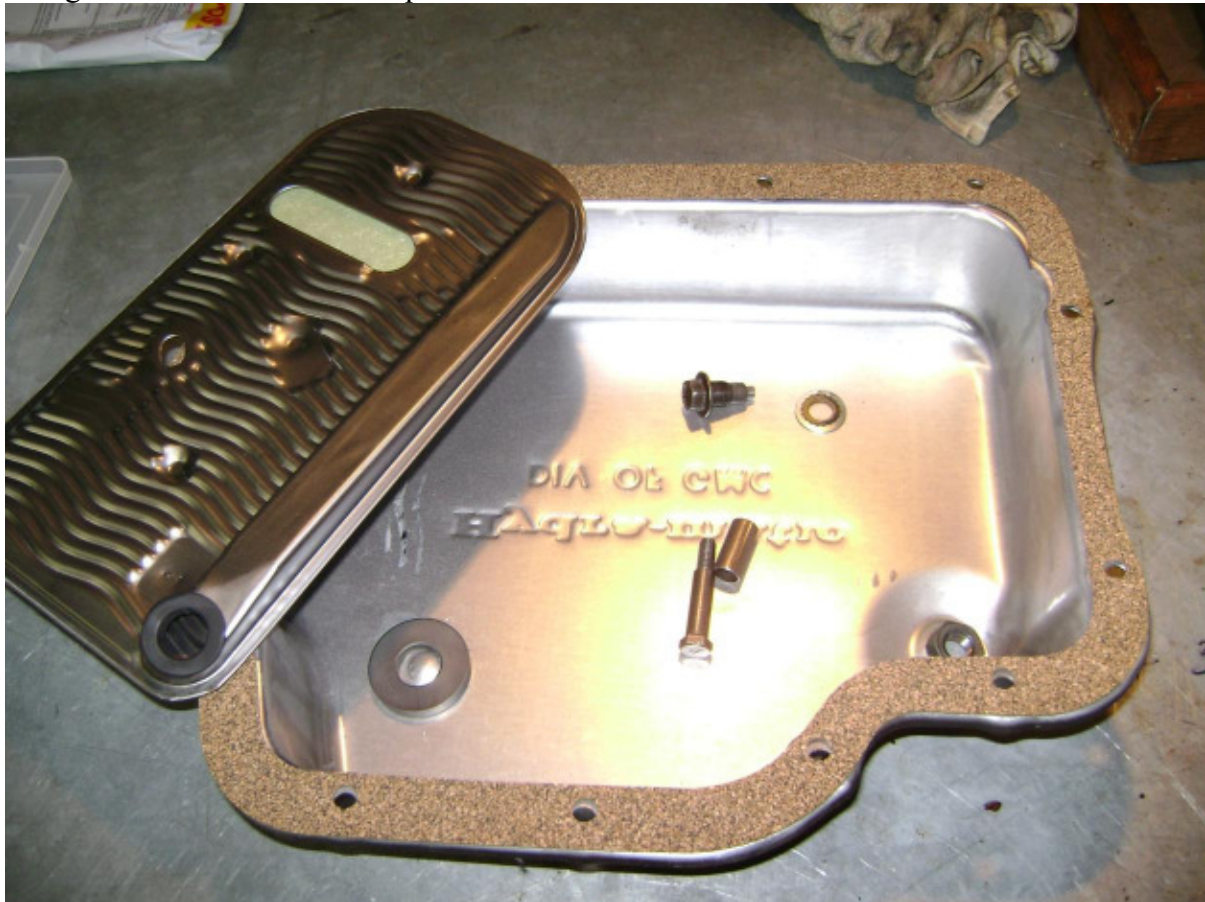
The 1989 models featured a deeper sump but fortunately the standard filter kit available from any auto store still fits the unit. The transmission is extraordinarily reliable and robust provided you keep clean fluid in it and keep that at the right level.

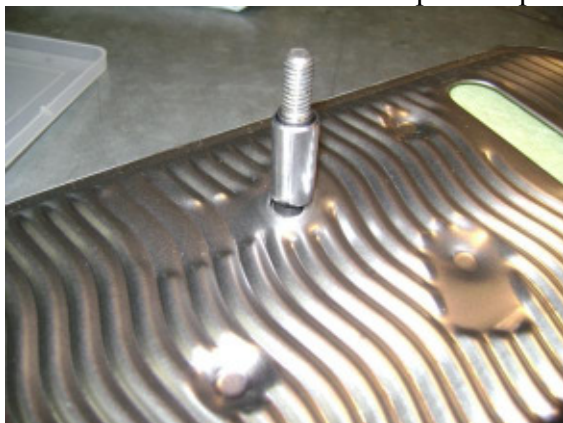
Because the sump is much deeper in the '89 models the filter which hangs loosely from the main casing has to be suspended lower. This is achieved by a spacer and longer bolt for the filter retainer.

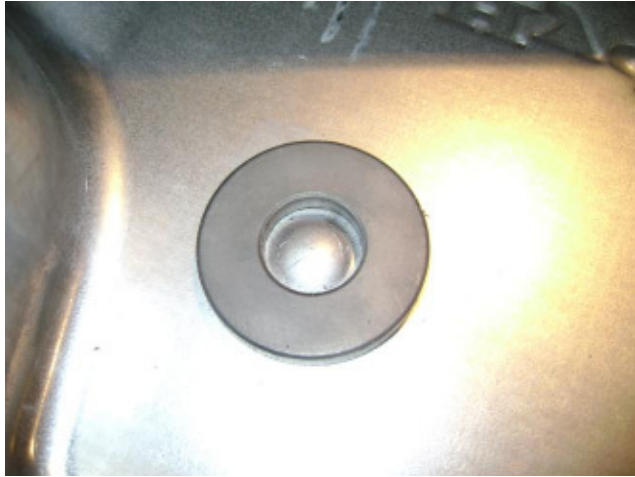
drilling in the right hand side to admit a pipe for filling purposes and checking the level. To change the oil involved draining some by loosening the filler tube at the side of the gearbox. This still left quite a bit of oil sitting in the sump.

To remove the latter involved dropping the rear end and lifting the front end clear of a couple of redundant lugs on the torus cover housing. Best you have a large tray underneath as the oil cascades out over the end of the sump.

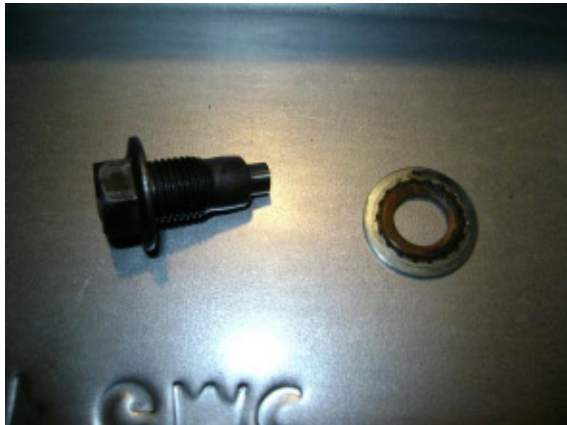
The last bastion for foreign material, a magnetic drain plug complimented by a modern day version of the doughty washer. Fortunately the latter can be used several times. This is probably the best practical feature of the later version of the transmission in that you can drain all the fluid from the main casing without drowning yourself in the stuff as with the old arrangement.

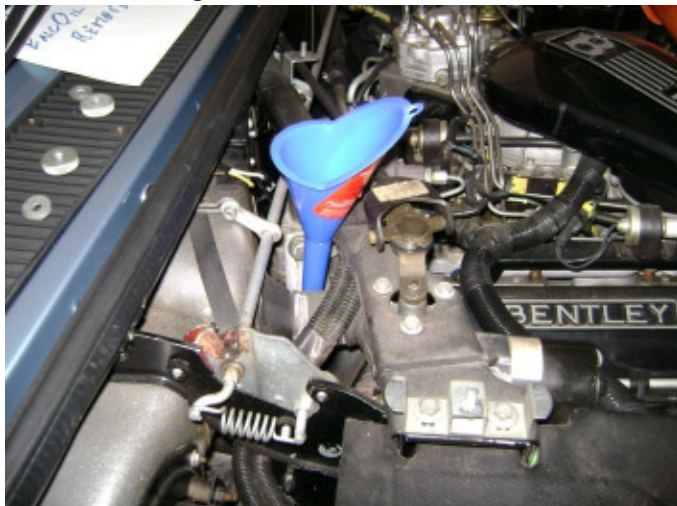
I found this nifty little funnel in Bunnings which makes for adding fluid to the transmission through that elusive pipe very easy. In the old days this would have been snapped up by the Factory given a part number and sold as a very exclusive special tool! While we are here the three bolts holding the wiper motor to its mount seen here at 4.00 o'clock to the funnel still come loose even with serrated washers and bolts. The solution seems to me a particularly tenacious dose of Locktite!

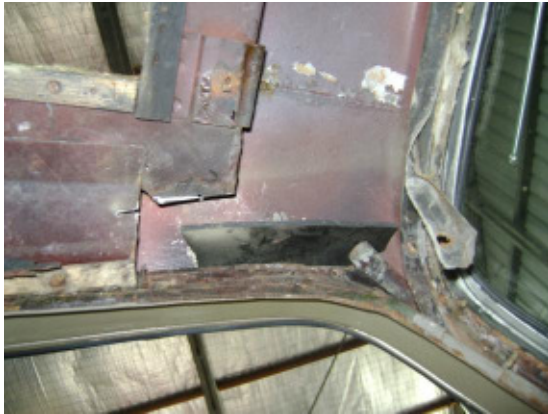
For post-war standard steel bodies with sun-roofs be aware that they are designed to let water get down between the sun roof and the body. It drips into a channel that extends a fair way back into the body, the left front corner of it can be seen in the picture. The channel is then supposed to drain to its four corners and down pipes to which it is connected by short lengths of rubber hose. The top of one pipe can also be seen in the picture. The corner drains block, rust and leak and the hoses perish and leak. Here the corner has been cut away to be remade.

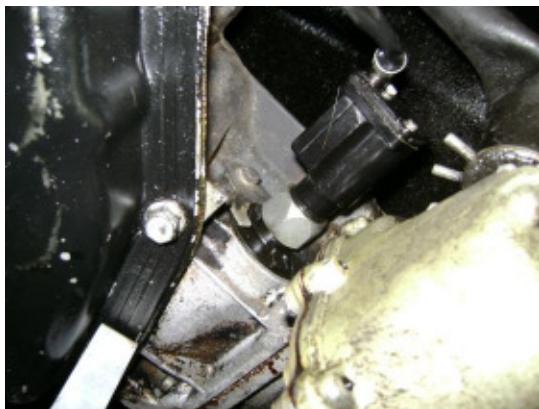
Be aware of of this little gadget seen jammed in the side of a transmission of a car fitted with an electronic speedo. It is called a transducer and generates a pulse which when transmitted by wire to the speedo causes the latter to give a speed reading. This one was fitted to an '85 Spirit and failed. For the moment they can't be repaired nor are they available so its off to the nearest wrecker and hopefully you will find a replacement. Be aware that the transducer for the Shadow II the first car to use the system is different from that used in the Spirit. The mounting threads are very different.

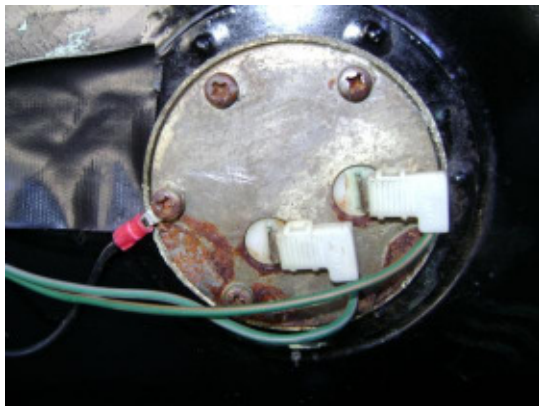
When American legislators realised that their motoring voters were not happy with being frequently immolated after a major rear end smash, they directed that petrol tanks be moved forward to minimise the risk of fire. The Shadow II was the first car to get the treatment. Australians apparently were more expendable as the modification did not reach our shores until the arrival of the Spirit. All this and the photo to point out a common insidious leak from the fuel gauge sender unit which thoughtfully rots the screws into the tank. The sender units are far from immortal and usually give up when the internal wiper gets into the half way area. Then you get a nil reading. But then you are all so careful you will reset your odometer each time you fill the tank and as you know you are getting 400 plus kilometres to a tank regardless of what the gauge says you know roughly whether you are going to get home!

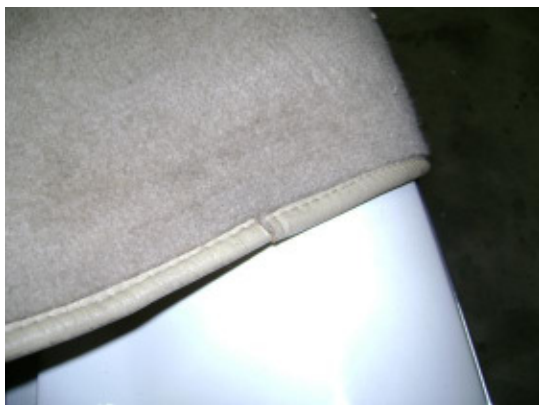
Isn't this sad and quite unnecessary. The carpets in case you haven't noticed are trimmed with leather to match the furnishings. All leather needs feeding including these little bits. Here the stuff has dried out shrunk, cracked and pulled apart. Whenever you pull your carpets to give them a good Hoovering get a good leather dressing on a cloth and rub some of the stuff into the binding. On carpets, I remember one of our very wealthy transport magnates having bought a new Shadow, liked the carpets so much he asked that his helicopter be fitted out with the same floor covering! On hearing that the carpet (allegedly Super Wilton) was \$1000 per yard he opted for the standard helicopter nylon!

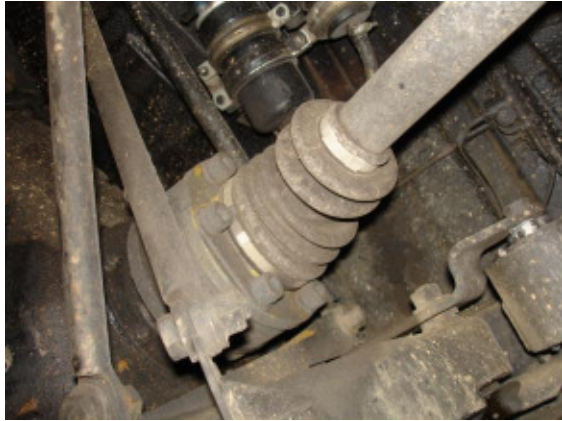
The Factory took a deep breath during early production of the Spirit and replaced the long used constant velocity and universal joints on the rear axles with Lobro joints seen here. Note the convoluted rubber boot which does a sterling job keeping the dirt and water out. Their life seems largely unpredictable but eventually they will crack and have to be replaced. It is a job that you can do yourself but be warned that there is some variation in the axle assemblies and for certain models of SZ cars the boots are not available. Some of the more comedic spares people will tell you that the solution is to replace the entire assemblies! The easiest solution is to send the axles to people who specialise in these units. They have boots that will fit anything and will clean the joints out re-grease them and you will have peace of mind for a lot more time.

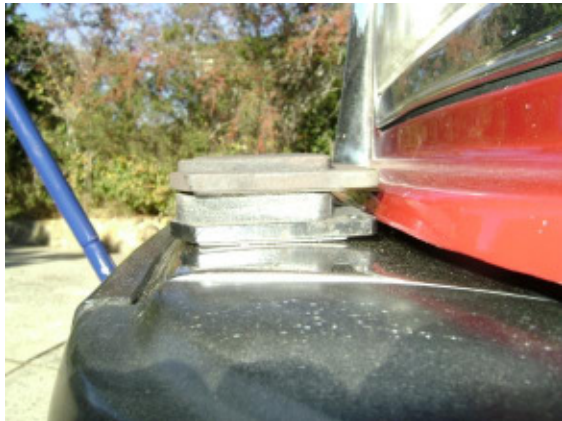
Owners often ask how low do you allow the brake pads to wear down? Well the best rule of thumb is when the pads are thinner than the backing plate. Here we see a worn pad sitting on top of a new pad and the difference is quite apparent. Some people hunt around to find 'non genuine' pads since they are cheaper. Well consider that in the event of an accident where emergency services are used, the police inspectors have a very close look at such things as brake pads. If you have had fitted non genuine items they might just claim that this choice precipitated or at the least contributed to the accident. Insurance is then void and you could well find yourself in the dock answering so very salient questions!

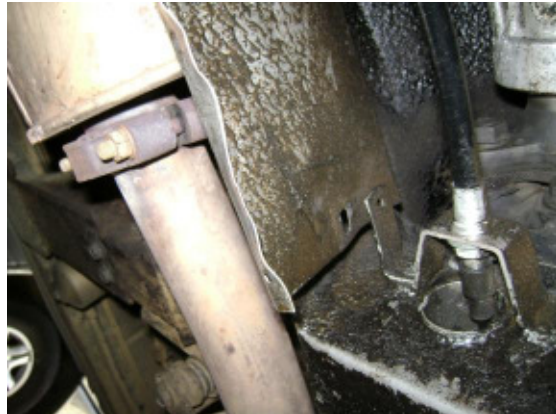
With the plethora of mufflers of various shapes and sizes the Factory had the task of shielding the floor of the car from the radiated heat of the units. Aluminium seems to be the favoured material an example of which is seen here. They are very light and don't require much fixing but it pays to keep an eye on the few bolts and bits used. Here is one that has vacated the car and provided an excellent source for a major rattle!

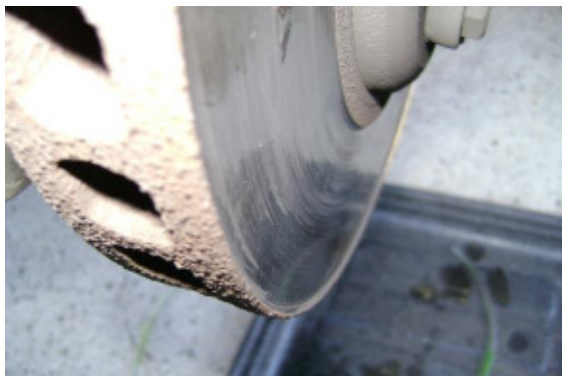
Remember that not only the brake pads wear but so do the rotors or discs as they are popularly known. Here can be seen the result of about 130,000K of reasonable wear and the disc has a pronounced lip on the periphery. Although appearances deceive, discs do not wear evenly especially if they are subjected to violent use. It is for this reason that periodically they need to be re-ground flat. This is a job for a machinist with specialised equipment. Ideally the front calliper is removed on the front wheel and a mobile grinder fitted to the hub. Alternatively the whole assembly needs to be removed and ground. The lip in itself is of little importance except that it does give an indication of wear. There is a minimum thickness permitted for these units which is stamped on the outer edge. Be aware that R A Chapman manufactures discs

for our cars at a very competitive price. Furthermore the discs are to all accounts a better design than the genuine and when they need replacing only the friction area which is detachable needs changing. An added feature is that the discs have been manufactured some .002" thicker than standard. This allows the discs to be ground on the car when new, thereby ensuring perfect concentricity with the stub axle.

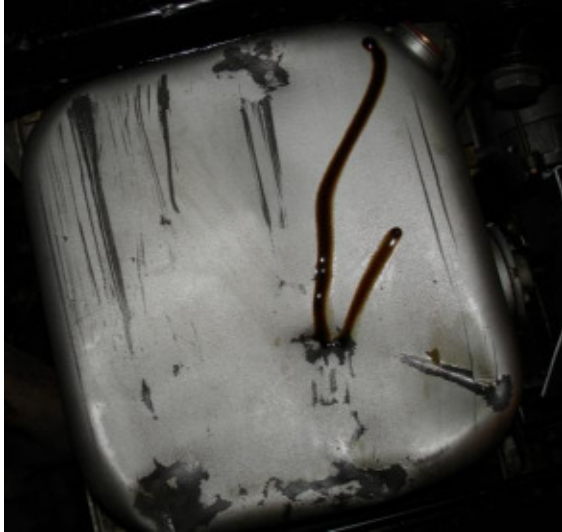
Firstly this is not a Salvadore Dali impressionist picture, but it is the damage done to the sump with a small hole punched to allow the oil dribble. Apparently crushed sumps are not uncommon since some garage people insist on jacking the car up by the sump sufficiently to dent it. The latter dent if deep enough partially blocks the intake strainer for the oil pump and disaster follows!

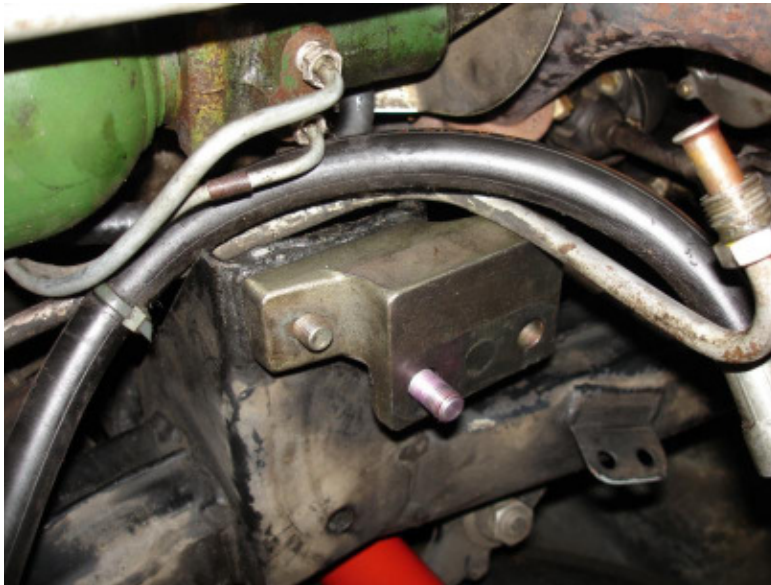
Here the steering rack has been removed. The peculiar block with the bolt poked through it is an adapter used for fitting the latest rack to the earlier cars. Accessing the main bolts holding the block to the sub frame does call for some ingenuity. Some can be reached from above using all the extensions you have as well as a couple borrowed from the neighbour otherwise one buys a very long extension and fashions it into a question mark. Using an appropriate socket with this adapter bar will allow you to undo bolts that you can only feel! Note the little two holed bracket on the subframe originally used on the Shadows for holding brake pipes. No wonder they call these cars Shadow III's.

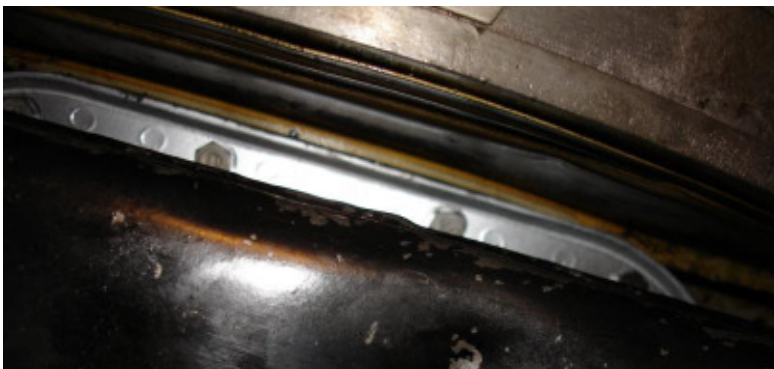
And here is why you have to slide the engine. The rear bolts holding the sump on are just that bit inaccessible to get a socket on them.

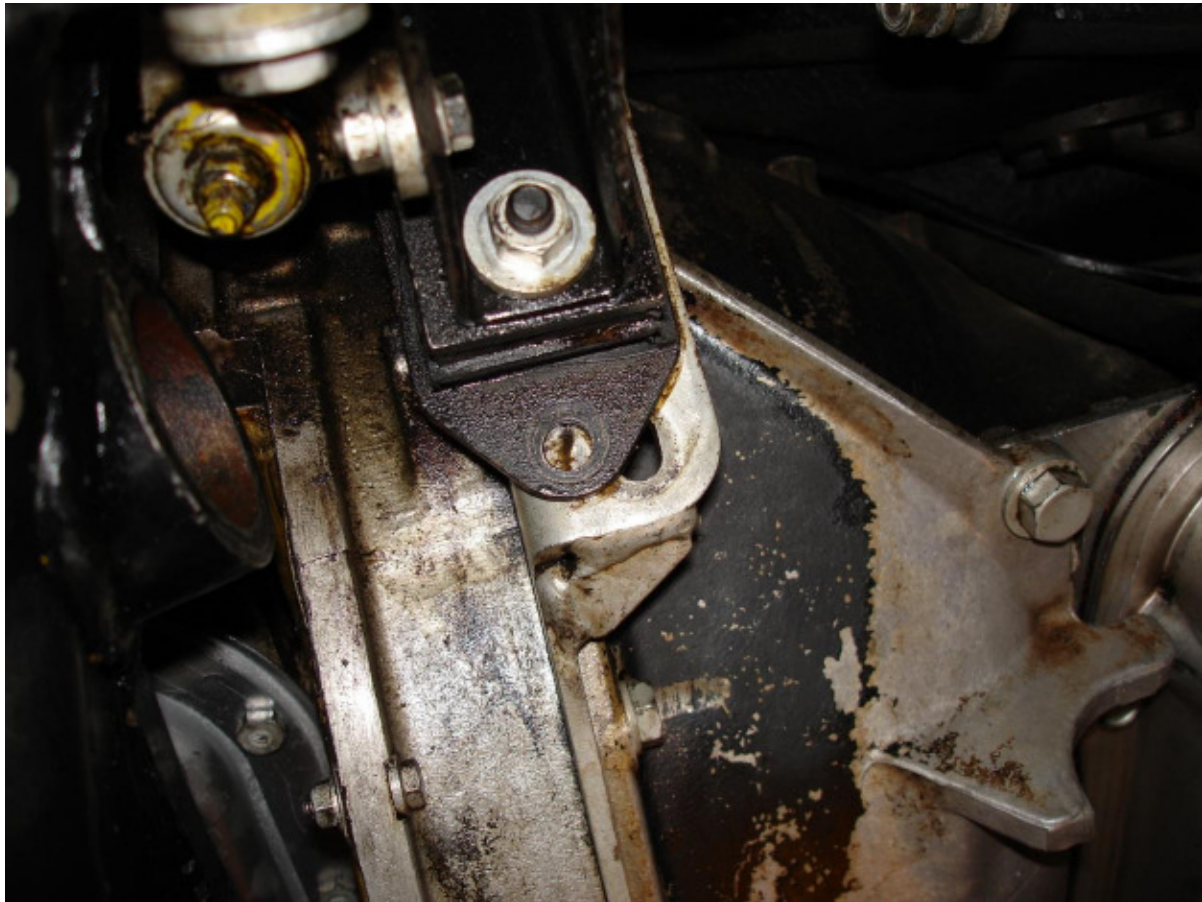
The engine on the move. The rear mounts have been disconnected allowing the whole engine to be slid rearwards exposing the rear set of bolts of the sump seen bottom left. There are still more bolts above the sub frame but more sliding forward and a little lifting allows you to get at them. The orange daubed nut at the top of the picture is the bottom end of a little shock absorber between the engine and the sub frame. Some cars had them others didn't. Why? I can't help perhaps you can!

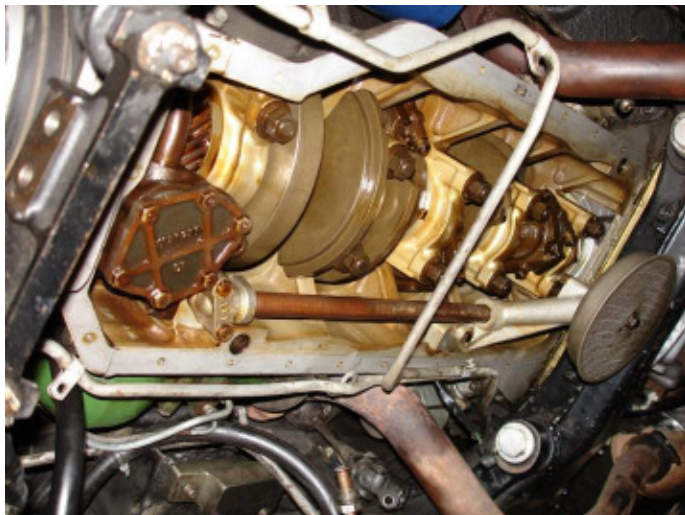
And this is where the go comes from. This engine has done about 100,000K and I am rather proud it is so clean. This comes from oil changes and not allowing the gunk to build up. While I keep an eye on the calendar and odometer I keep a closer eye on the dipstick. The moment the oil starts to darken, it gets changed. Oil is cheap engines aren't!

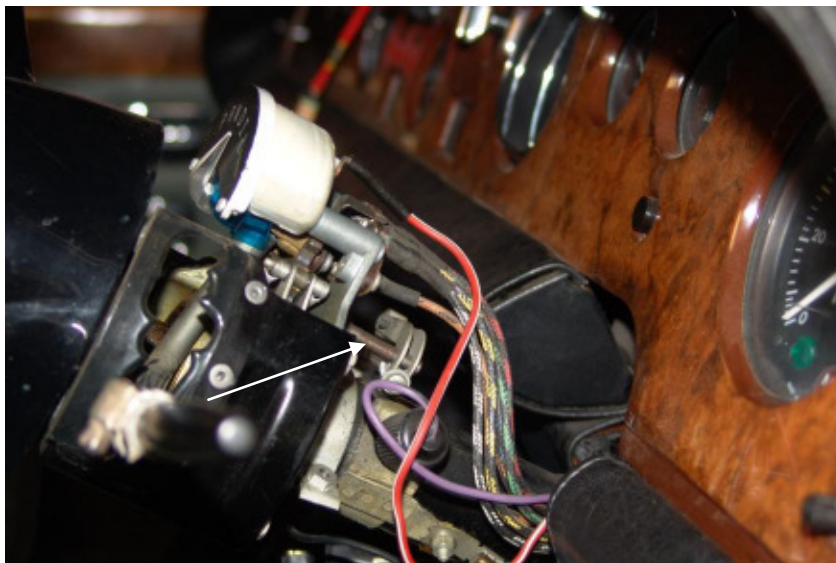
The system is quite simple in that a standard Burgess switch which is normally open is placed between the starter switch in the main switch box and the starter relays.

The real item of interest in the mess at left is the small shaft with a lever clamped to it. This shaft is the 'axle' on which the gear lever assembly turns and which various bits are mounted to turn lights on and hold pointers.

Moving the gear selector moves a shaped lever that in turn depresses the little button on the Burgess switch. This latter action needs to be quite definite as there is little movement in the various parts. So if the button is not pushed quite far enough it's a case of no start.

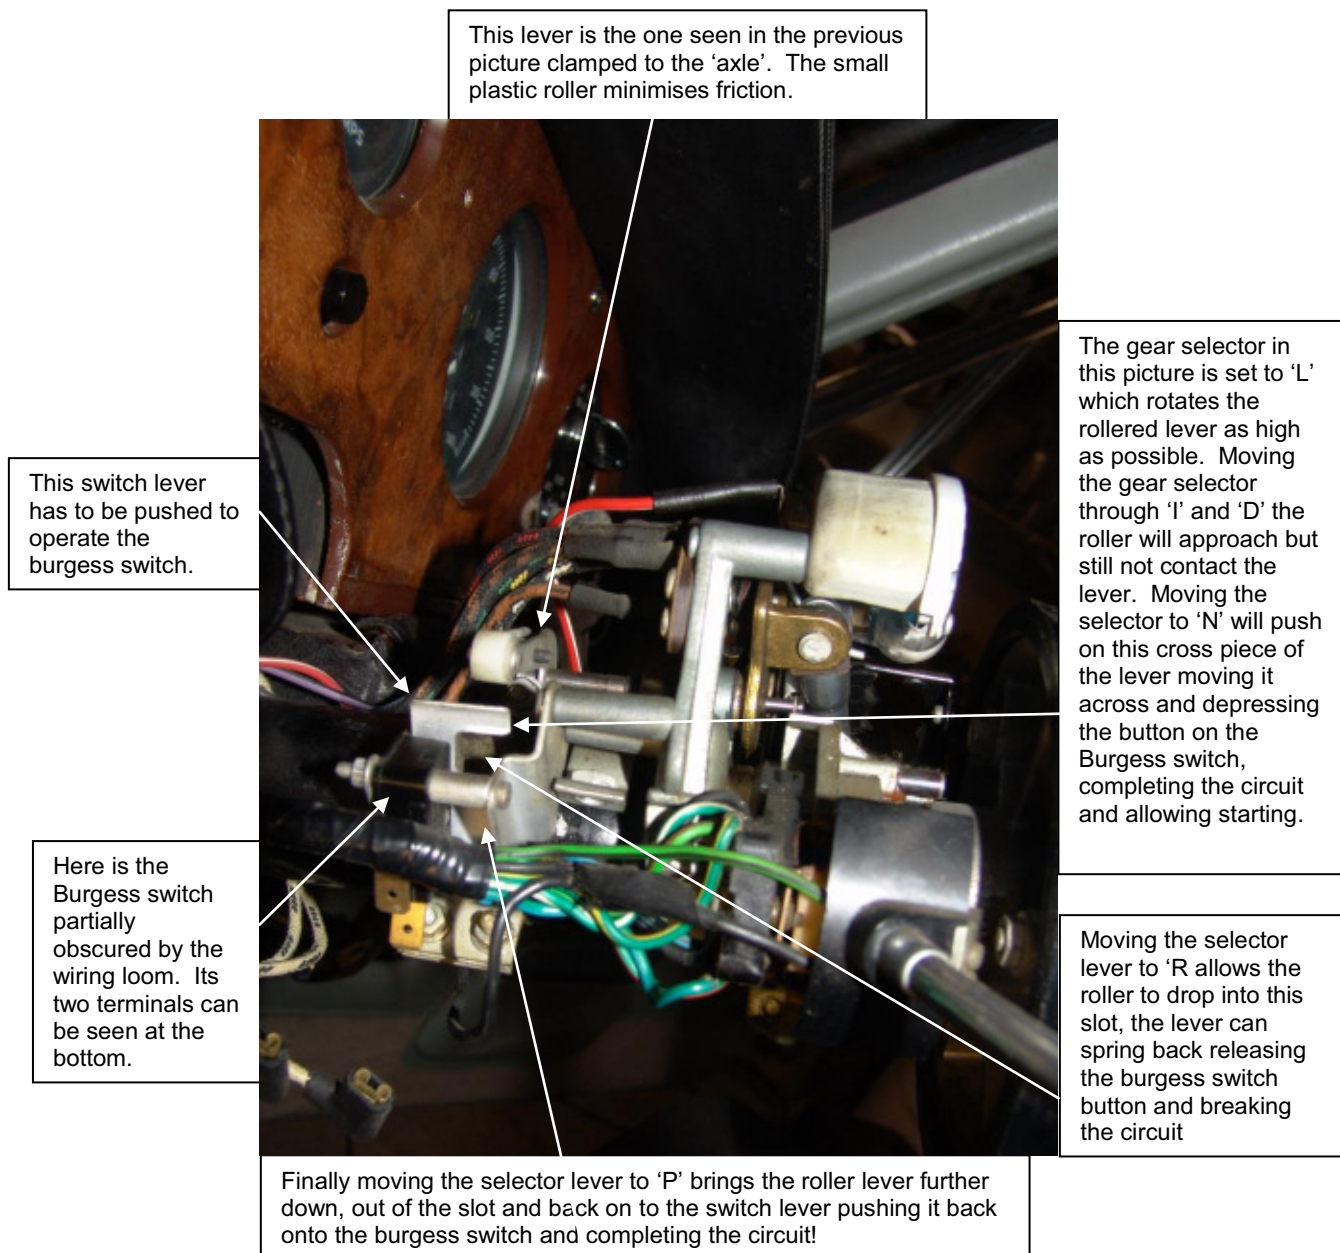
All this is to explain that a fault that is becoming more common is wear in the casting in which the central gear lever axle rotates. This allows the end of the 'axle' to swing away from its centre line taking its lever with it. Moving gear lever to 'P' or 'N' doesn't move the switch lever far enough to trip the Burgess switch so the starter won't operate. The wear can easily be detected by gentle pushing on the end of the gear lever in the direction of the steering column. If it can be notably depressed then spring back on release, the casting is worn. The immediate solution is to hold the gear lever down while starting.
