# TEE-ONE TOPICS

Number 77 July, 2008

## ARE YOU GETTING THAT SINKING FEELING?

## PUSH ROD BLUES

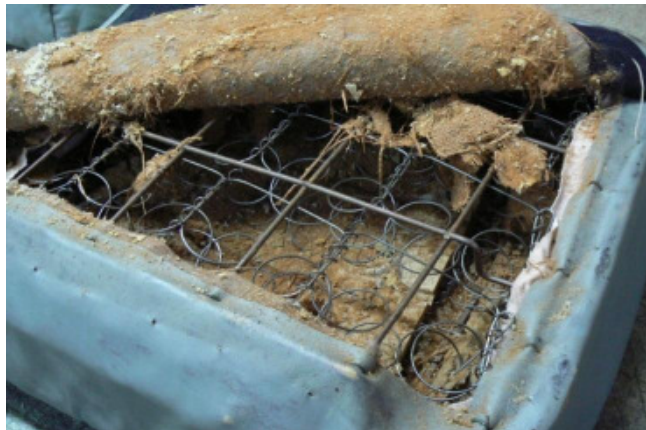
My first reaction was that we had opened a rats' nest. There was a general infestation of what turned out to be crumpled foam rubber right through the seat. It was, it seemed, disintegrating!

There were no rat droppings.

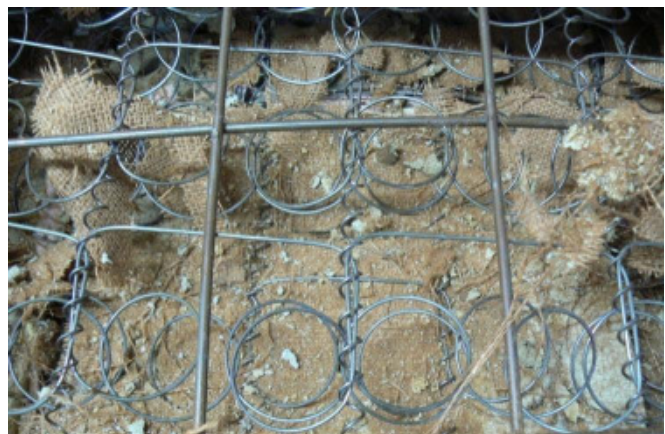
The springs having devoured the protective hessian were quietly eating the nicer sponge rubber the latter was protecting.

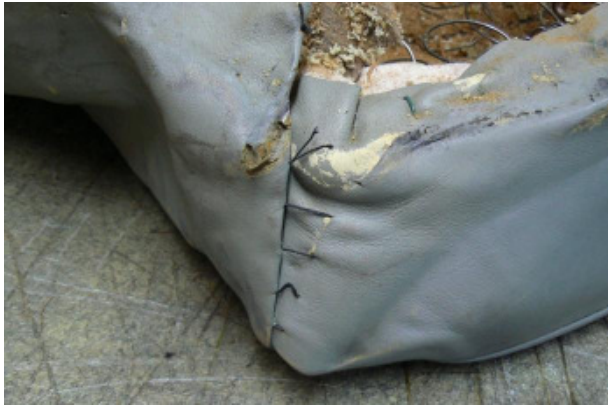
Thought to be a bit of an overkill, this bit is hand stitched. Most other manufacturers don't bother.

The heavier steel cross pieces are the 'chassis' of the seat. The actual springing is an ingenious woven network of springs that are tied together and interwoven. It should be remembered the beating our seats take. Not only do they soften the ride vertically but they have to hold your derriere in place while you are driving. And then there is the plonking of 100 plus pounds of flesh flung onto the seat and dragged sideways to get in position!

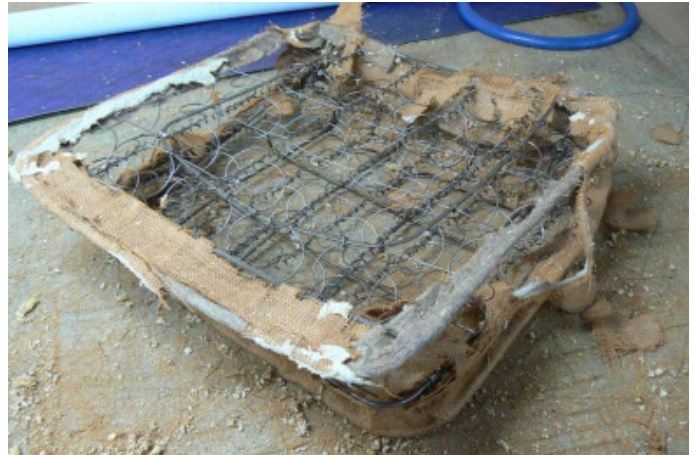
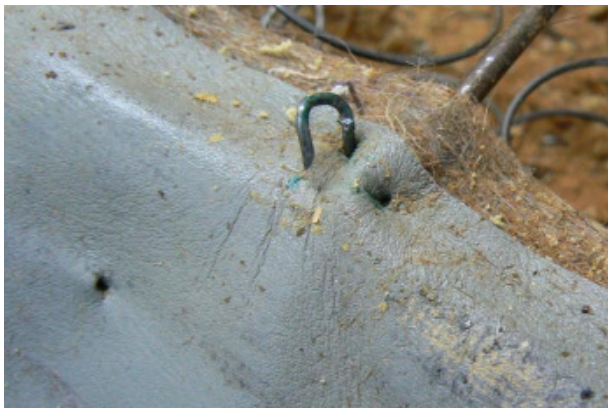
The 'hog ring' used to hold the leather cover in place. These are removed with the aid of side cutters and a strong wrist. The evidence of partial removal can be seen here!

The leather itself when not fed, cracks on the underside and literally chomps on the foam underlay. Here the damage is repaired with inlays

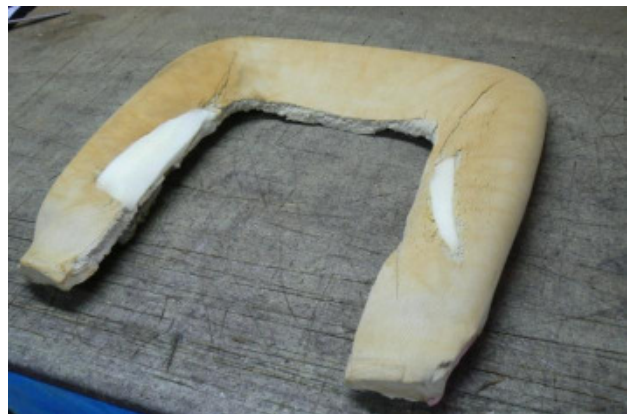
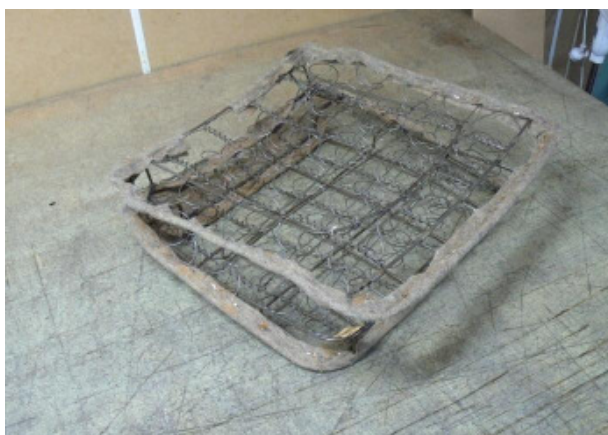
Stripped to the chassis with protective covers on the wearing bits, springing repaired where necessary.

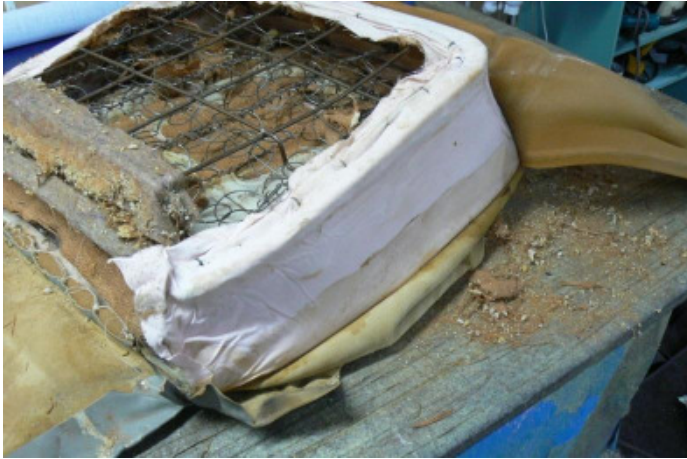
The calico wrapping had rotted and was about to disintegrate.

The cover almost off showing the moulded rubber horseshoe glued to all that is left of the original hessian.

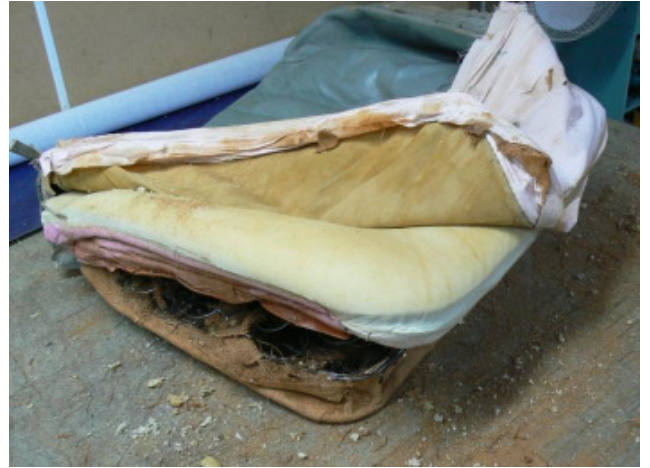
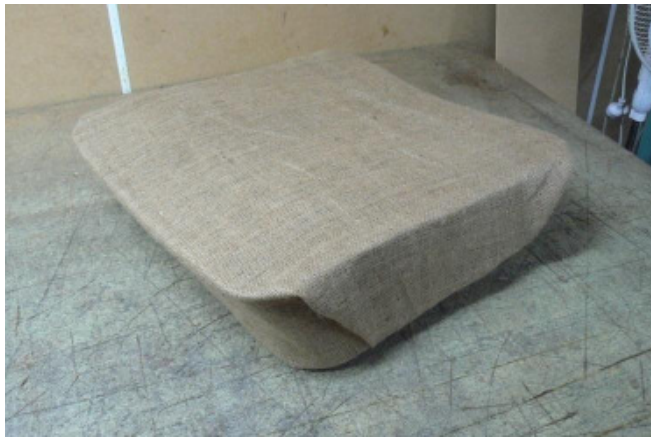
The basics having been repaired and wrapped, re-assembly can be completed.

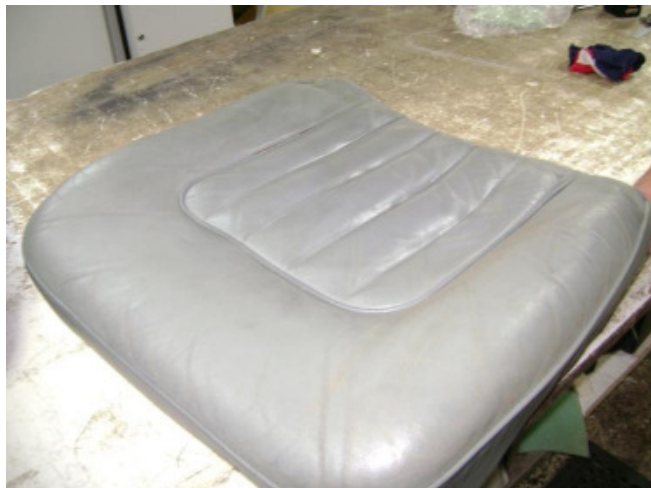
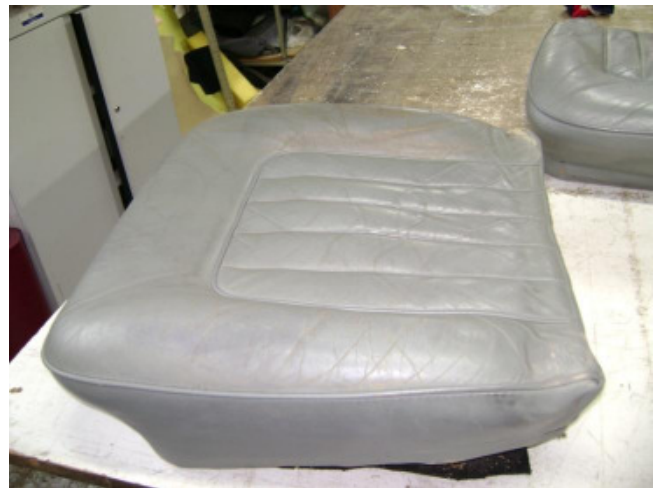
Before

After

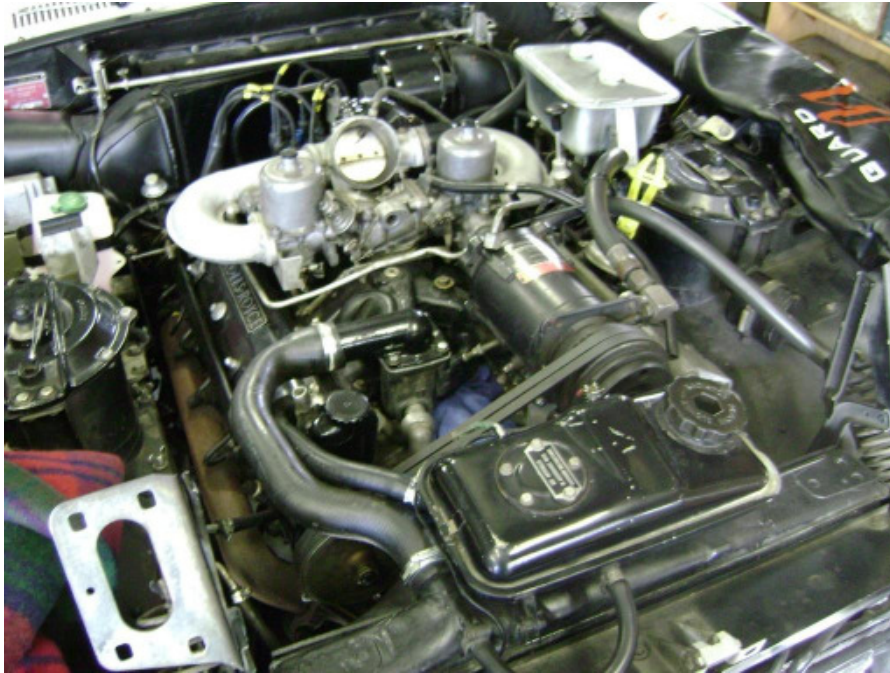
Step 1 was to remove the bonnet. This takes two people and two spanners (preferably ratchet), a blanket on the roof (of the car that is) disconnect the engine lighting wires and the earthing strap and carefully placing the bonnet on top of the car!

Undo the drain tap under the radiator and drain the coolant since you are going to remove the intake manifold which should be full of liquid!

Exhaust the brake accumulators by pumping until the lights come on and your leg hurts.

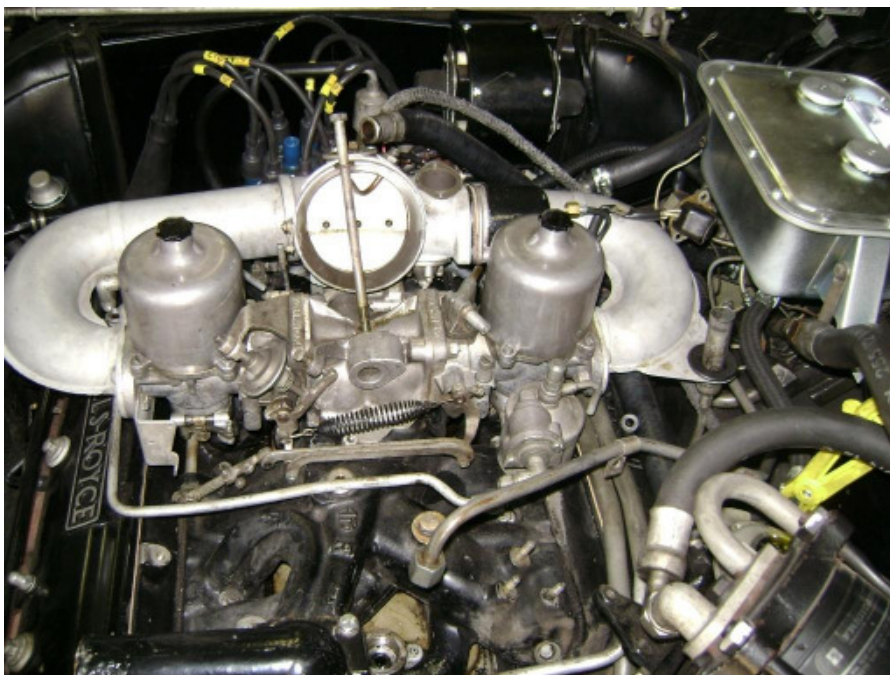
And here is the legendary \$300 bolt that holds the whole fuel supply setup on top of the intake manifold. The bolt should you need a new one can be bought for \$5 at your local nut shop! Here the aircon compressor has been unbolted, the front bolts are usually metric and the whole unit carefully tied over to one side. The dip stick has been withdrawn and the induction air trunk holder removed from the 'A' bank cylinder head. The more eagle-eyed among you will have realised that the front pump has already been removed. This engine actually had another problem to be discussed later.

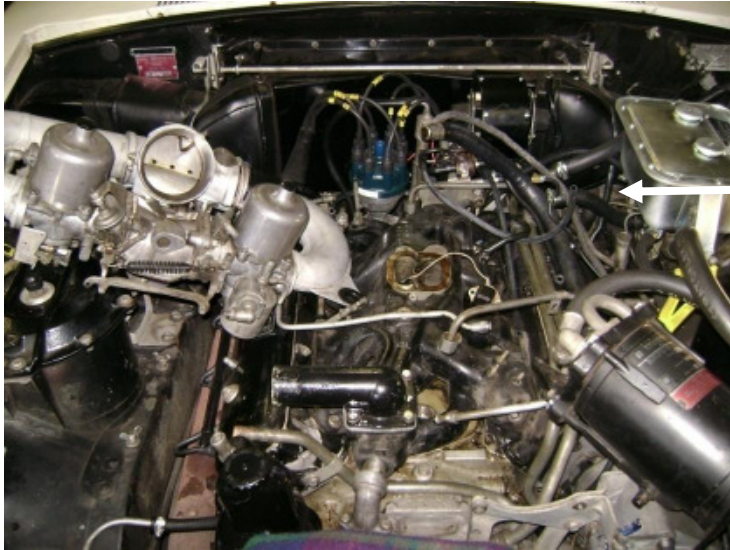
The fuel lines have been disconnected at the carburetors, the choke solenoid removed and laid to one side, various wires disconnected, the two choke stove pipes disconnected and ideally removed and the whole assembly lifted clear. This is a great time to clean the gunk out at the back of the engine!

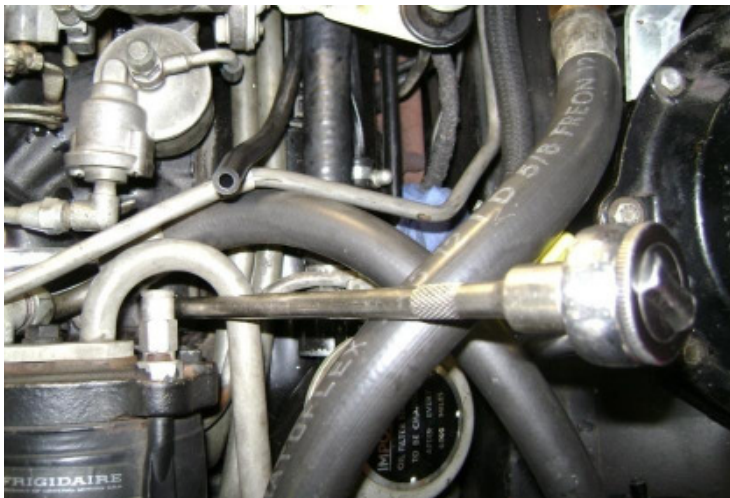
Can I digress for a moment? The three nuts holding the rear of the compressor seem somewhat hidden. This is the time to invest in 3/8" drive sockets and small spanners. The old 1/2" equipment was the best they could manage in the days of yore given the metallurgy of the day.

And if you haven't got a wobbler extension (see below) get one! These ingenious bits allow you to get around obstructions to get at bolts and nuts

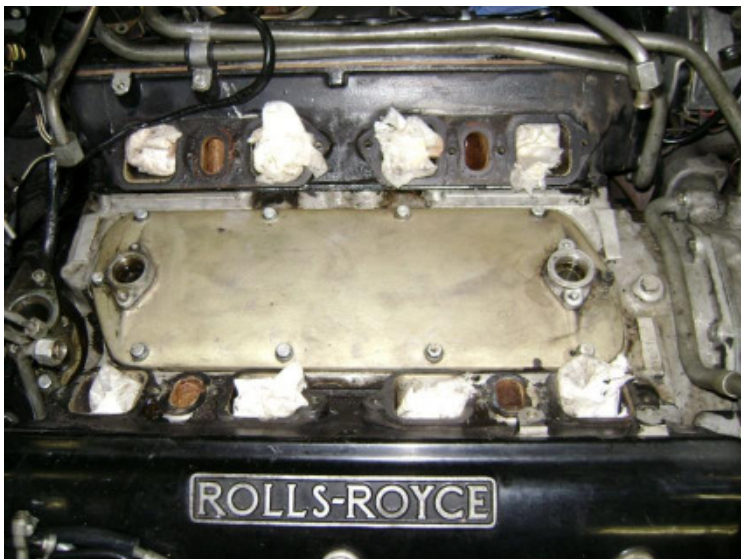
Well the intake manifold has been unbolted and removed and if I had taken the right picture there would have been two pumps sitting in those holes. As you know they have castellated bases which can be gripped by a 'C' spanner and unscrewed.

Imagine going through all this, repairing the pump or pumps putting it all back together and finding they didn't work. And so they designed the special castellated tube spanner which at three hundred dollars whether you have it made or buy it has got to be a real bargain.

Valley cover removed. Note the hydraulic cam followers/valve lifters which can be removed at this point. They are held in place by tappet blocks bolted to the main engine block. The exclusive cams that drive the pumps are arrowed.

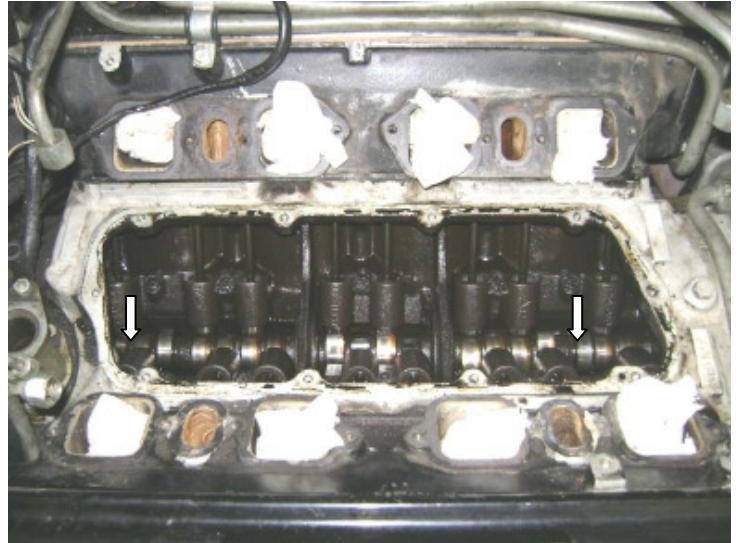
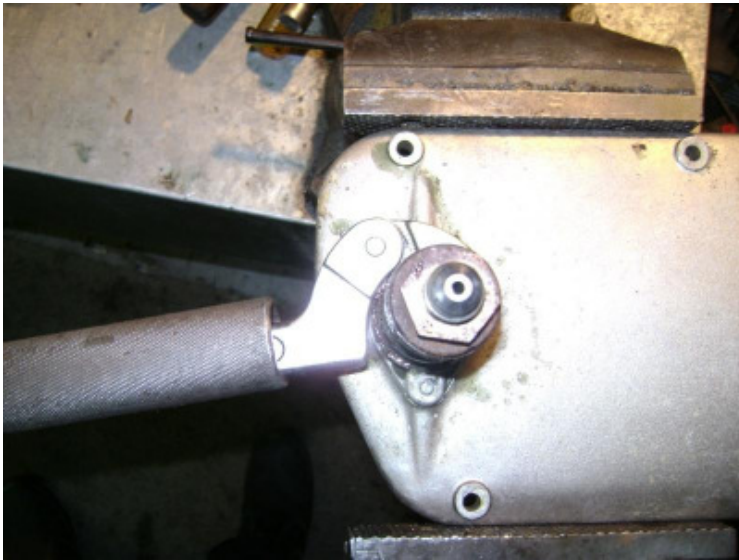
And here is the 'C' spanner in action. The valley cover has been removed because the pump was so tight I was worried I might ruin another expensive spanner. There is a full jack handle on the end of that spanner!

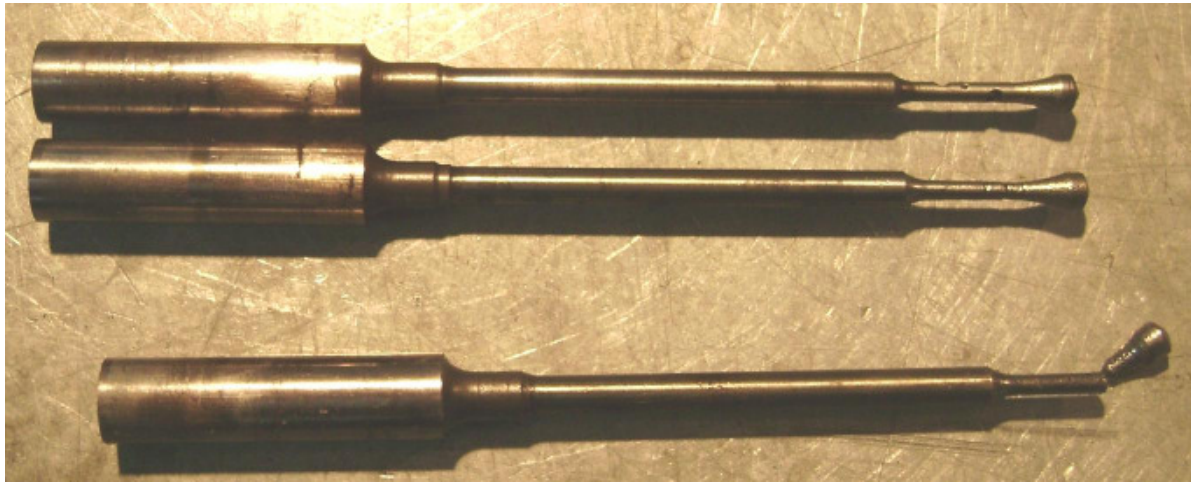
The pumps as you now know are driven by exclusive cams on the cam shaft. Cam followers ride on the cams and riding on them are dinky little rods some of which are pictured above and these in turn push the internals of the pump up. The less confident among you will be waiting for advice on the safety valve to prevent a possible catastrophe if all this doesn't work as it should. Well those little rods are just that. Note the waisting of the rod near its

bottom end. When the pressure gets too great there is the most gentle snap and the pump stops. A perfect example is pictured at the bottom of the picture above.

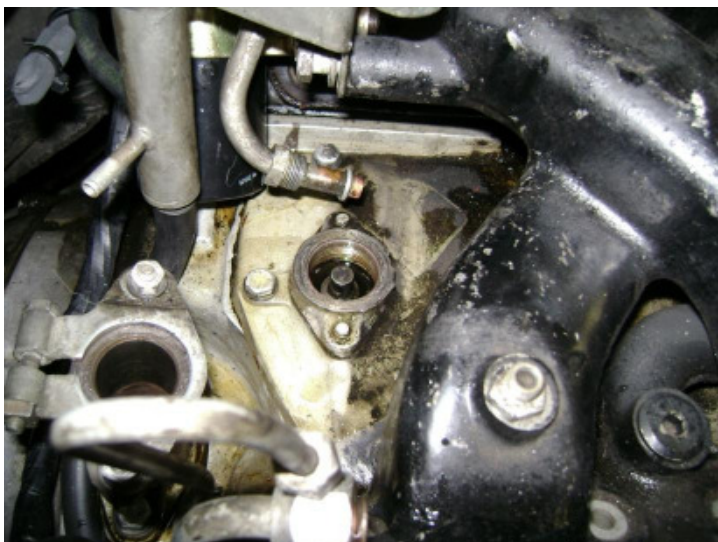
Have a good look at the upper two rods and you will see small indentations in the waisting. This is caused by corrosion which clearly weakens the rod. This is what broke the bottom rod, not some romantic runaway pump!

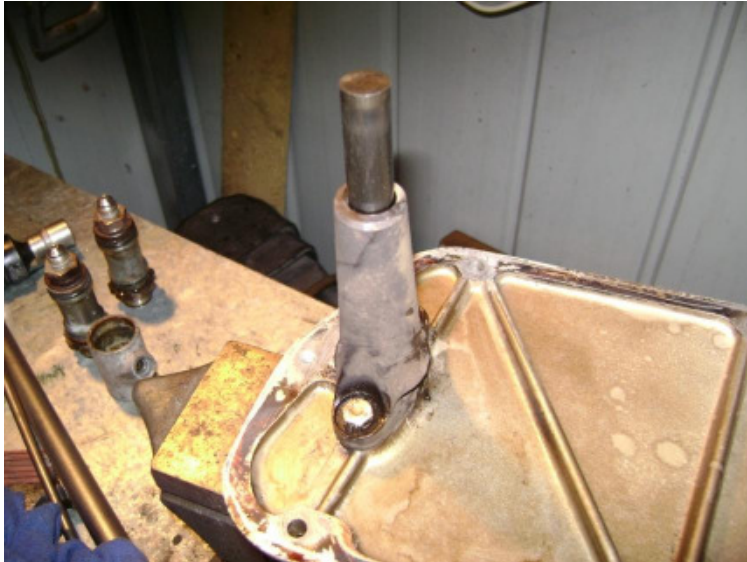
At left is a common view of the rear of the valley cover with a

nicely exposed pump mount and there sitting in the middle is the top end of the push rod. From time to time the pumps are removed because they get a bit of detritus in their valving or they corrode through neglecting to regularly change the fluid. It is when they are out that the push rod can be extracted with a strong magnet and checked for corrosion.

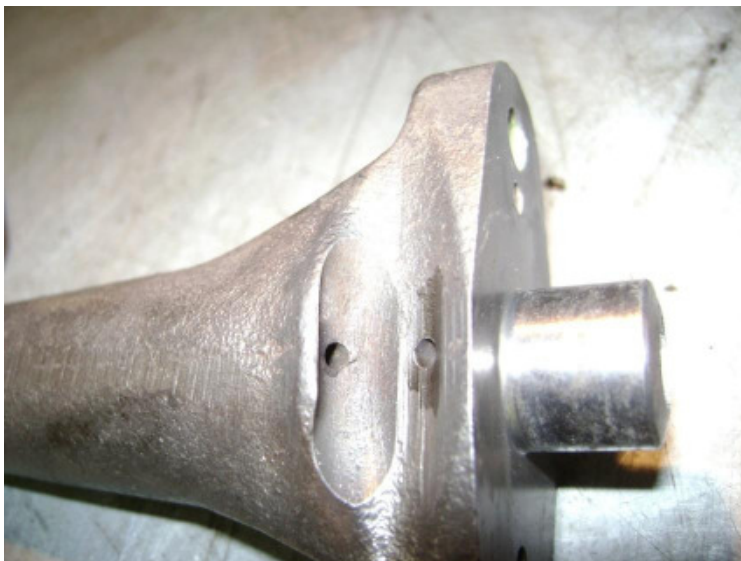
The push rods ride in cam followers seen at left in the up-turned valley cover of an early ('72) Shadow. Since they are practically running under oil they seldom wear unless the camshaft itself breaks down in the case hardening. The two bolts securing the holder to the cover are locked with tabs. These obviously have to be replaced if they are undone. Lubrication on these holders is via holes drilled in the castings near the top flange.

A close view of the lubrication holes. These simply clog up in a dirty engine. There are two holes as seen here which point to the centre of the engine and one hole on the other side.

The material these holders are made of is relatively soft. They tend after years to stick in the valley cover casting. They should be pressed out with a soft mandrel otherwise the mouth of the 'guide' will cave in and the thing will need machining!

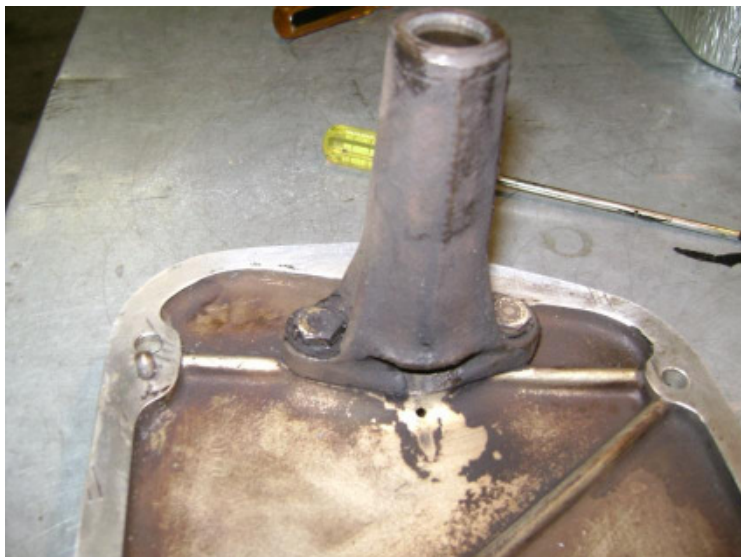
There is one other hole of interest seen here drilled through the valley cover. Sometimes the pump is allowed to wear so much that it actually leaks internally through its base into the threaded adapter bolted to the top of the valley cover. From there it drains through the small hole seen here into the tappet chest and mixes with the oil. An excess of brake fluid in the oil

usually plasters the internals with a varnish like film!

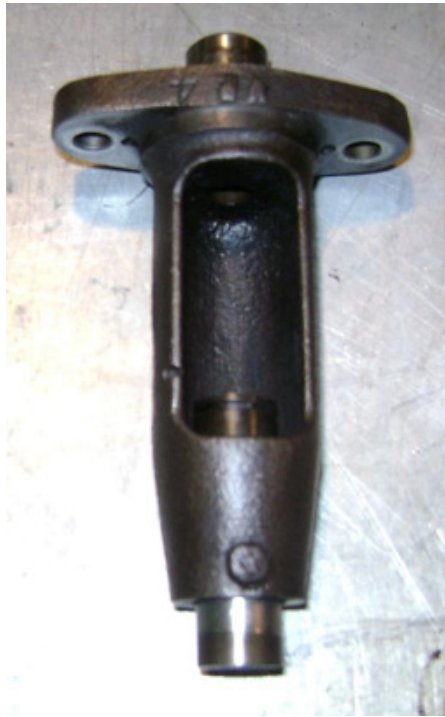
Later engines used an improved holder seen at left. They are readily applicable to early cars. Lubrication is clearly not a problem. The build up of oil sludge in the cam follow sitting there with its mouth open should also be minimised with the amount of oil sloshing around. Note the groove machined in the top neck of the follower. This is to receive a small 'O' ring after the follower has been poked through the holder. When you then invert the whole assembly to put it back on the engine the followers don't drop out. For the earlier fittings a use grease to hold them!

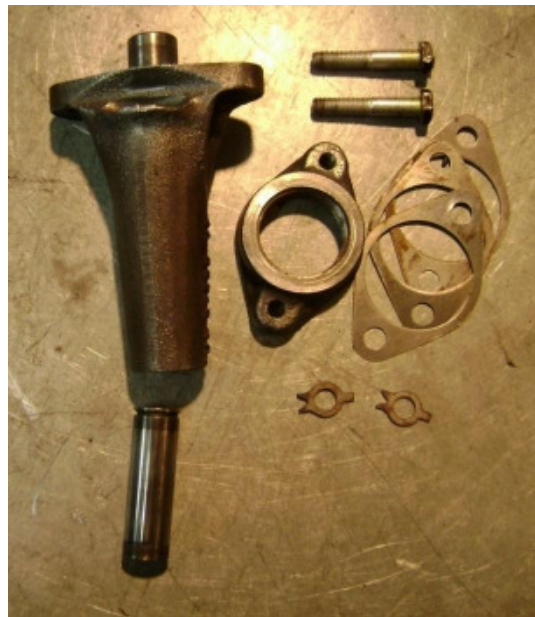
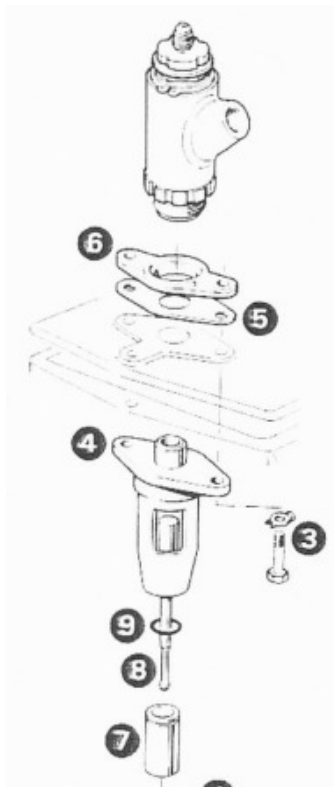
At right are all the bits to work the pump – minus the pushrod. Interestingly the cam

follower you will note has a groove in the top but with the original holder there was no access for the rubber ring. Presumably the designers were thinking ahead!!!??? To the right of the holder is the mounting ring for the pump which is held in place by two bolts screwed from under the valley cover.

The height of the pump above the cover dictates the clearance between the pump plunger and the top of the pushrod which must be a factor of the traditional click! To adjust this clearance the mounting ring is raised or lowered by shims also seen in the picture.

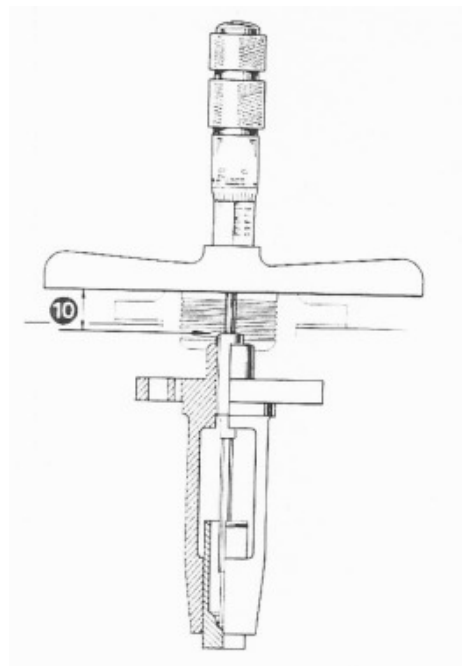
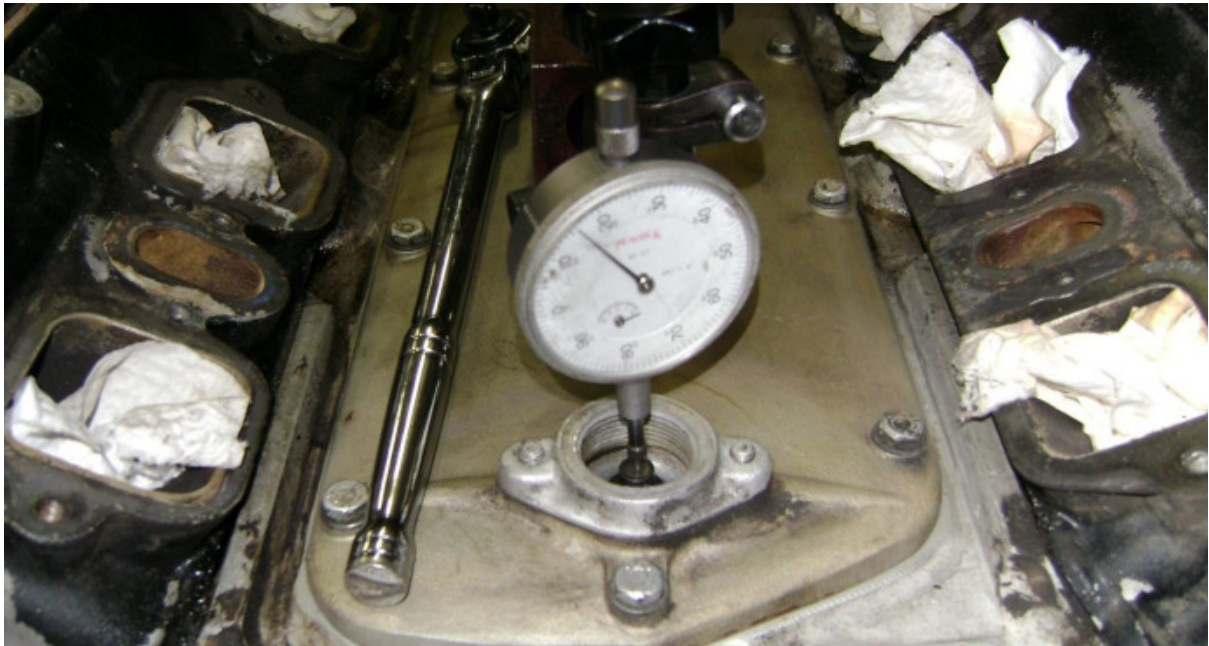
At left is a view of the setup in very much later cars but the assembly is essentially the same.

At right is the method of measuring the height of the pump mounting holder relative to the top of the push rod.

The first requirement is to turn the camshaft until the cam follower for the individual pump is on the back of the cam. A dial gauge is the quickest way surely. For those who don't have one, if you are going to do this job, buy one. China makes adequate instruments which sell at a reasonable price and now that you have seen the amount of work involved the cost of a gauge will be peanuts compared with paying someone to do it.

Please note that the cams for the two pumps are NOT synchronous i.e. they don't go up and down together so you have to do this camshaft rotating quadrille for each one!

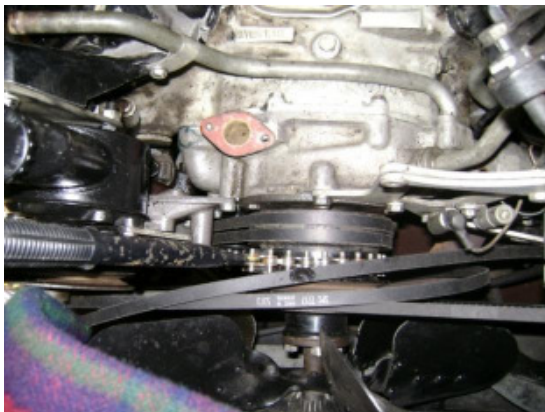
The embuggerance of having to remove plugs then get a grip on the engine is beyond me these days. I simply ensure the water pump belts are tight and use a chain wrench on the fan pulley. This does not improve the pretty paint but that can be tarted up later!

You certainly cannot turn the engine with the starter to get a dial gauge reading!

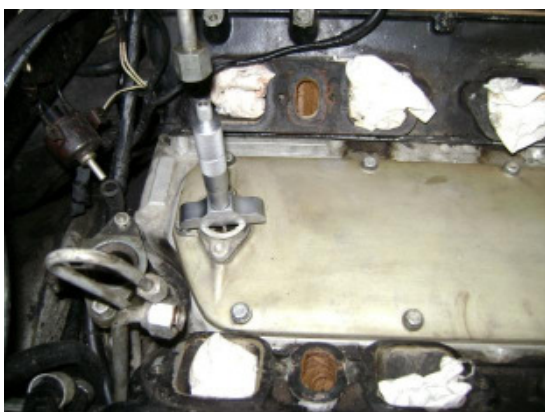
Measuring the depth of the pushrod when it is fully lowered requires a depth micrometer. The valley cover and block faces of course will be very clean and free of sealant and other crap. You might like to invest in an adapter for your drill to drive a socket wrench since screwing the

bolts in and out quite a number of times, can be boring.

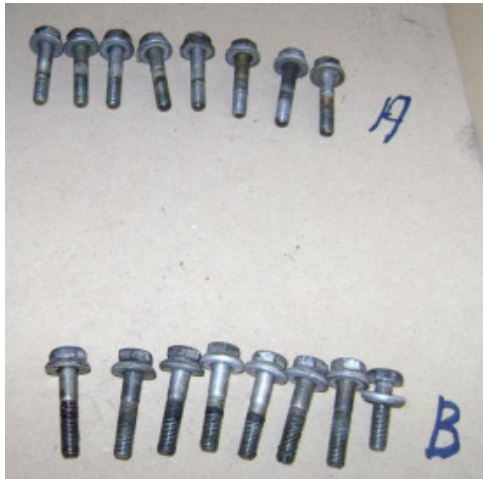
A common trap for beginners is to not notice that the front bolt holding the inlet manifold to the heads on the 'B' bank side is shorter than all the others. Put a longer one in and you cut off valve lubrication for that side!!! Always use anti-seize of which there are a number of versions, when you re-assemble as a measure of respect for the next poor fool who has to undo them!

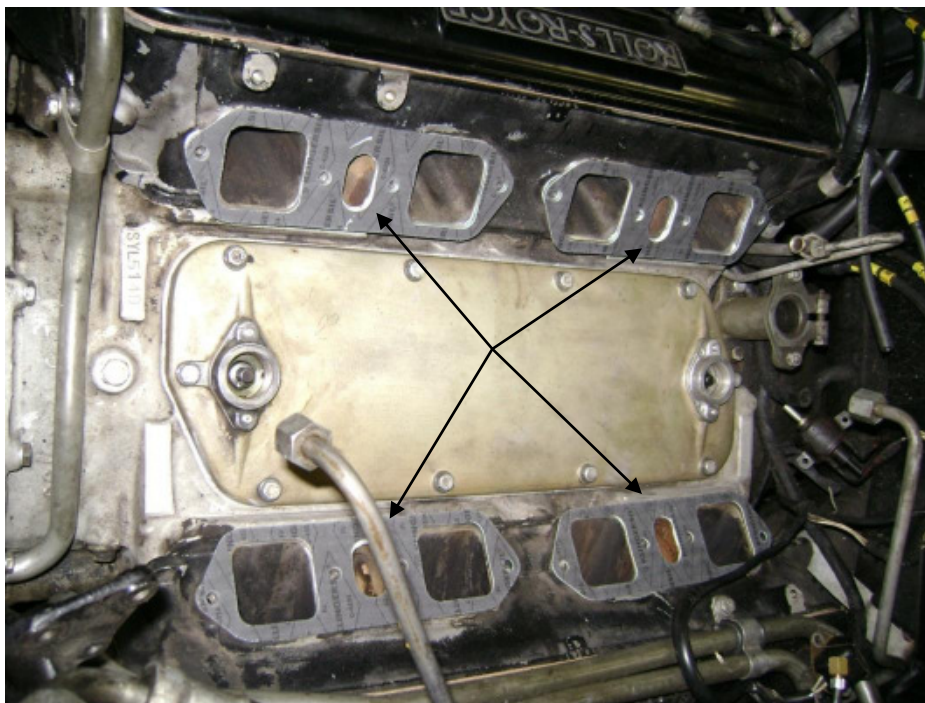
Having adjusted the pump mounts to suit the new pushrods, the valley cover is re-installed with a good and appropriate sealant – the legendary silk thread will not be necessary! Similarly use sealant both sides of the gaskets where the coolant flows (arrowed).

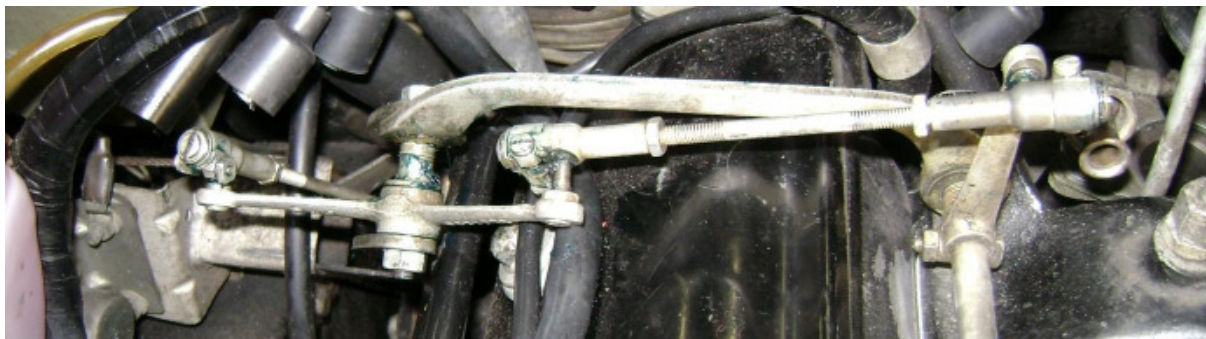
While de-gutting the top of the engine pull the throttle trapeze to pieces and clean and grease it. Put a clean cloth under it before you start as you are bound to drop bits.
