THE ROLLS-ROYCE OWNERS' CLUB

SILVER CLOUD/S: 1955-1966

VOLUME I  
A/C & VENTILATION  
ENGINE & POWER TRAIN  
SUSPENSION & BRAKES

## SC-1 or S-1 Heater/Demister System Repair (Part 1) Bob Mendenhall (CA)

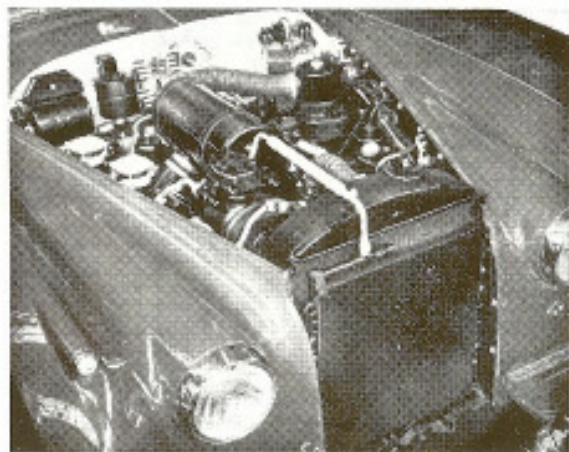
The compressor-pump is belt driven and has a magnetic clutch. Incidentally, note the reservoirs for the car's two independent hydraulic systems
