SERVICE INSTRUCTION LEAFLET

ISSUED BY
BENTLEY MOTORS (1931) LTD.

Engine - Tappet Clearances
3½ and 4¼ Litre Bentley.

Subject : ENGINE
MAIN AND CONNECTING ROD BEARINGS
BENTLEY 3½ AND 4¼ LITRE.

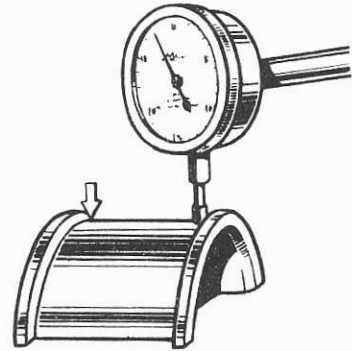
FIG.7.

Each half shell should then be checked for parallelism of the butt faces in relation to the bore centre-line, by placing it on a surface table face downwards and "clocking" each side of the back adjacent to the flanges at the highest point. Inequalities should be corrected by lightly filing the butt faces, removing as little metal as possible. There should be no perceptible "rock". (See Fig.7)

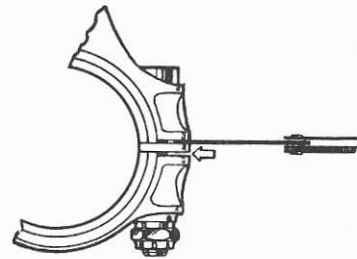
FIG.8.

Tighten down normally on both sides, slack off one side completely and re-tighten to finger tightness. A gap will now be apparent between each side of the shim and the housing butt faces. The shim is held centrally by the pressure of the shell on its inner edge. (See Fig.8)

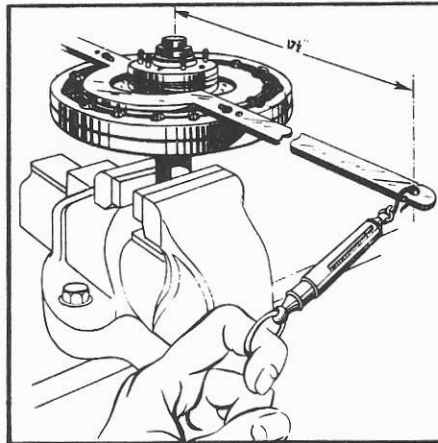
The effort required to overcome the frictional drag which is exerted by the damping springs is measured on a spring balance and is obtained in the manner detailed below:- (See Fig.5).

1. Fit the damper assembly on to an appropriate mandrel and secure in a vice.
2. Attach the testing bar to the damper flywheel in the manner shown in Fig. 5.
3. Secure the spring balance to the bar at a radial distance of $17\frac{1}{2}$ " (44.45 cms), and pull on the free end of the balance.
