BENTLEY MARK VI

MODIFICATIONENGINE OIL FILLER CAP WASHER.

REPLACEMENT OF TAPPETS.

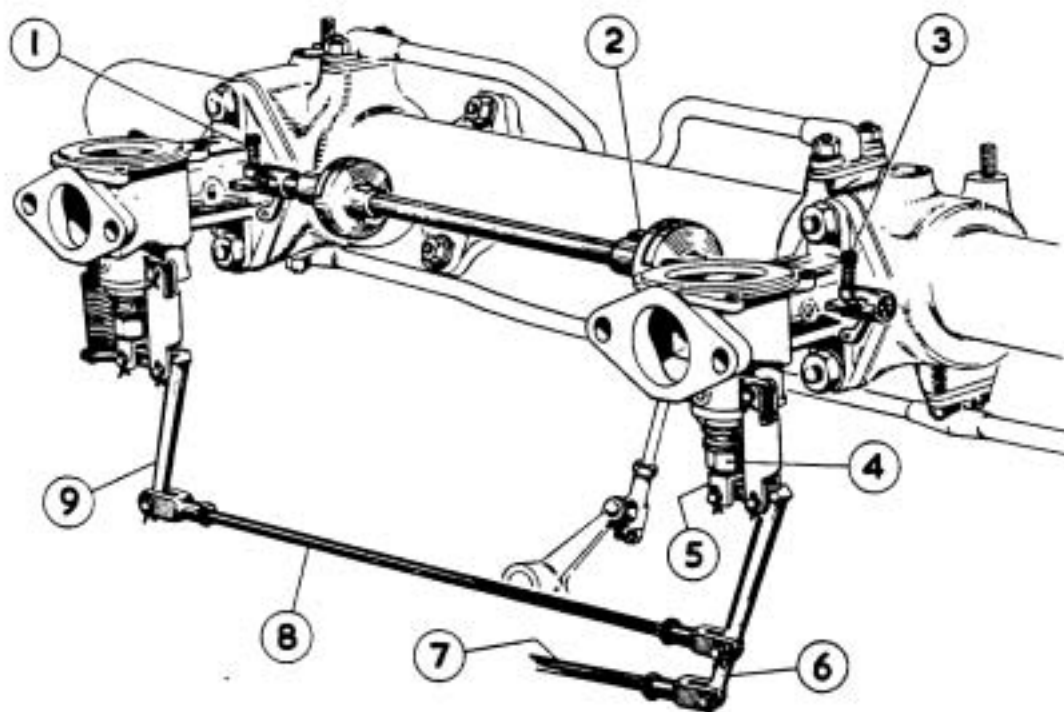
FIG. 2. VIEW OF CARBURETTOR CONTROLS (CARBURETTORS PARTLY DISMANTLED FOR CLARITY).

The jet adjusting nut is actually a "stop" against which the jet head (5) should bear. Screwing up the nut weakens the mixture and unscrewing it strengthens the mixture.

If the mixture is weak, the exhaust note will be irregular and splashy, whereas, if the mixture is too rich, the exhaust note will have a constant rhythmical uneven beat, known as "hunting".

- (v) Again push the mixture lever (6) towards the rear, and offer up the jaw of the control rod (8) to the mixture lever (9) of the rear carburettor, line up pin holes as found necessary. Fit the control pin and secure with a new split pin.

- (vi) With the hand throttle lever on the steering wheel placed at the bottom of its range, adjust, if found necessary, the throttle stop adjusting screw (3) of the front carburettor until the correct idling speed has been obtained.

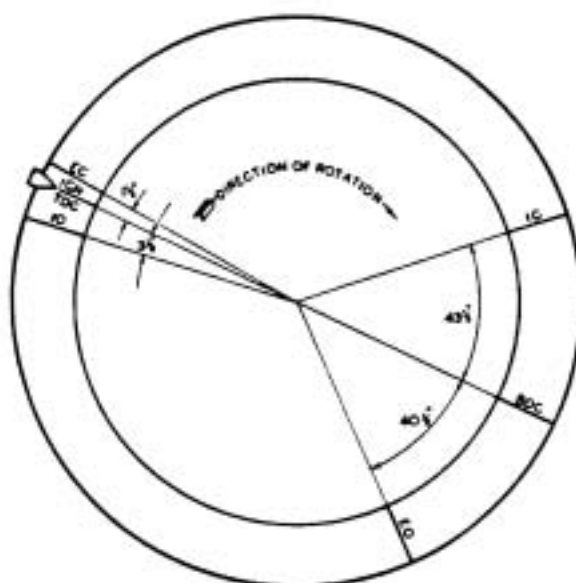
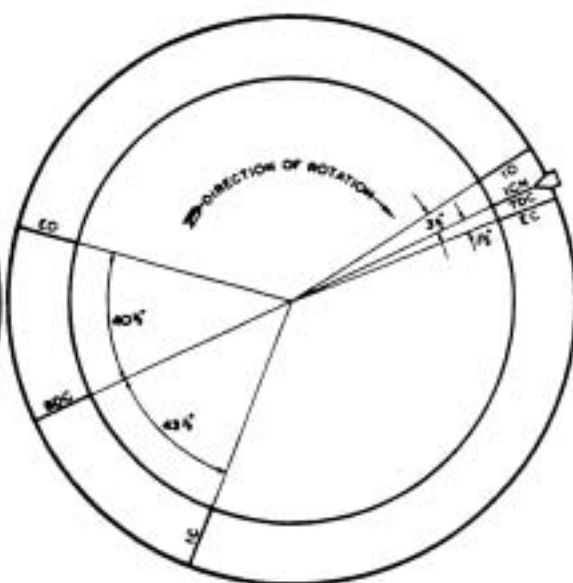
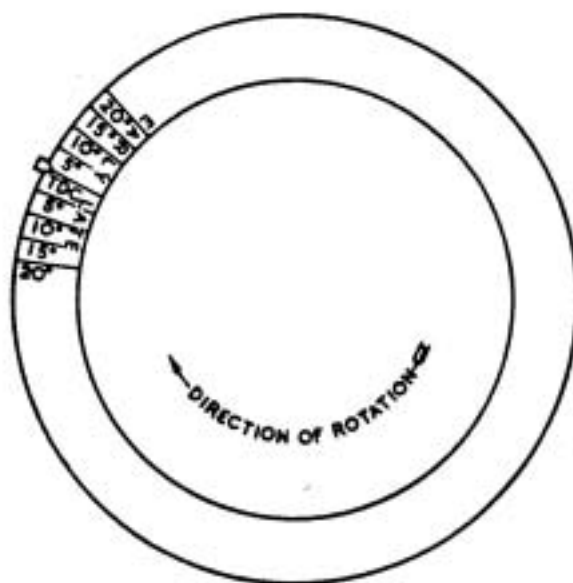
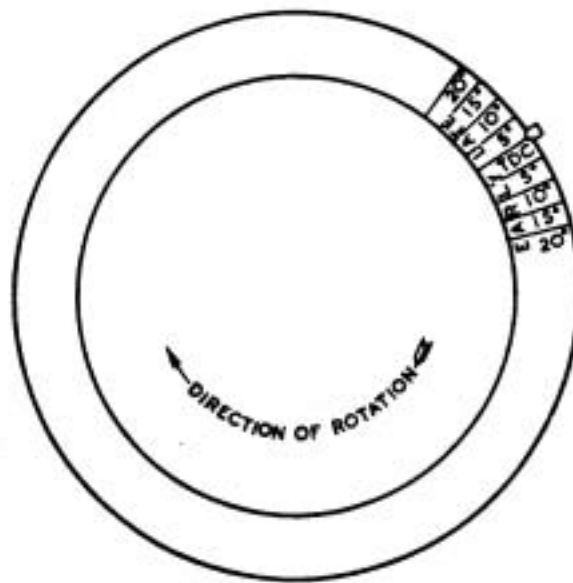
Basically, owing to the possibility of camshafts and flywheels having been replaced in service, valve timing should be carried out in accordance with the camshaft fitted and not necessarily in accordance with the markings on the flywheel fitted.

Early type flywheels are marked as shown in Fig. 1 and 2. Later type flywheels and replacement flywheels, will be marked as shown in Fig. 3. It will be noted that the T.D.C. mark only is shown with additional markings at five degree intervals from 5° to 20° on either side of the T.D.C. mark designated EARLY and LATE.

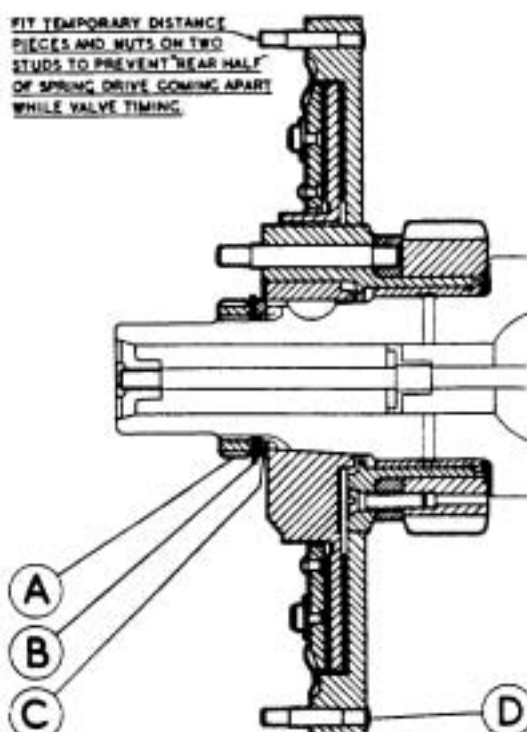
FIG.5 SECTION - 'REAR HALF' OF 'PRE-BENCH' TYPE CRANKSHAFT DAMPER (SPRING TYPE)

With the camshaft set in position, the procedure differs according to the type of crankshaft damper fitted. The early or 'Pre-Bench' type, was fitted from Chassis Nos. B-2-AK to B-126-DA inclusive and the later 'Bench' type from Chassis No. B-128-DA and onwards. The two dampers may be distinguished by the fact that the 'Pre-Bench' type has twelve studs (D, Fig.5) fitted to the rim of the rear damper wheel, whereas the 'Bench' type has six bolts (E, Fig.6).

First loosen the serrated nut 'A' (Fig.5) and with extractor 3759/T1016 or tool 1617/T1003, withdraw the damper about  $5/16"$  from its fully home position on the crankshaft nose. Remove the camshaft gear and reposition it as required, ensuring that the circular locking plate is refitted.

- (ix) When the correct timing has been obtained, fit two of the four camshaft gear fixing studs, new lockwashers and nuts. Fully tighten and lock the nuts. Remove the two temporary setscrews and similarly fit the other two studs. Tighten and lock the serrated damper retaining nut (A Fig.5).
- (x) Reset No.1 inlet valve clearance to .006" (.15 mm).
- (xi) Fit the front damper wheel complete with the eight damper springs (and adjusting washers if fitted behind the springs), ensuring that the co-relation marks 'O' on both damper wheels are in alignment. Tighten the four hub nuts and lastly the twelve rim nuts, locking with new lockwashers.
- (xii) Align and refit the wheelcase and remaining components.

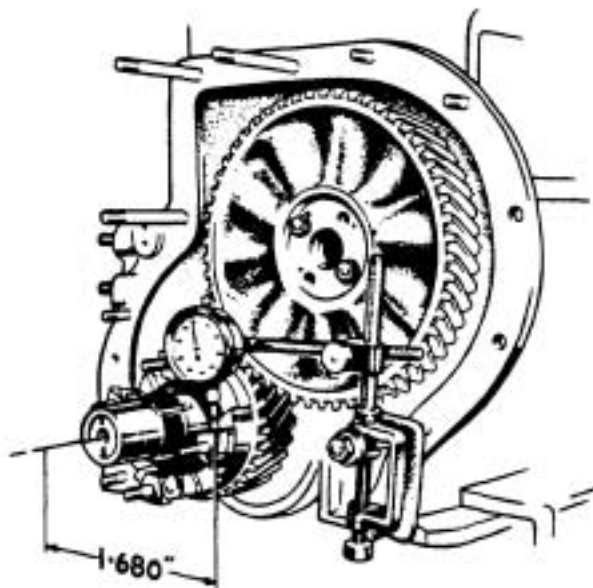
FIG. 2. CHECKING BACKLASH BETWEEN PINION  
& CAMSHAFT GEAR.

In the unlikely event of the backlash being less than .002" (.05 m/m) or exceeding .006" (.15 m/m), then the only alternative would be to try another set of gears.

- (ii) Place the crankshaft pinion on to the crankshaft. Secure the dial indicator to the crankcase as shown in Fig.2 and check the camshaft driving gear for backlash at four equidistant places. The registering member of the dial indicator should rest on a driving lug of the pinion as shown in the illustration and at a radius of 1.680" (42.7 m/m) from the centre of the crankshaft.

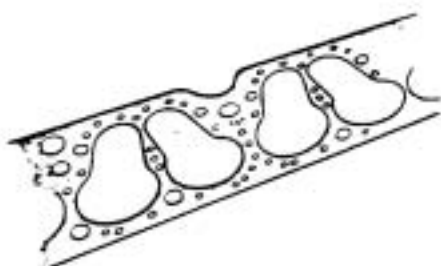
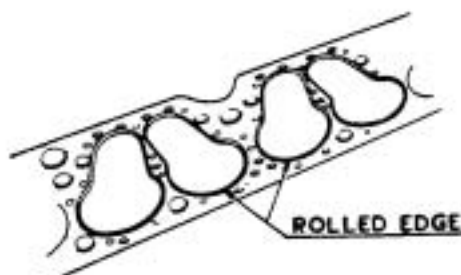
As an aid to recognition the characteristic differences between the top and bottom faces of the gasket are illustrated in the above two sketches. A further means of identification is provided by the word "TOP" which will be found stamped between Nos. 3 & 4 cylinder openings on the plain face as shown.

Retailers are advised that the correct procedure when fitting replacement C & A cylinder head gaskets in service is to ensure that these are fitted with the plain face uppermost and the rolled, or lapped, face to the cylinder block.

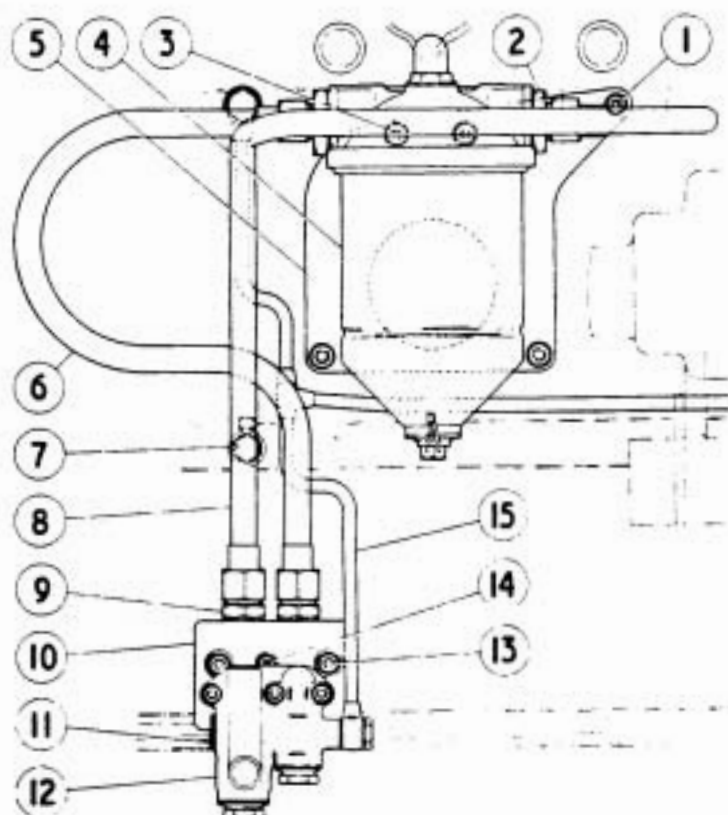
FIG. 9. FRONT ELEVATION - FULL FLOW OIL FILTER.

Concerning Scheme 'B' of Service Bulletin No. BB-143 (Section E), it has been brought to our notice that in one or two instances the external inlet and outlet oil feed pipes, (6 & 8 Fig. 9 of Bulletin No. BB-143) to and from the Full Flow Filter have been reversed when fitting to the transfer block (10). This arrangement causes the filter element to collapse and block the oil flow.

- a) Before starting up the engine, unscrew the union nut of the inlet oil pipe (6 Fig.9) from the union on the filter, and with a syringe, fully prime the pipe and then prime the oil filter. Reconnect the union nut.

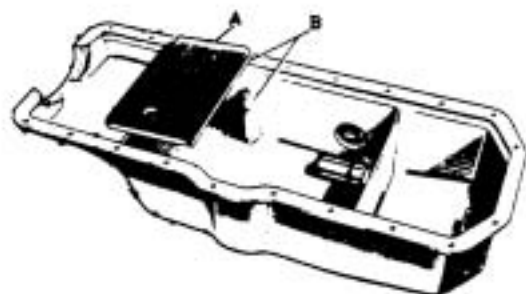
FIG. 11. CRANKCASE LOWER HALF.

- (xiii) When offering up the lower half of the crankcase, it will be found that the union nut securing the oil feed pipe to the standpipe (21) fouls the oil baffle ('A' Fig.11) and the locating lug at points 'B'. Remove the baffle and file the lug until it just clears the nut and then file the edge of the baffle to suit. It may also be necessary to file the inside of the lower half of the crankcase to clear the nut. Refit the baffle.
