MODEL: BENTLEY MARK VI

## MODIFICATION.

### REAR BRAKE EQUALISER.

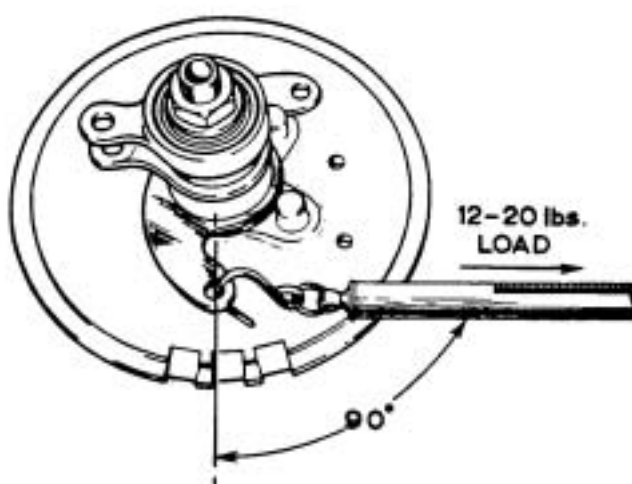
FIG.3.

A spring balance is then attached to the brake actuating lever and the poundage figure accurately taken; this must be between 12 and 20 lbs (Fig.3).

and the adjusting nut re-tightened, a lower poundage figure will be recorded. This must be done, by increasing the feeler gauge thickness, until the brake actuating lever poundage is satisfactory.

Finally, remove the .0625" washer and re-assemble servo motor.

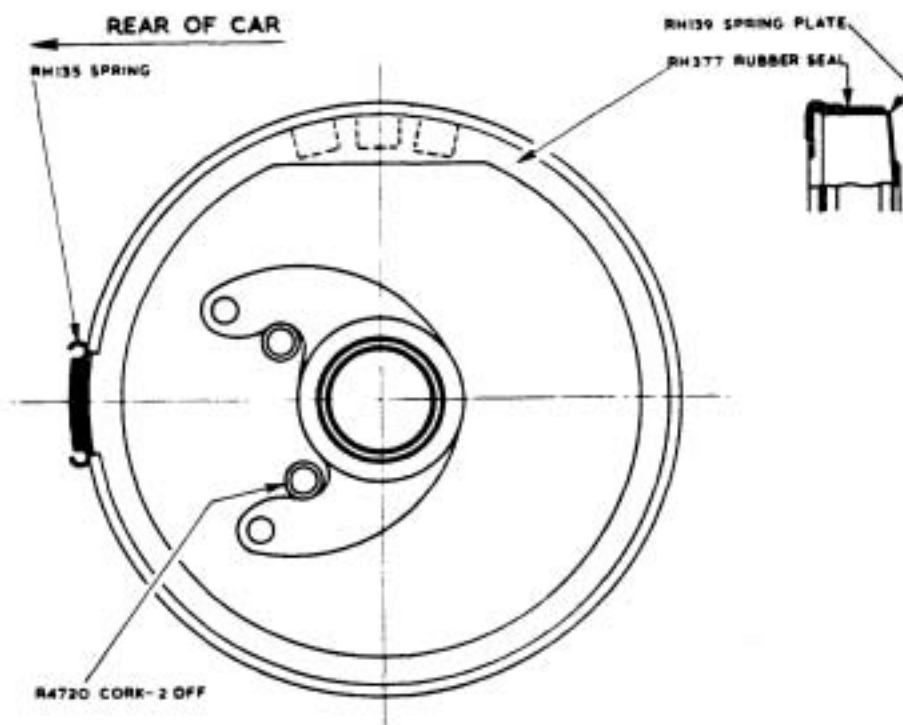
FIG.4.

Whenever a servo is overhauled following a complaint of inefficiency which is found due to oil or water contamination of the liner and when there is no obvious source of leakage such as from the servo main shaft seal, the engine or chassis lubrication systems, or water leakage from the cooling system, the servo is to be completely sealed with the special rubber seal RH.377.

The servo spring plate, lined plate, pressure plate and servo main shaft are to be put together so that after the seal has been fitted the servo can be completely re-assembled and re-fitted, (Fig.4).

the edge of the plate, not by pulling on the outer edge of the seal as might be expected, but by pulling on the inner diameter; this prevents distortion of the outer periphery. The rest of the seal is then eased into position, still pulling on the inside diameter until the inner periphery fits closely into the spigot running around the upper face of the pressure plate. The whole seal is then to be eased into position finally and retained by the protector ring which must be fitted with the lower rate spring RH.135, otherwise it will not fit over both the seal and the pressure plate. The spring is to be positioned towards the rear of the car and not to the lowermost position as was usual. On certain servos the ends of the brake actuating lever operating pins will be open; these must be sealed with two corks (Fig.4).

The servo can then be re-fitted to the car, the seal being finally checked after road test.

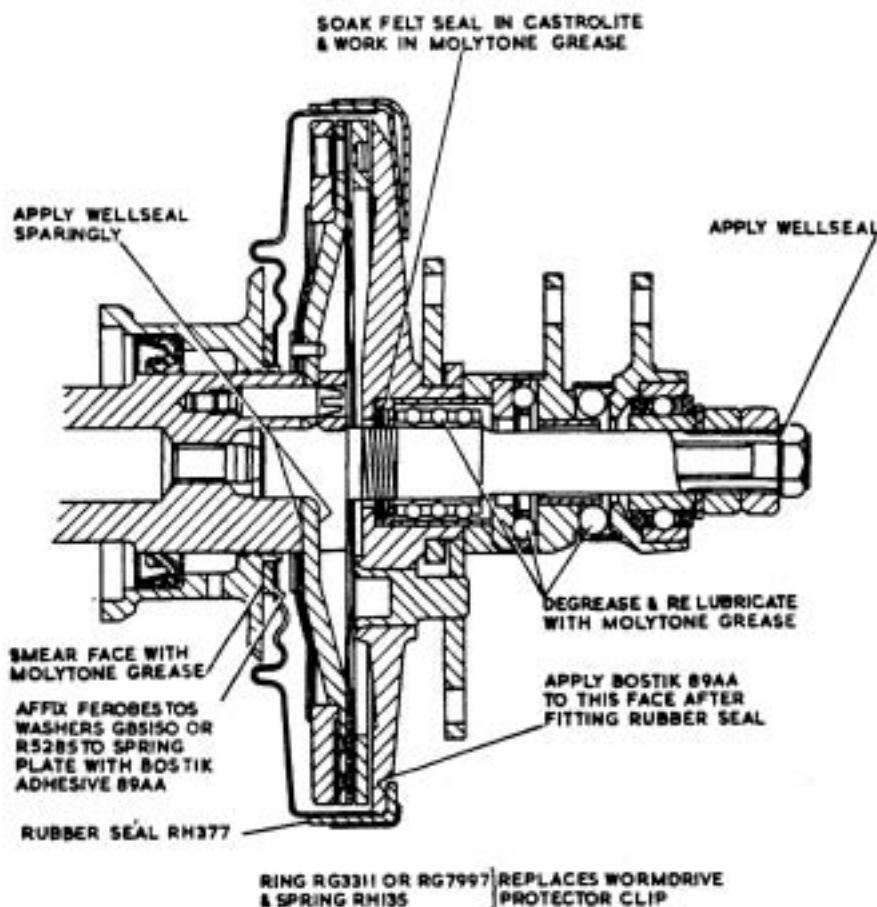
FIG. 1.

It has been found that the effective life of the servo liner may be greatly reduced, due to contamination by oil or water from various sources.

Where inspection of the liner shows the presence of oil, the source of oil leakage must first be ascertained and rectified.

Before re-assembling, the following modifications are required, if not already incorporated.
