No. CB.72

DISCHARGED BATTERIES.

DYNAMO FAILURE.

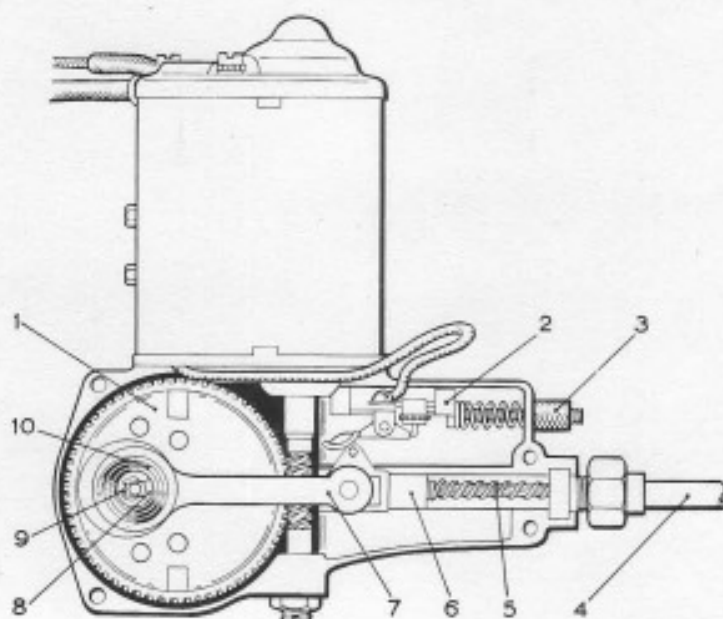
Fig.1. DR 3. Type windscreen wiper motor.

Remove the circlip, which retains the connecting rod, followed by the plain washer, conical spring and shaped washer (see fig. 1.); care should be taken when removing the conical spring as it is under compression.

Unscrew the four screws and remove the cover from the wiper motor.
