Post-War Pre-Shadow Tune-Up Seminar

Based on notes from
Roger Hadfield, Ont. & Bob Leonard, PA
Photography © 1992 M. Karger

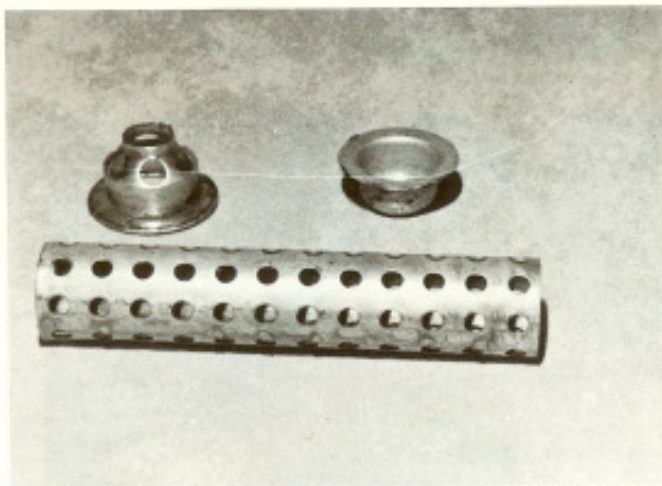
1478 Here are the bits you must take from an original "British" filter. S/SC II & III take the same filter.

In order to use a conventional filter cartridge in place of the R-R element on a SC-1 or S-1 engine, strip the felt socks and supporting metalwork from the core. This is done easily with a pair of side-cutting pliers; tack-weld deposit should be ground off the center core.

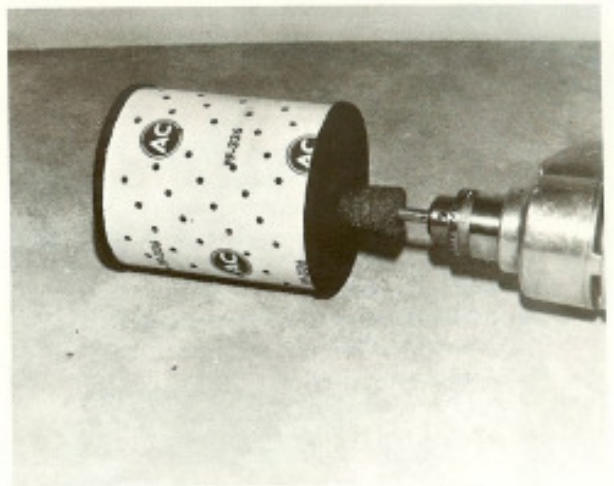
One way to enlarge the hole in the U.S. filter.

Get a Purelator P-76-1 or A-C PF-336 from your neighborhood discount house and grind the end holes to slip over the core, about 15/16 in. dia. Slip the end

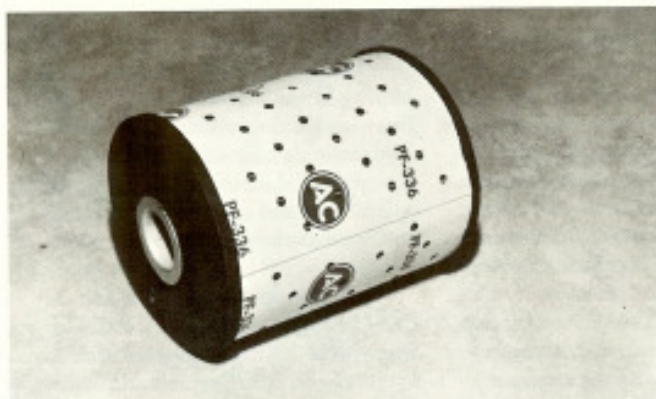
Here is the bottom installed in the U.S. filter.

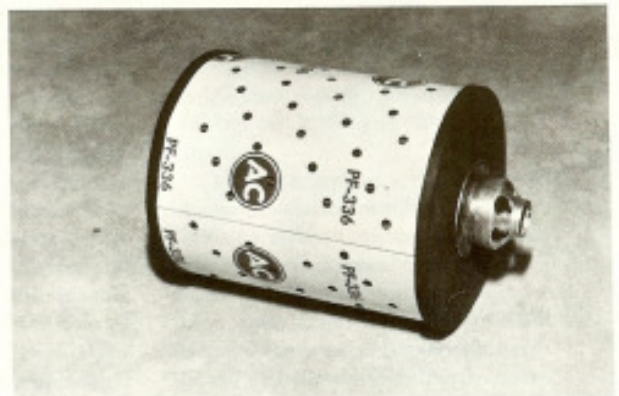
The top of the U.S. filter. Metal center supports the pressure.

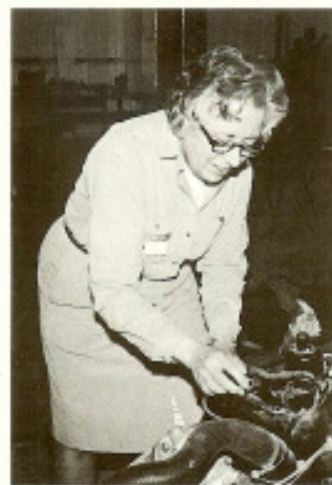
The automatic choke responds to the inter-related workings of the vacuum diaphragm, a bimetallic spring, and an electromagnetic switch which keep the engine on fast idle until certain conditions of vacuum, oil pressure, engine temperature, and under bonnet temperature are met. Examination of the various mechanisms involved fascinated seminar participants.

On S Series cars, a flapping choke after start denotes a failed diaphragm, where the vacuum line connects up. Be very careful of the fragile pin when aligning and tightening nut on new diaphragm.

Louise Newman, NH, investigates the workings of the automatic choke which she expects to repair on her own Silver Cloud II.

Depress accelerator pedal only once to set choke. The engine should start in 1/2 to one full revolution. The choke is then pulled open 1/4" for fast idle at 1,800 rpm. At normal operating conditions, the butterfly is flat open. Make certain it has not been bent.
