MODEL BENTLEY MARK VI

STONE GUARDS ON REAR WINGS AND SILL.

Bulletin

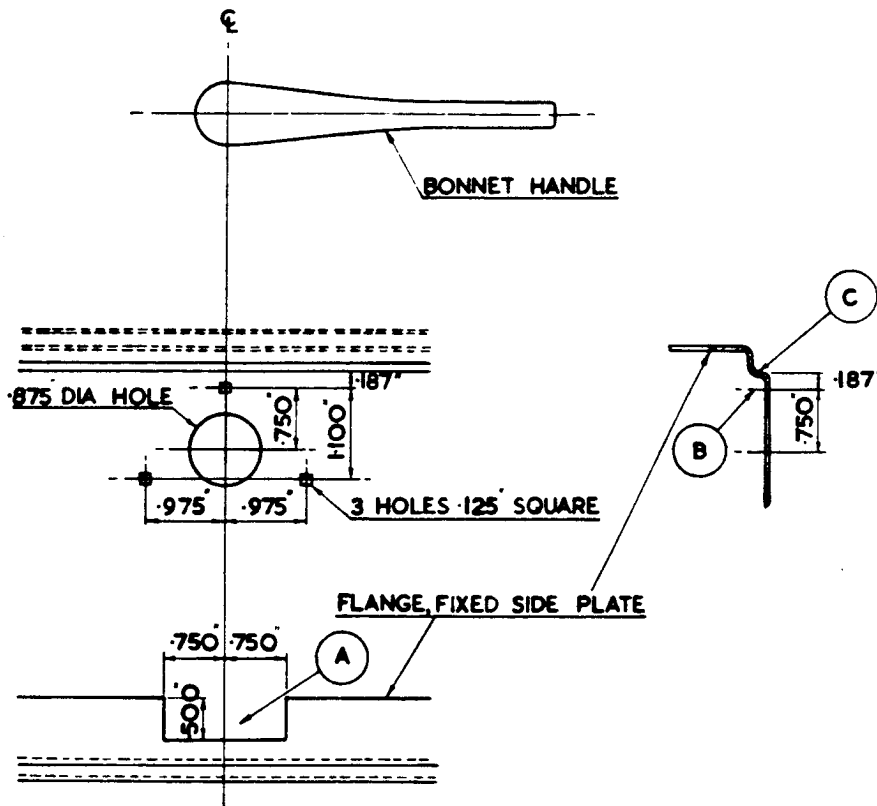
FIG. 1. DRILLING INSTRUCTIONS - BONNET LOCK.

- (i) Cut a slot, 'A' Fig.1, in the flange of the fixed side plate as shown.
- (ii) Mark off and drill the fixed side plate as shown in Fig.1. It is important that the 0.187" dimension (from the ledge 'C', of the side plate to the centre line 'B') should be adhered to closely to ensure that the distance piece (5) & lock are located as high as possible inside the fixed side plate as shown at point 'A' Fig.2.
- (iii) Lightly radius the distance piece at point 'A' (Fig.2) and with it in position on the lock, temporarily fit the lock to the side plate and check for being square. The three square holes may be trimmed slightly to provide adjustment.

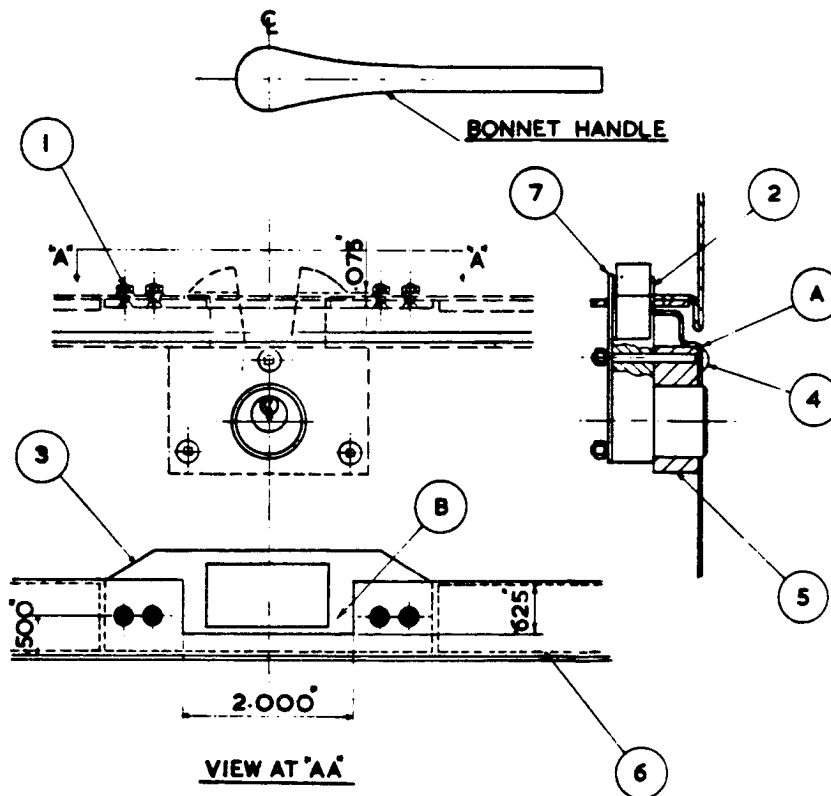
FIG. 2. ARRANGEMENT OF BONNET LOCK.

- (iv) Check that there is a clearance of approximately 0.062" between the face of the lock and the slot in the flange.
- (v) Fit the lock assembly and repeat for the opposite side.
- (vi) Remove the bonnet and cut away the bonnet rest tape on the flange 2.500" either side of the centre line, leaving a gap 5.000" wide to accommodate the lock socket plate (3 Fig.2).

- (vii) Cut a slot 'B' Fig.2, in the flange of the bonnet as shown.
- (viii) Place the lock socket plate on to the flange. With the plate correctly centered and bearing against the side of the bonnet, drill four holes 0.125" diameter in the flange, using the plate as a template. Fit the plate. Drill a further hole 0.125" diameter and fix the loose end of the tape with a split rivet.

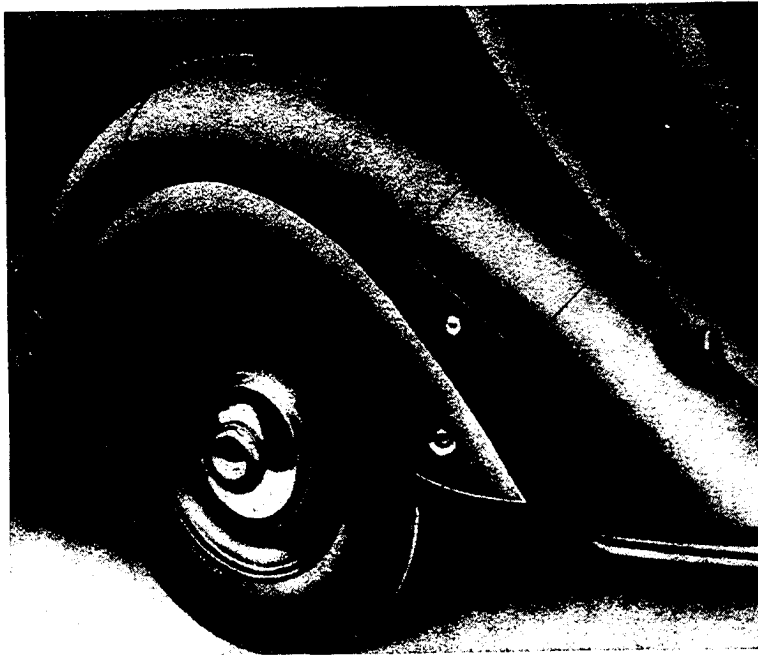
FIG. 1.

Fig. 1, shows the finished appearance of a rear wing with a fairing fitted.

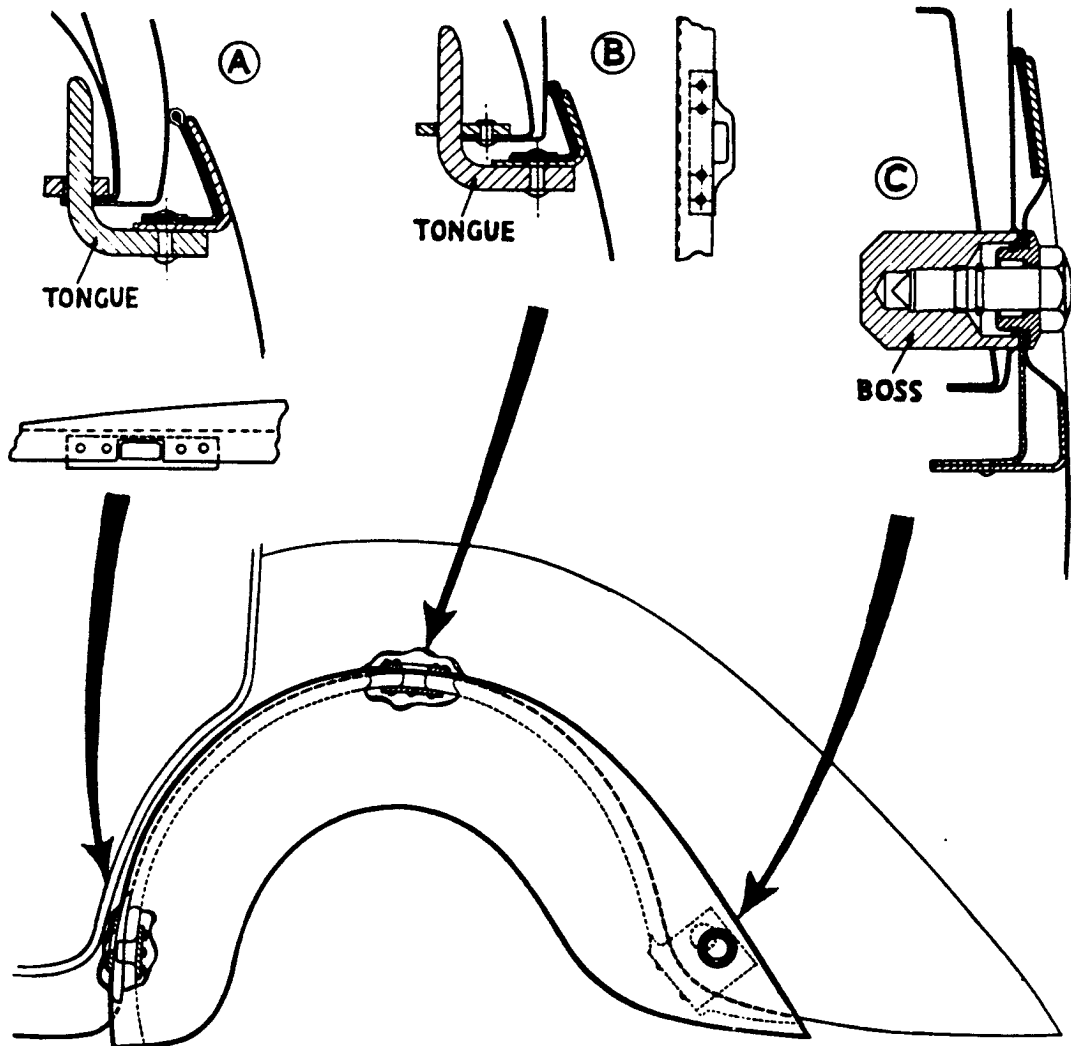
FIG. 2.

When fitted, the wing fairing is secured at three points as shown in Fig. 2. Items 'A' and 'B' are tongue and slot fittings, tongues being fitted

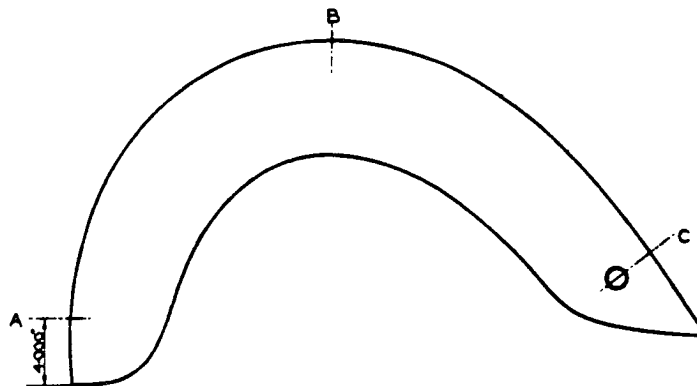
FIG. 3.

- (i) Jack up the rear of the car, remove the wheel and clean the inside of the wing.
- (ii) Mark off positions of 'A' and 'B' tongue centres on the outer edge of the wheel fairing as shown on Fig. 3. 'A' centre should be 4.000" from the bottom of the leading edge and 'B' centre equidistant from 'A' and 'C' centres on the outer edge of the fairing.

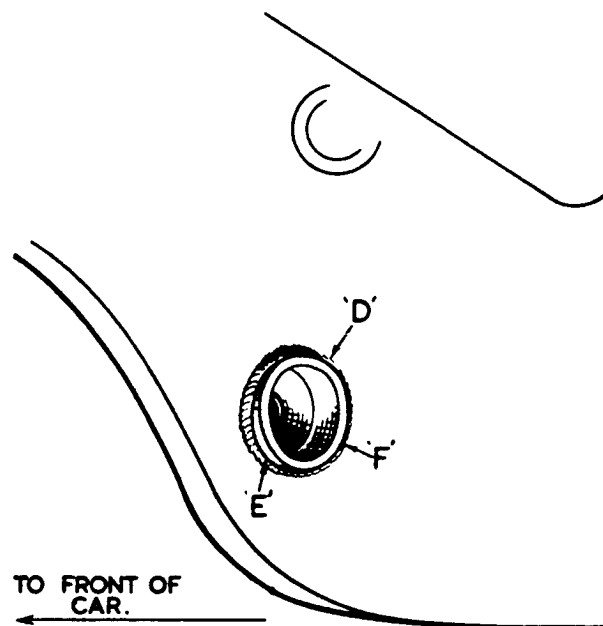
FIG. 4.

- (viii) The next operation is to fit and weld the boss 'F', Fig.4 (also shown in view 'C', Fig.2) in the appropriate position on the rear wing. It will be observed from Fig.4 that the outer face of the boss is nearer to the wing at point 'D', than at point 'E', in order to ensure that the rear end of the fairing fits snugly to the wing. To fit, proceed as follows:-

- c) Trim the hole in the wing until the boss is a good push fit in this hole. Trim the hole in the skin (it is not necessary for the boss to be a good fit in this hole) to allow the boss to be tilted so that when the outer face of the boss is flush with the wing at point 'D' Fig.4, the face of the boss at point 'E' will project from the wing by approximately $3/16$ ". To assist in positioning the boss, point 'D' should be approximately 45° from the vertical line.

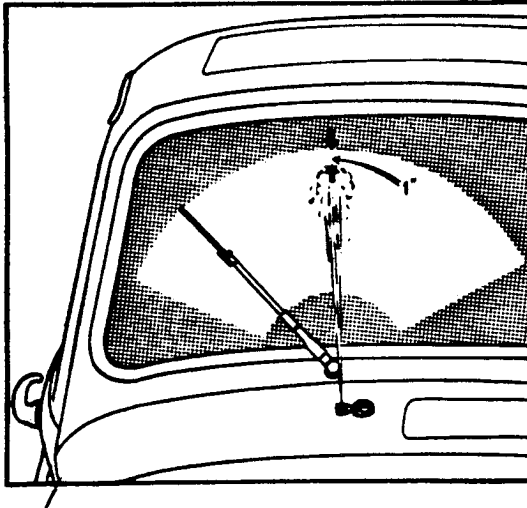
FIG. 8.

A certain amount of adjustment will be required to ensure that the two jets of water impinge on the windscreen both centrally and at approximately 1" below the highest point of each respective wiper arc as shown in Fig. 8.

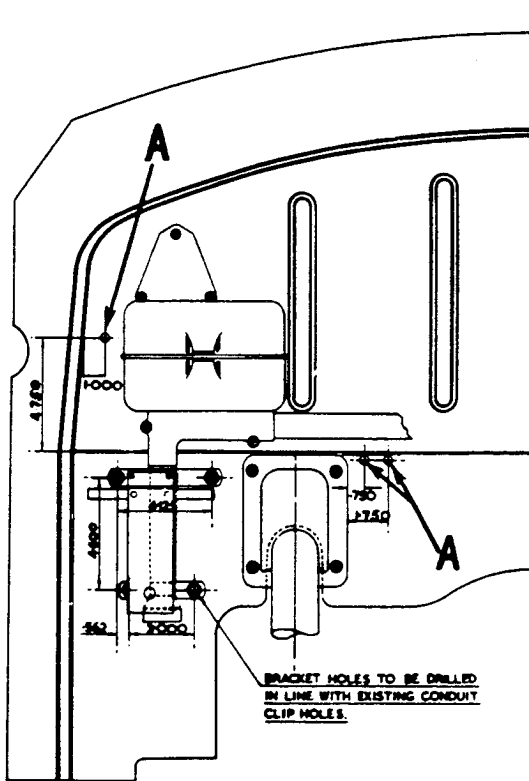
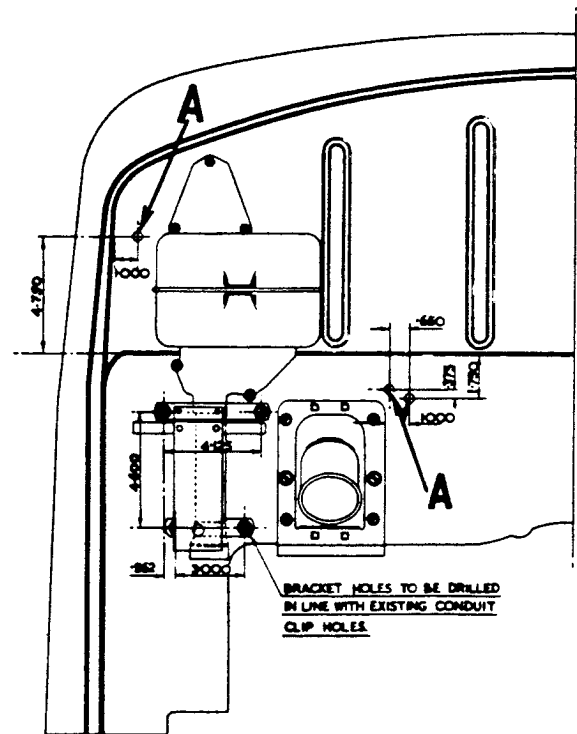
1. Drill the dashboard for the storage jar mounting and rubber tubing grommets in accordance with either Fig. 2 or Fig. 3.

FIG.2. DRILLING FOR EARLY TYPE DASH.
(One-shot tank on L/H side)

FIG.3. DRILLING FOR LATE TYPE DASH.
(One-shot tank on R/H side)

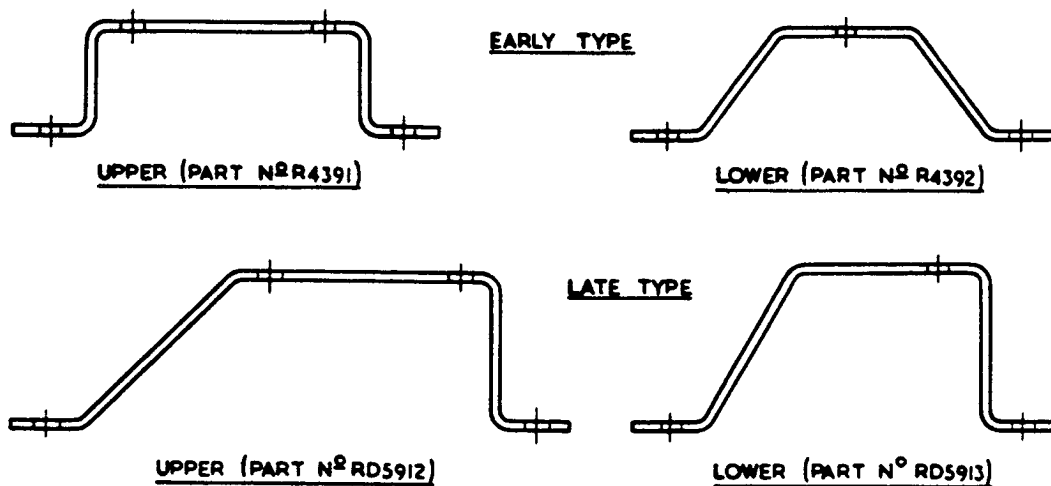
FIG. 4. MOUNTING BRACKETS.

NOTE: Due to alteration in the dash layout on the later model chassis, two types of mounting brackets are employed as shown in Fig.4, the upper pair being for use on those chassis fitted with the early type dash (Fig.2), and the lower pair on the later type dash (Fig.3). Where the late type brackets (RD-5912/3) are used, the right-angled bracket arm should be fitted AWAY from the engine.

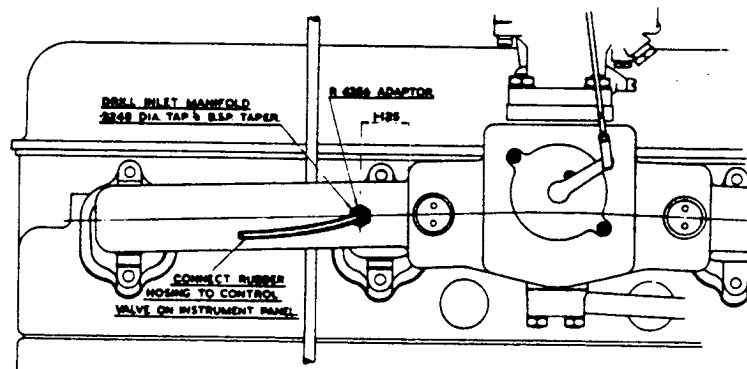
FIG.5. DRILLING OF MANIFOLD (LEFT-HAND DRIVE CARS).

3. Bolt the cradle assembly on to the dash and fit the storage jar as shown in Fig.1. (N.B. Sufficient clearance should be allowed between the pump diaphragm at the top of the jar and the fuse box cover to permit the subsequent removal of the cover without having to remove the jar).
4. Fit the suction pipe adaptor to the induction manifold:-
 - a) Left-hand drive cars:- Drill and tap the induction manifold and fit the special adaptor (R-4356) as shown in Fig.5.

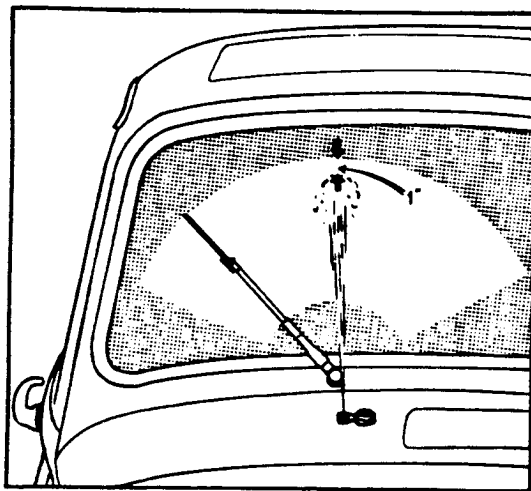
FIG. 12.

A certain amount of adjustment will be necessary to ensure that the two jets of water impinge on to the windscreen both centrally and at approximately 1.00" BELOW the highest point of each wiper arc, Fig.12.

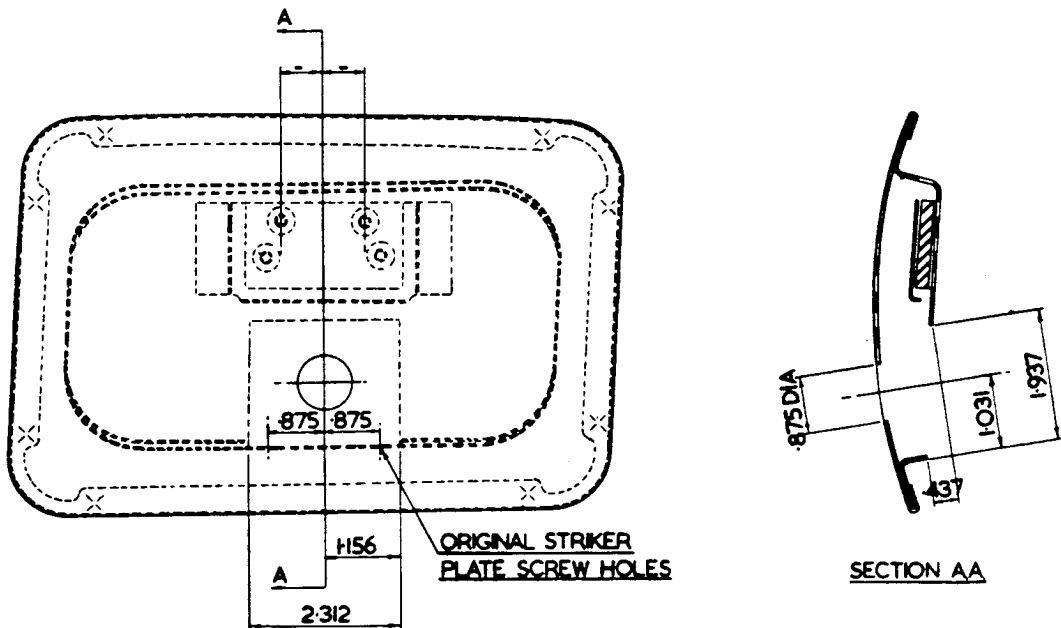
FIG. 2.

1. Remove the filler door from the wing.
2. Remove the existing filler door striker plate.
3. Mark off the datum line "AA" as shown in Fig. 2.
4. Mark off and then cut away the inner panel of the door as shown in Fig. 2.
5. Drill the outer panel of the door as shown in Fig. 2.

NOTE: Particular care should be taken when drilling this hole, as any appreciable error will result in difficulty being experienced with the operation of the door lock when it is finally assembled.

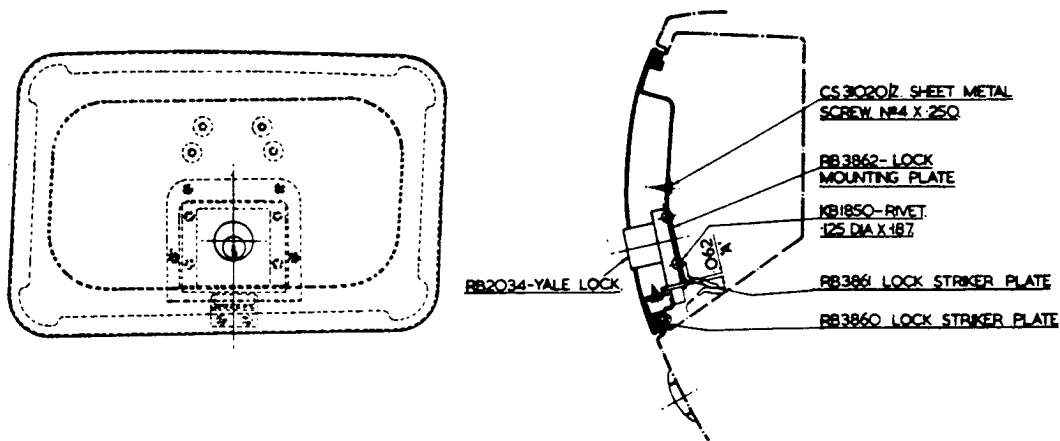
FIG. 3.

6. Weld the rear lock striker plate to the back of the lock mounting plate, ensuring that this is set $1/16"$ (1.6 mm) inwards from the bottom edge of the mounting plate as shown in dimension "A" Fig. 3.
7. Rivet the lock assembly to the front of the mounting plate, using the four rivets provided.

NOTE: Prior to riveting, it is recommended that the slot cut in the mounting plate is checked for clearance in conjunction with the tongue of the lock.

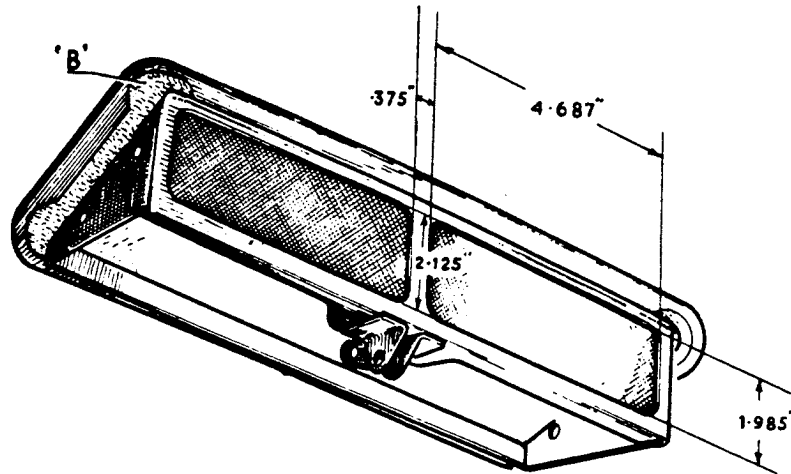
Fig. 2.

The lids of a number of cars in service have already been attended to in this respect.

- (a) Thoroughly clean the underside of the lid and fill in the depression at each corner with solder to surface level, ('B', Fig. 2). Also fill in the channel running along the two sides, which lead into each corner. Face off the solder as necessary until it is flush all the way round.
- (b) Mask the wire screen and re-cellulose the lid taking care to match the colour. Do NOT cellulose the wire screen.
Note: The above method of filling-in, which is preferable to the method described below, should however, only be undertaken where it is possible to match the existing colour, because, owing to the blistering effect of the solder it will be necessary to entirely re-cellulose the lid.

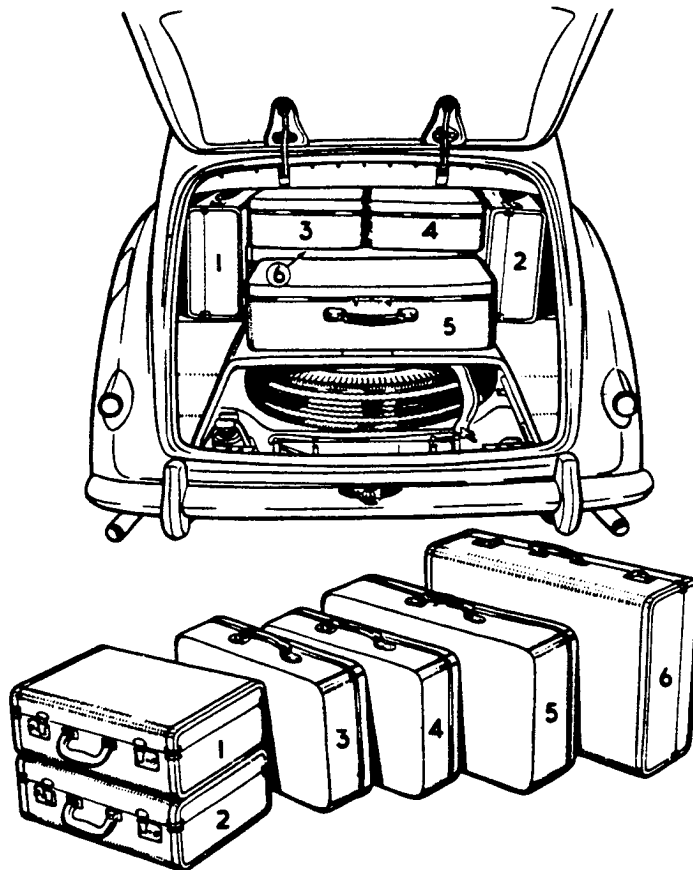
ILLUSTRATING CORRECT METHOD OF STOWAGE.

Retailers are advised that some owners have found difficulty in correctly stowing the special Bentley supplied suitcases.

The largest suitcase, No.6, must be placed centrally and as far back as possible into the boot, the smaller cases, 1 and 2, are then packed at each side of No.6. Nos. 3 and 4 should then be laid on top of No.6 and, finally, the second largest case, No.5, placed in position to fit snugly between No.6 and the boot lid.
