**Bulletin**

MODEL BENTLEY MARK VI

**MODIFICATION.****REAR BRAKE EQUALISER.**

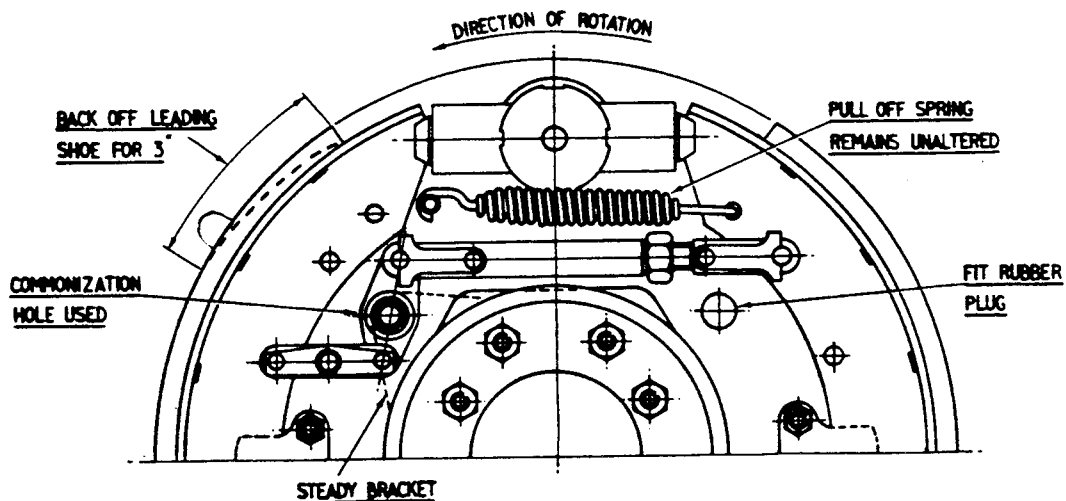
FIG. 2.

REPLACEMENT OF EQUAL WEAR LINKAGE:

- (a) Replace the existing push rod and jaw of the equal wear assembly with the strengthened parts Nos. RG-6045/6 and nut K-4010/Z.  
NOTE: If these parts are not available, the existing push rod and jaw may be used, but should be replaced at the first opportunity.
- (b) Invert equal wear linkage assembly, and replace on fulcrum pin (P). (The short link should now be to the front of the car, and will line up with the lowest of the three top holes in the leading shoe, and the push rod will be to the rear and will line with the second hole from the top in the trailing shoe).
- (c) Replace pin (109) in the short link, locking plate (110) and the setscrew and spring washer (111).

- (d) Replace pin (95) in the push rod, locking plate (96), and the setscrew and spring washer (97).
- (e) On cars fitted with the steady bracket, the grease catcher assembly from the left-hand wheel must be replaced on the right-hand wheel and vice-versa.
- (f) Replace the front hubs, and secure the retaining nut and washer.

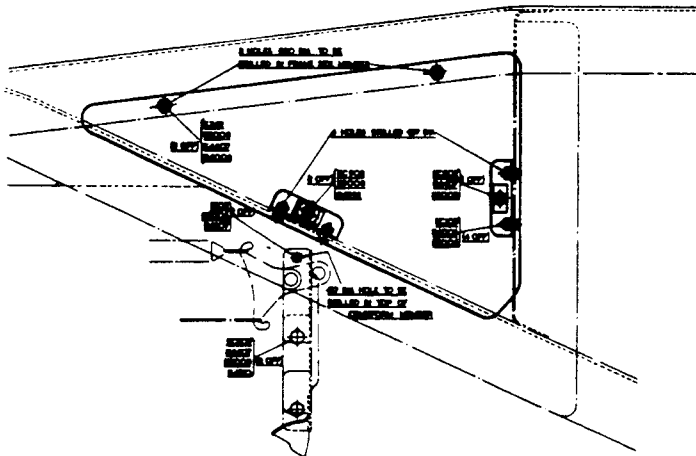
FIG. 1. FITTING OF UNDERSHIELD.

This modification is now offered as a chargeable improvement for fitting to existing models of earlier chassis, and its incorporation is recommended in all cases where servo inefficiency is traced to water on the friction faces.

1. Place the car over a pit, or elevate on a suitable hoist.
2. Remove the battery.
3. Remove the existing right-hand rear undershield immediately below the servo unit.
4. Offer up the new undershield from below the chassis and cover the triangular gap formed by the frame side member and cruciform member forward of the battery container. Mark off the relative positions for the two

7. Offer up the baffle plate with its flanges towards the engine, forward of the servo unit, and mate the head of the leading rivet securing the spring clip to the top of the cruciform with the radiused slot cut in the top flange of the plate. Mark off the relative position for the 2-BA bolt hole in the top of the cruciform as shown in Fig.1. Drill accordingly.

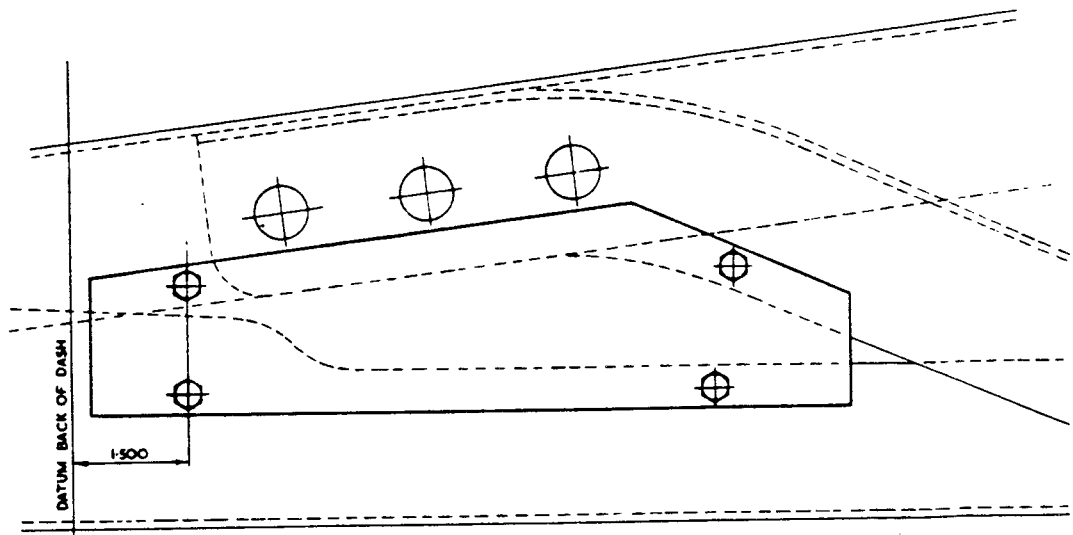
FIG. 1 FITTING OF UNDER-FRAME COVER PLATE.

Further to the above, it is recommended that additional protection plates for the throttle control countershaft on the right-hand side frame member are also fitted whenever this modification is incorporated on early type chassis.

- (a) Hand-hole in the side of the right-hand frame member just forward of the front body support bracket.
- (b) Gap below the chassis frame formed by the frame side member, engine bearer and cruciform member.

1. Fit the under-frame cover plate (RF-6209) as shown in Fig. 1.
  - a) Offer up the plate, and mark off the relative positions for the four retaining setscrews.
  - b) Drill the four holes 0.1562" dia., and then tap 2 BA (31 T.P.I. R/H).
  - c) Fit the cover plate.

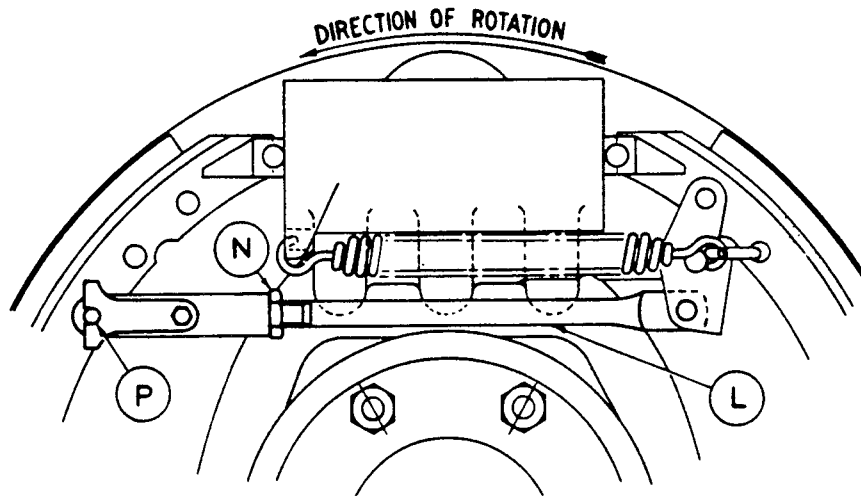
FIG. 1. DIAGRAM - SETTING INSTRUCTIONS - FRONT BRAKES.

When, during service, the front brake shoes have to be removed for replacement by a set of reconditioned shoes (new linings), or should it be found necessary to centralise the shoes in relation to the drum, the following are the setting instructions:-

- (i) Build up the brake complete, but do not fit the locking plate for pin P, Fig. 1, or lock the nut N. For an initial setting, the link L, should be adjusted to 7.375" (187.3 m/m) between the pin centres.

- (viii) Slacken back the adjuster and remove the drum, fit the locking plate for pin P, and lock the nut N. Check that all other split pins etc. are correctly fitted, replace the drum.

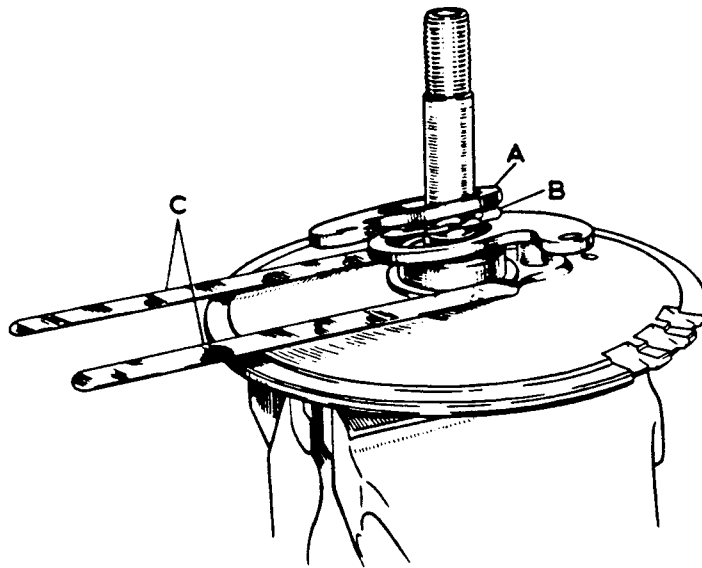
FIG.2.  
A. Brake Actuating Lever. B. Servo Washer (R.5037).  
C. Feeler Gauges.

1. From approximately B-311-YA and onwards a spring clip was fitted to the upper brake actuating lever to eliminate servo "clonks", this will have to be removed if it fouls the corrugated washer when compressed.
2. Under certain circumstances it has been found that owing to servo manufacturing limits, difficulties have arisen in fitting the corrugated washer, and in order to overcome this, and to ensure a long service life, the following method of fitting is to be employed.

The complete servo motor is to be removed, dismantled, and a packing washer approximately .0625" thick placed between the pressure plate

and the flange on the servo shaft. The servo is then placed in a vice as shown (Fig.2), the corrugated washer fitted into position, and the servo assembled. The adjusting nut is tightened fully home, thus compressing the corrugated washer.

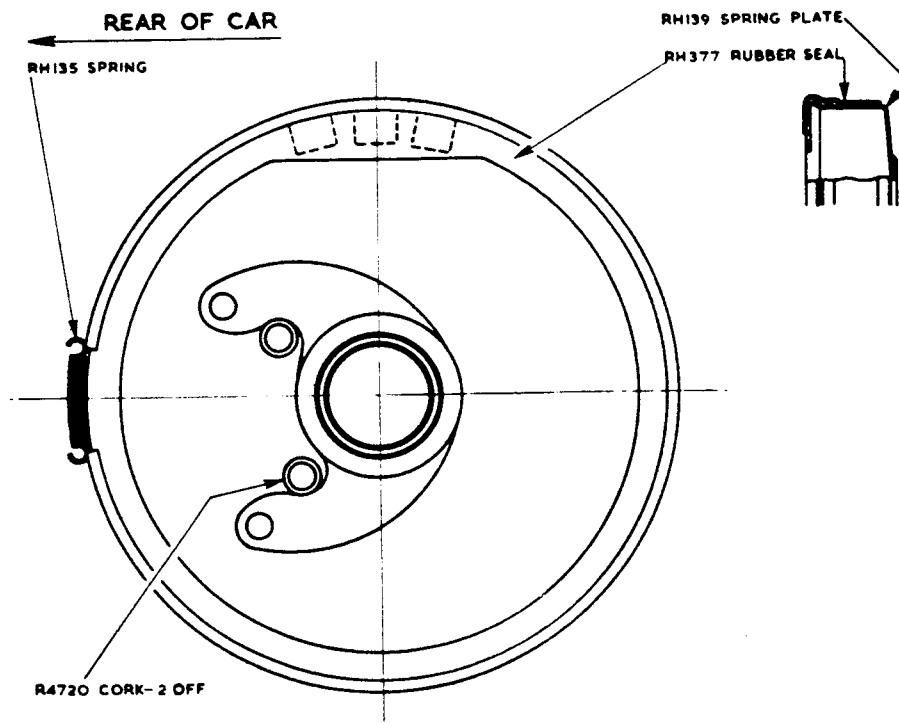
FIG.4.

NOTE: It is not possible to use the rubber seal more than once, nor is it possible to use the seal if it has been stretched in an unsuccessful attempt to fit it.

The servo spring plate, lined plate, pressure plate and servo main shaft are to be put together so that after the seal has been fitted the servo can be completely re-assembled and re-fitted, (Fig.4).

the edge of the plate, not by pulling on the outer edge of the seal as might be expected, but by pulling on the inner diameter; this prevents distortion of the outer periphery. The rest of the seal is then eased into position, still pulling on the inside diameter until the inner periphery fits closely into the spigot running around the upper face of the pressure plate. The whole seal is then to be eased into position finally and retained by the protector ring which must be fitted with the lower rate spring RH.135, otherwise it will not fit over both the seal and the pressure plate. The spring is to be positioned towards the rear of the car and not to the lowermost position as was usual. On certain servos the ends of the brake actuating lever operating pins will be open; these must be sealed with two corks (Fig.4).

The servo can then be re-fitted to the car, the seal being finally checked after road test.

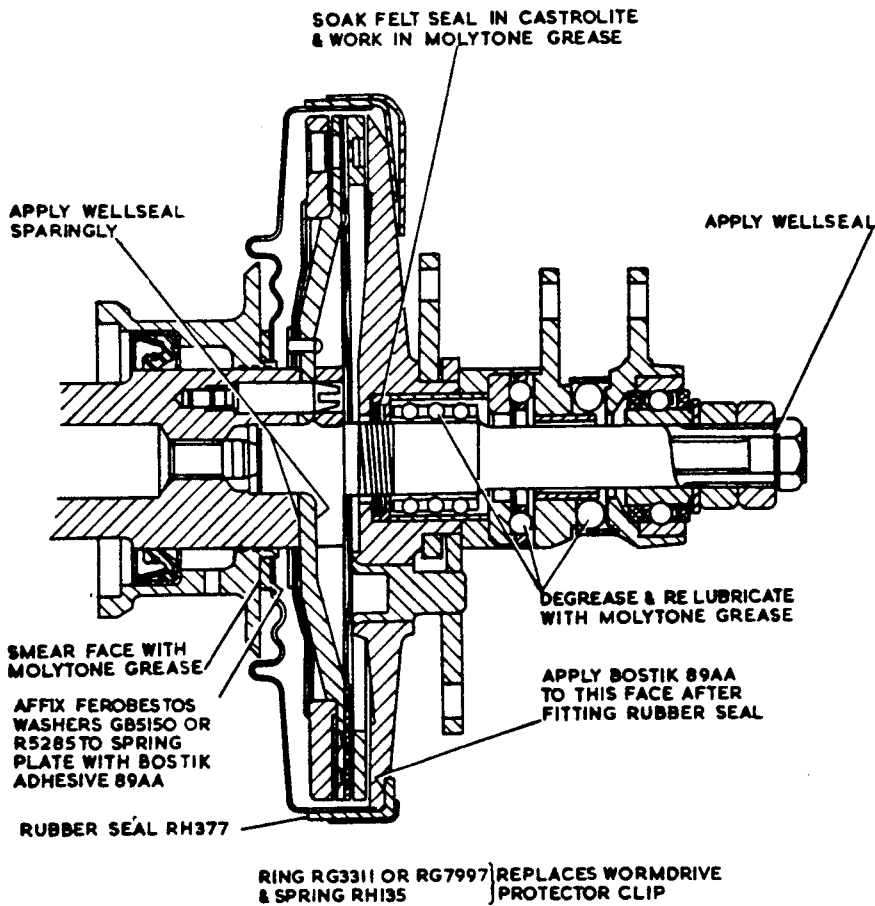
FIG. 1.

Where inspection of the liner shows the presence of oil, the source of oil leakage must first be ascertained and rectified.

Before re-assembling, the following modifications are required, if not already incorporated.
