MODEL BENTLEY MARK VI

MODIFICATIONENGINE OIL FILLER CAP WASHER.

REPLACEMENT OF TAPPETS.

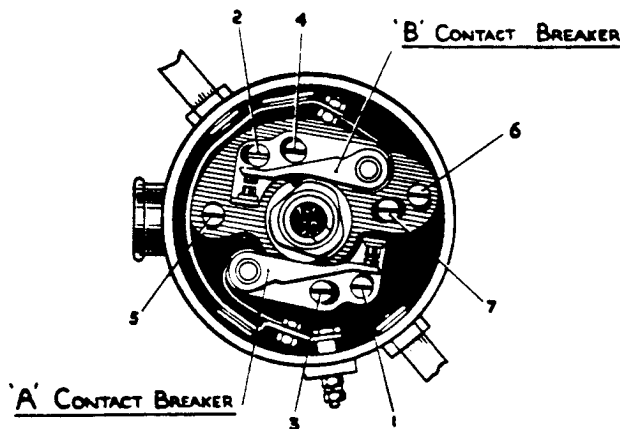
FIG. 1. PLAN VIEW OF DISTRIBUTOR.

- (iii) Trim up the points as necessary with a fine carborundum stone until the faces close flush with each other. All raised portions of the contact surfaces should be removed, but it is not necessary to remove the pit marks. If the points are badly pitted, then they should be renewed.
- (iv) Refit the contact plates, adjusting washers and breaker arms to their original position. Apply a few drops of engine oil to the felt wick at the top of the distributor spindle and one drop of oil to the rocker arm pivot pins. Smear a trace of Mobiloil Grease No. 2 on the cam surface and refit the rotor.

- (i) Remove the rotor arm from the top of the spindle.
- (ii) Loosen the small bolt attaching the spring of 'A' Contact breaker, Fig.1, to its anchorage and remove the breaker arm complete with its fibre adjusting washer/s. Remove the locking screw 1, (Fig.1) and remove the contact plate. It is essential that each contact breaker arm, their respective fibre adjusting washer/s and contact plate should be kept together and refitted to the same side of the distributor from which they were removed. Carry out the same procedure for 'B' contact breaker - removing the locking screw 2.

- (v) Turn the engine until the fibre heel of 'A' contact breaker arm is on a lobe of the cam to give maximum opening, loosen the contact plate locking screw, 1, and turn the adjusting screw 3, to obtain the correct gap between the points i.e. .020" (0.508 mm), and then retighten the locking screw (1). Check that the setting of the gap has not been disturbed by the tightening of the locking screw. Carry out the same procedure for 'B' contact breaker arm by loosening the locking screw 2, and turning the adjusting screw 4.

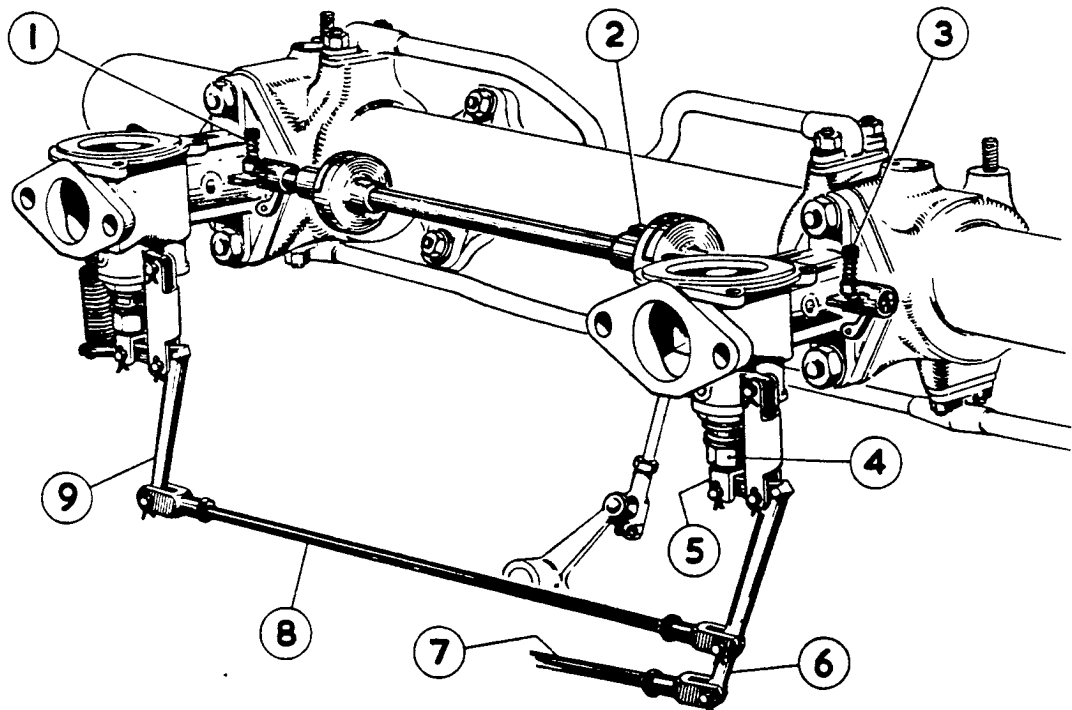
FIG. 2. VIEW OF CARBURETTOR CONTROLS (CARBURETTORS PARTLY DISMANTLED FOR CLARITY).

If the mixture is weak, the exhaust note will be irregular and splashy, whereas, if the mixture is too rich, the exhaust note will have a constant rhythmical uneven beat, known as "hunting".

The jet adjusting nut is actually a "stop" against which the jet head (5) should bear. Screwing up the nut weakens the mixture and unscrewing it strengthens the mixture.

- (vi.) With the hand throttle lever on the steering wheel placed at the bottom of its range, adjust, if found necessary, the throttle stop adjusting screw (3) of the front carburettor until the correct idling speed has been obtained.

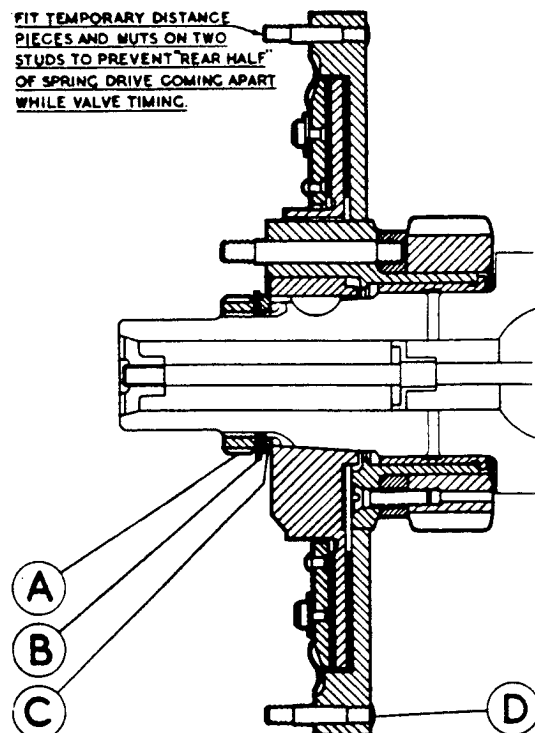
FIG.5 SECTION - 'REAR HALF' OF 'PRE-BENCH' TYPE CRANKSHAFT DAMPER (SPRING TYPE)

With the camshaft set in position, the procedure differs according to the type of crankshaft damper fitted. The early or 'Pre-Bench' type, was fitted from Chassis Nos. B-2-AK to B-126-DA inclusive and the later 'Bench' type from Chassis No. B-128-DA and onwards. The two dampers may be distinguished by the fact that the 'Pre-Bench' type has twelve studs (D, Fig.5) fitted to the rim of the rear damper wheel, whereas the 'Bench' type has six bolts (E, Fig.6).

- (vi) Fit the plain washer (C, Fig.5), a new locking washer 'B' and the serrated retaining nut 'A'. Tighten the nut with tool 3759/T1007 but do not lock.
- (vii) Check that No.1. inlet valve commences to open on the appropriate flywheel marking.
- (viii) If the timing is incorrect, the location of the camshaft gear on the camshaft must be changed and eight holes are provided in the camshaft gear for this purpose. Turning the gear through 45° to the next stud hole will alter the setting by a quarter of a tooth, equivalent to $7/16"$ (11 mm) on the flywheel periphery; turning the gear through 90° will alter the setting by half a tooth, equivalent to $7/8"$ (22 mm) on the flywheel periphery.

First loosen the serrated nut 'A' (Fig.5) and with extractor 3759/T1016 or tool 1617/T1003, withdraw the damper about $5/16"$ from its fully home position on the crankshaft nose. Remove the camshaft gear and reposition it as required, ensuring that the circular locking plate is refitted.

- (ix) When the correct timing has been obtained, fit two of the four camshaft gear fixing studs, new lockwashers and nuts. Fully tighten and lock the nuts. Remove the two temporary setscrews and similarly fit the other two studs. Tighten and lock the serrated damper retaining nut (A Fig.5).
- (x) Reset No.1 inlet valve clearance to .006" (.15 mm).
- (xi) Fit the front damper wheel complete with the eight damper springs (and adjusting washers if fitted behind the springs), ensuring that the co-relation marks 'O' on both damper wheels are in alignment. Tighten the four hub nuts and lastly the twelve rim nuts, locking with new lockwashers.
- (xii) Align and refit the wheelcase and remaining components.

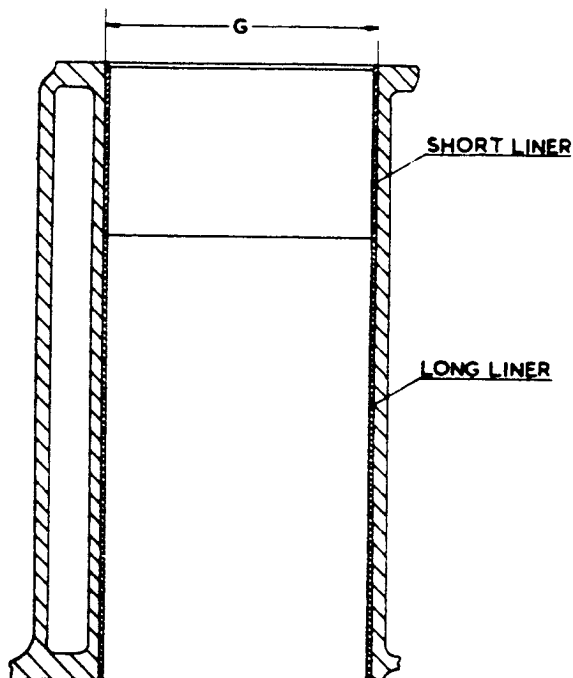
FIG.3. SECTION - CYLINDER - TWIN LINERS IN POSITION ($3.500''$ DIA. BORE ENGINE).

Note: Should one or more of the cylinder bores be found to be deeply scored, then consideration should be given to fitting twin liners. (See Para.4).

- (vi) Again set up the crankcase on the boring machine with the upper end of the 3.625" (92.07 m/m) dia. counterbore CONCENTRIC with the boring cutter and bore out the cylinder in stages, the whole of its length, (See G Fig.3), to a diameter that will allow the correct interference fit between the cylinder and the pair of matched liners. The finish of the bore must be a MACHINED AND NOT A HONED FINISH, prior to pressing in the liners.

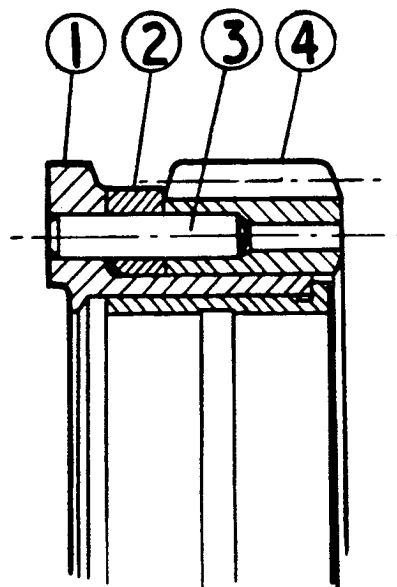
FIG.1. Scrap Section - Crankshaft Pinion Assembly. ("Wraith" type Spring Drive).

1. Driven Dog.
2. Distance Piece.
3. Driving Pin (2 off).
4. Crankshaft Pinion.

- (i) Remove the two (2 BA.) countersunk screws from the crankshaft pinion assembly. With a flat ended steel punch $.150''$ (3.8 m/m) dia; drive out the two driving pins (3. Fig.1). These pins are a tight drive fit. With an aluminium drift remove the crankshaft pinion (4) from the driven dog (1). These two parts have a taper of 1 in 200.

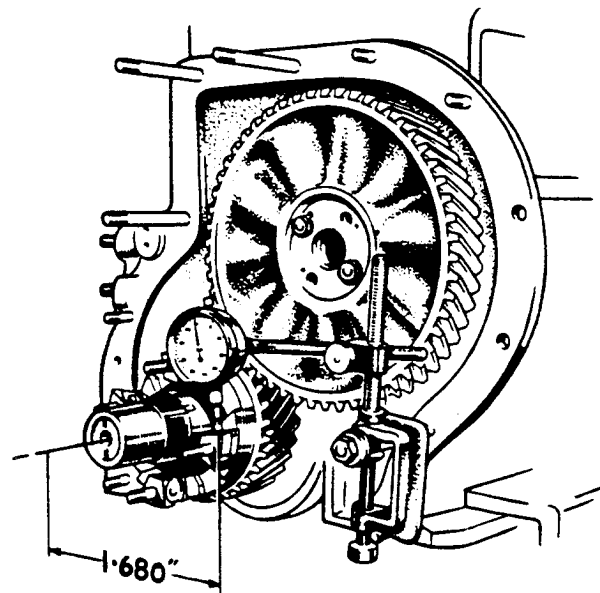
FIG. 2. CHECKING BACKLASH BETWEEN PINION & CAMSHAFT GEAR.

In the unlikely event of the backlash being less than .002" (.05 m/m) or exceeding .006" (.15 m/m), then the only alternative would be to try another set of gears.

- (ii) Place the crankshaft pinion on to the crankshaft. Secure the dial indicator to the crankcase as shown in Fig.2 and check the camshaft driving gear for backlash at four equidistant places. The registering member of the dial indicator should rest on a driving lug of the pinion as shown in the illustration and at a radius of 1.680" (42.7 m/m) from the centre of the crankshaft.

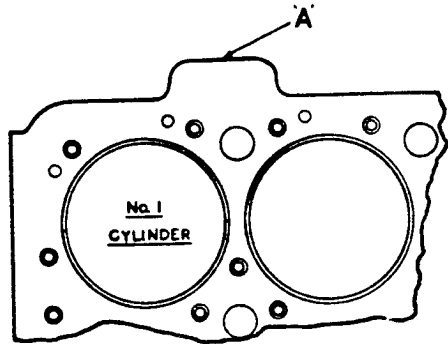
FIG. 8. SCRAP VIEW SHOWING CRANKCASE LUG ('A').

NOTE: In the unlikely event of the lug having been machined back on an engine prior to 'H' series chassis, then it will be necessary to fit the circular distance piece (23 Fig. 10) interposing it between the filter mounting plate and the lug when fitting the mounting plate and filter assembly to the crankcase as described in Sub-para. xv.

- (vi) File back the face of the crankcase front lug, 'A' Fig. 8 and fit the stud (1) KB-751/Z as described in sub-para. (iv) of Para. 3 for Scheme 'A'.

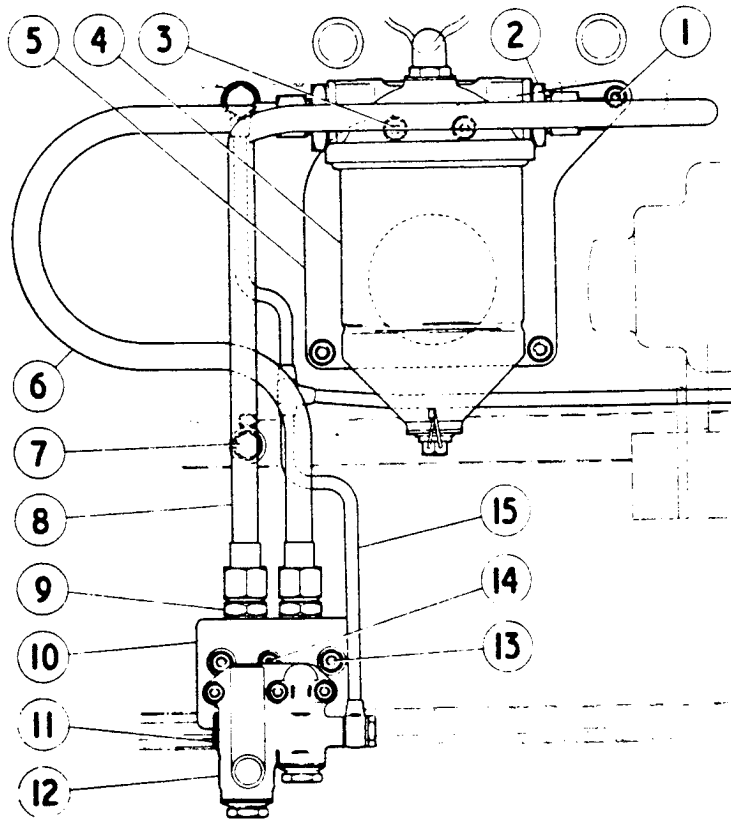
FIG. 9. FRONT ELEVATION - FULL FLOW OIL FILTER.

Concerning Scheme 'B' of Service Bulletin No. BB-143 (Section E), it has been brought to our notice that in one or two instances the external inlet and outlet oil feed pipes, (6 & 8 Fig. 9 of Bulletin No. BB-143) to and from the Full Flow Filter have been reversed when fitting to the transfer block (10). This arrangement causes the filter element to collapse and block the oil flow.

It will be observed upon reference to Fig. 9, that the lower end of the inlet oil pipe (6) is connected to the right-hand side of the transfer block and the outlet oil pipe (8) to the left-hand side.

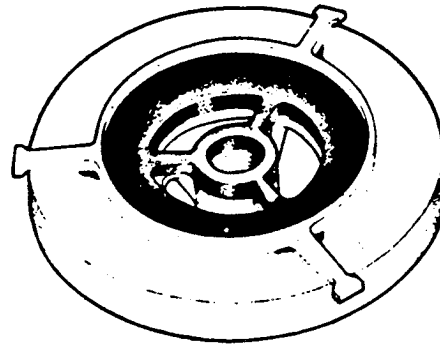
Fig.4. Original 'Top Cap'

If the inner sealing face stands proud of the outer lip (see Fig.2) the original 'Top Cap' (as shown in Fig.4) can be retained. For future replacements only the modified 'Top Cap' will be supplied.

The filter head should be painted with a green spot to serve as a means of identification after the above instructions have been carried out.
