Number 71 January, 2008

GETTING IT UP AND KEEPING IT UP

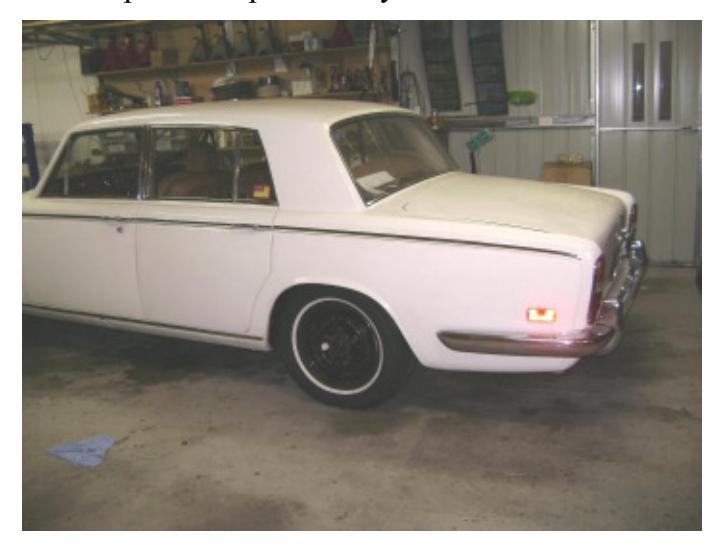
This is the common attitude of many Shadows. If the levelling valves and rams are still working by the time the car has dropped this far they will be working all the time. The usual reason levelling stops is that the accumulators are on the way to be exhausted and there is simply not enough oomph to lift the car. If you have just bought the car, lack of levelling will often be explained by the system having been blocked off.

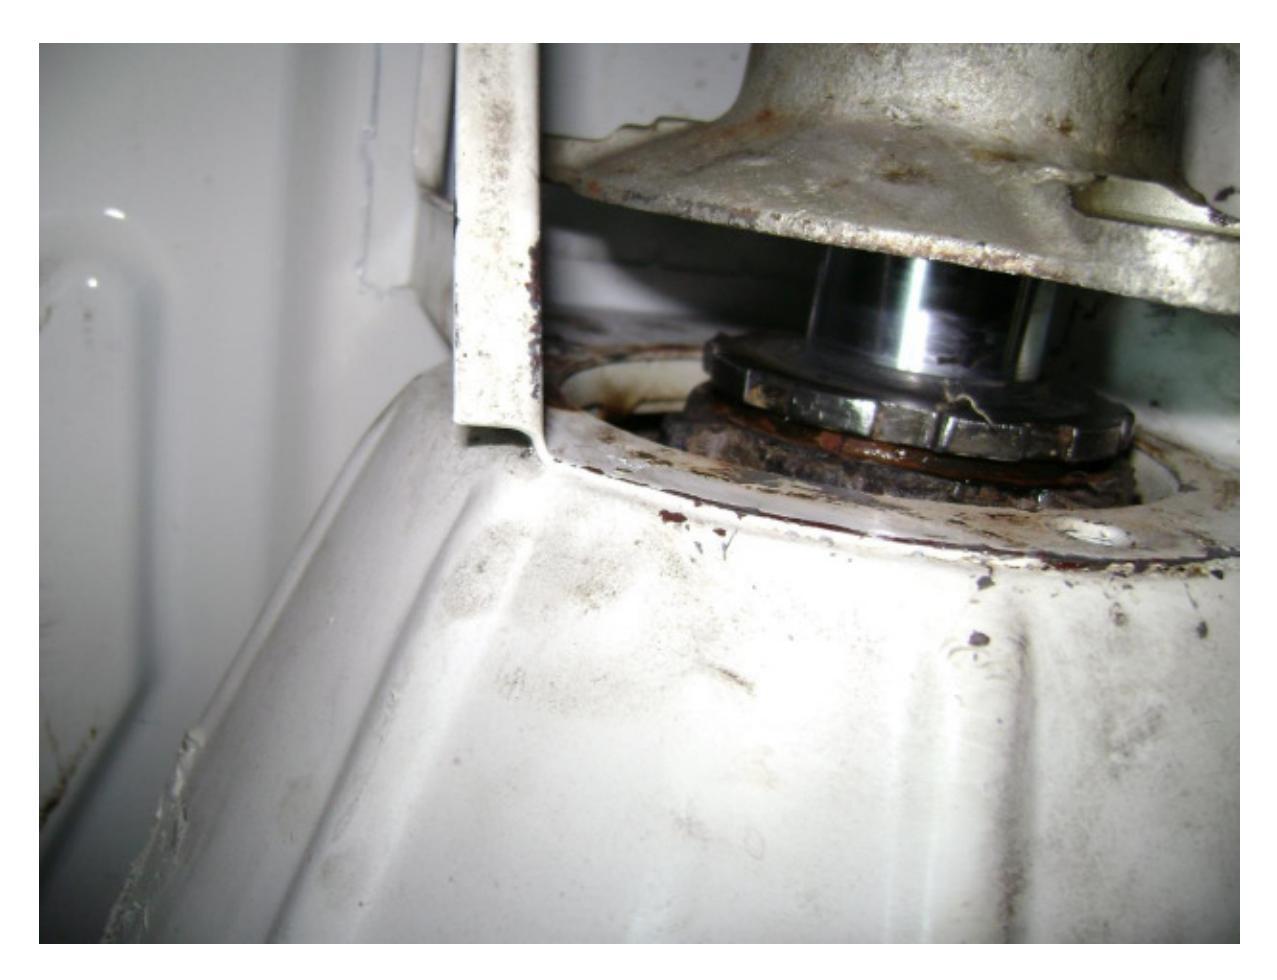
And here is where it all happens. Most owners have peered behind the rounded carpet mouldings in the rear corners of the boot (trunk for the US) and found the ram cylinders which lift the rear of the car. It is sobering to think that the weight of the car is taken on three bolts passing through the flange of the cylinder which is why the manual quietly points out not to use other than the bolts supplied! The actual ram can be seen disappearing into the cylinder in this picture. The serrated flange at the bottom of the ram screws into the spring holder. To remove the ram having disconnected the pipes simply unscrew this flange from the holder. Unfortunately some operators screw the rams into the holder to prevent the car being flung into outer space. Add to that tension some rust because the same operators are too lazy to put plenty of never seize grease on the threads, you can have a real problem.

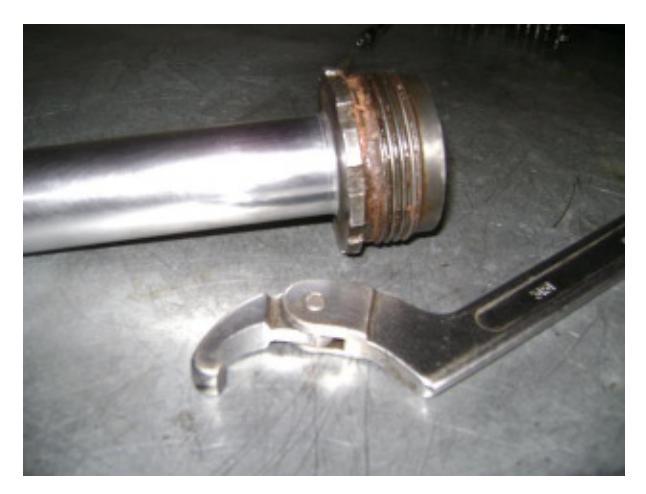
And here is the means by which the ram, now removed, is unscrewed from the spring holder. Note the very course thread. Early cars used a fine thread which often spelt doom for the system. The problem is that applying whatever force to the ram, if the thread was locked, turning the ram simply turns the spring holder! Fortunately I have not had this happen to me but if it did there would be a way to bolt on a finger to one of the mounting holes that would project down and engage one of three 'ears' cast into the top of the holder to prevent it turning. If that fails cutting the ram out may be the only option.

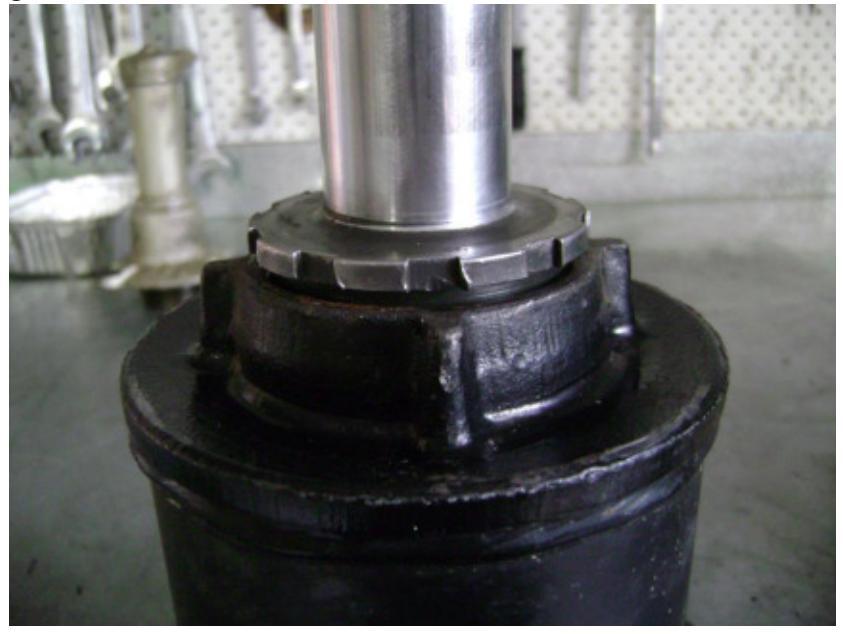
The ram screwed into the spring holder. Note the damage to the serrations from indiscriminate bashing which (blush) all of us have had to resort to at times to get the blasted things to unscrew. When you do get these out please tidy the serrations up with a file for the next bloke (or so help me, gal) use plenty of never seize grease and simply nip them up. They do not have to contain a nuclear explosion!

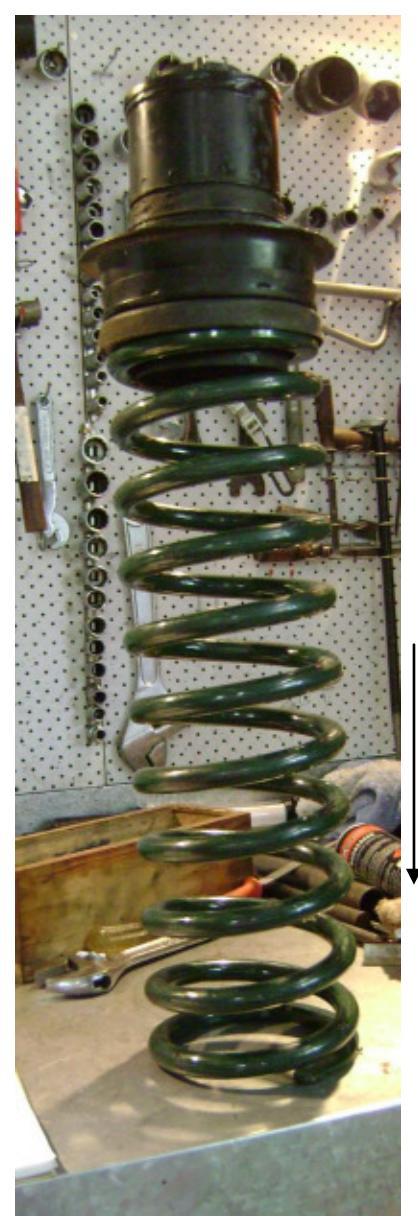
This gives some idea of the length of the spring. Note the fabric collar at the top. A similar one fits at the bottom. These help isolate road noise from the car interior.

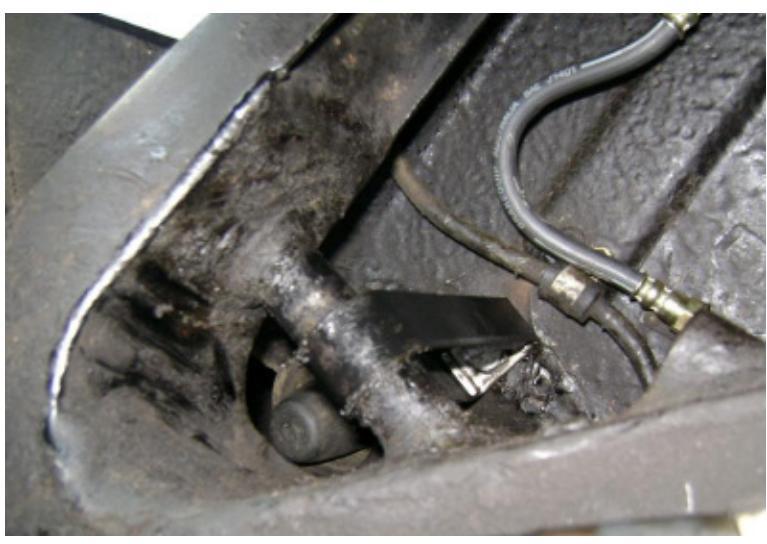
Above. This is one of four points that need to be disconnected before the rear wheels can be dropped right down. The levelling valve can be seen here with suitable encrustations indicating some leakage of brake fluid. On its right side is the operating arm bolted to the lower suspension arm. It is at this point that the 'levelled height' – i.e. using the rams) is adjusted. If this link is not disconnected and the wheels are allowed to drop down the levelling valve itself may be damaged.

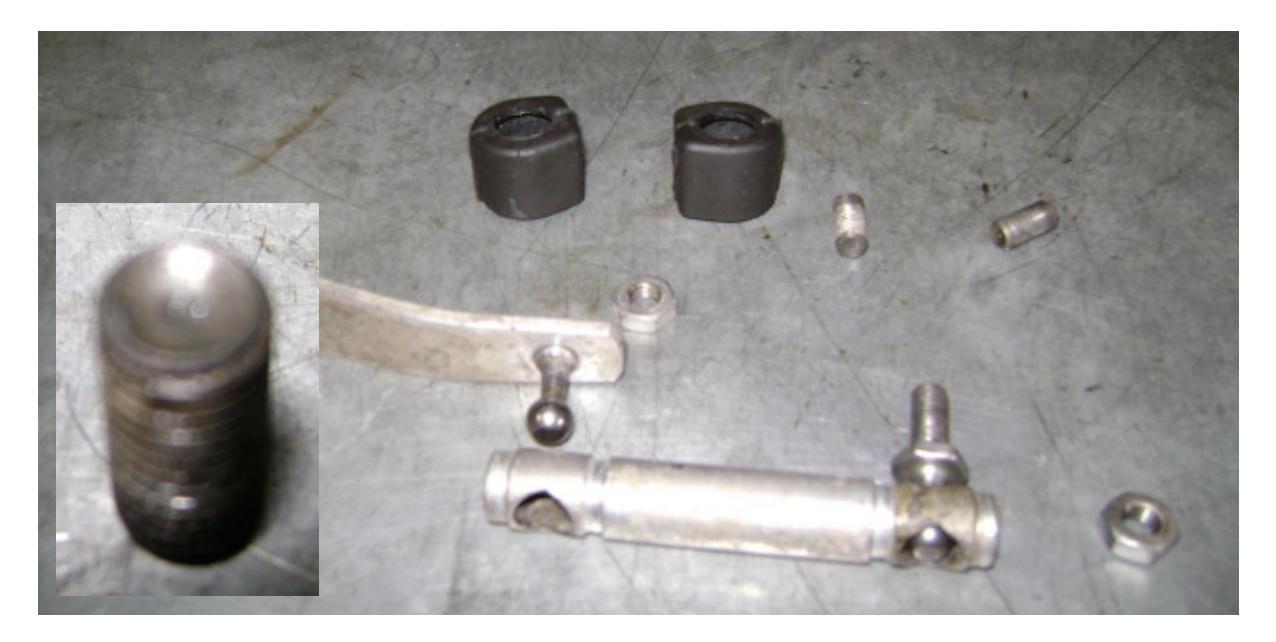
This is one application, the links connecting the rear suspension arms to the levelling valves mounted on the rear sub frame. The two small screws at upper right at first glance seem simple slotted headless bolts but closer examination displays intricate hardened spherical seats on one end (see inset).

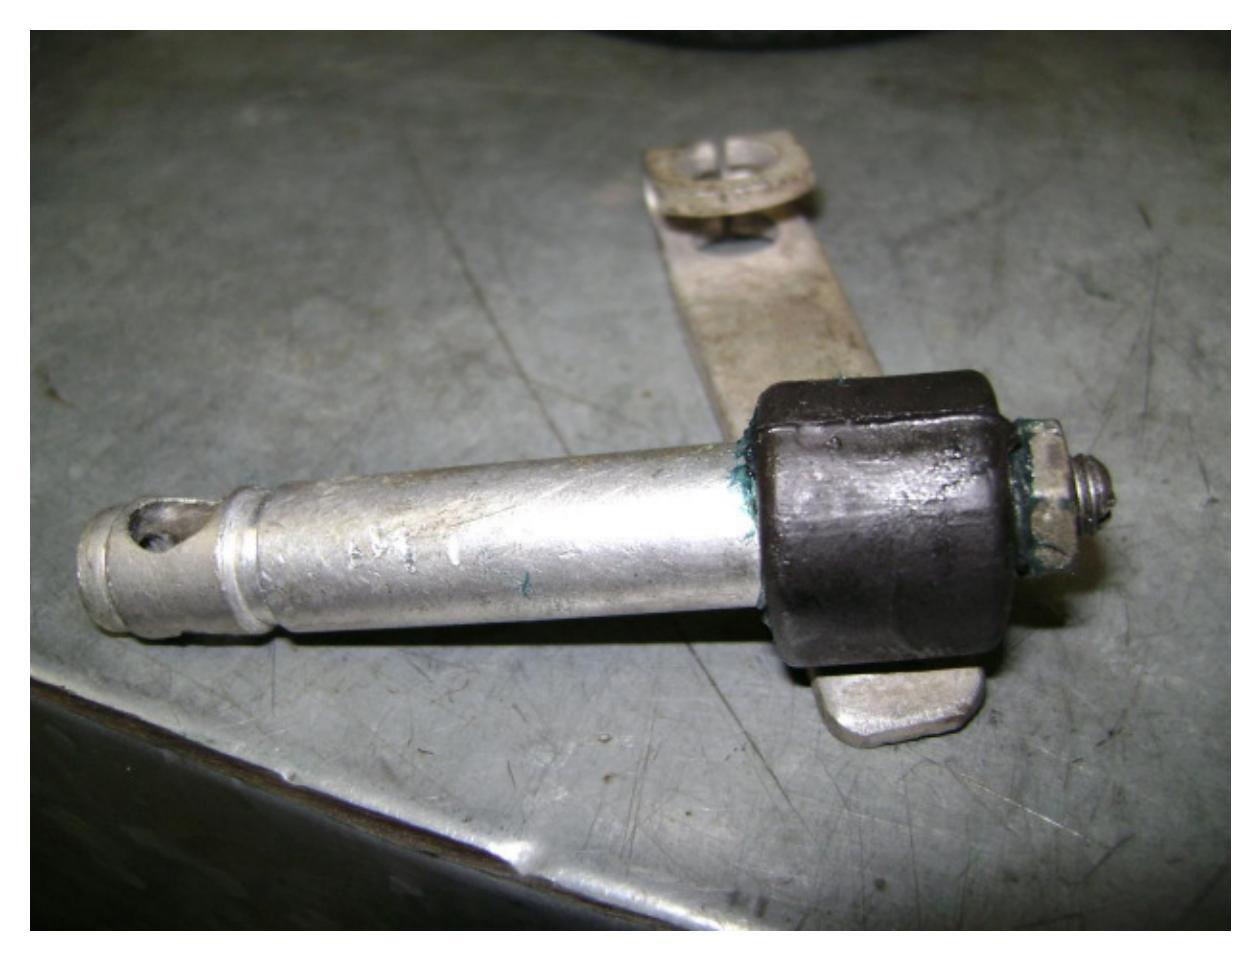
All together. A good check for tightness is that you should be able to swivel the main shaft around the joint. Before fitting the rubber boot clean it and give it a birthday with a good dose of ArmorAll inside and out.

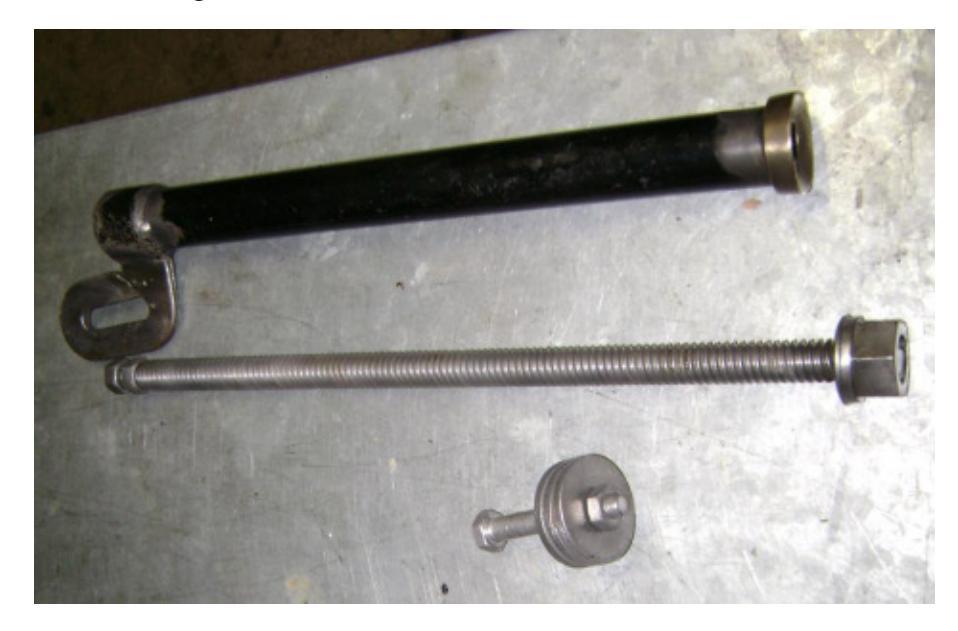
This is the business bit of the spare wheel carrier. It is supposed to be wound down during servicing and the thread wiped and greased. It is so easy to simply remove these bits, clean them lubricate and refit them. Simply undo the two nuts at the bottom of the threaded shaft and screw it up and the other bit down... The latter bolts straight to the carrier.

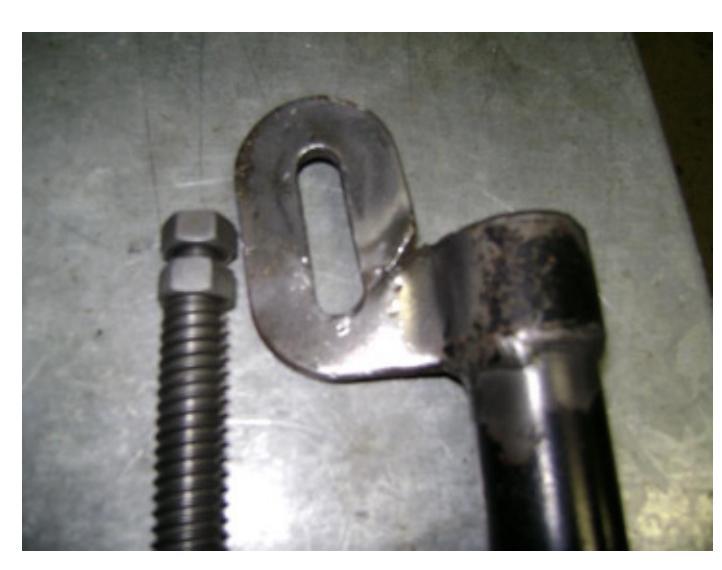
The straightened end of the screw mechanism seen here wearing a crack from its bashing was later welded. The slot allows the height of the carrier to be adjusted to ensure that when fully wound up the tyre is firmly squeezed to stop it moving.

The picture on the previous page probably justifies the stance of the wheel stowing politbureau if you notice the bottom of the winding

mechanism tied to the wheel carrier with some good electrical wire. I would guess this was brought about by a driver lunging up a steep driveway and forgetting that his bum would probably drag on the ground – in this case with considerable force.

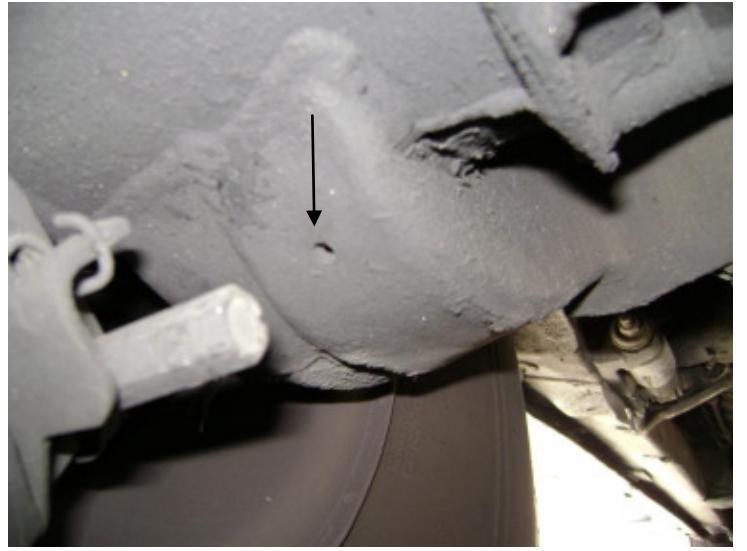
Those of you who are still awake will immediately notice the modification. No?? Observe the small hole drilled in the arm allowing the air inside to breath and hopefully minimise or prevent any condensation. The hole is about 3/16" in diameter. Sadly these sorts of modifications had to be done surreptitiously because in this day's litigious climate such news could well spark demands from customers that the arm be replaced on their car or better still the whole rear

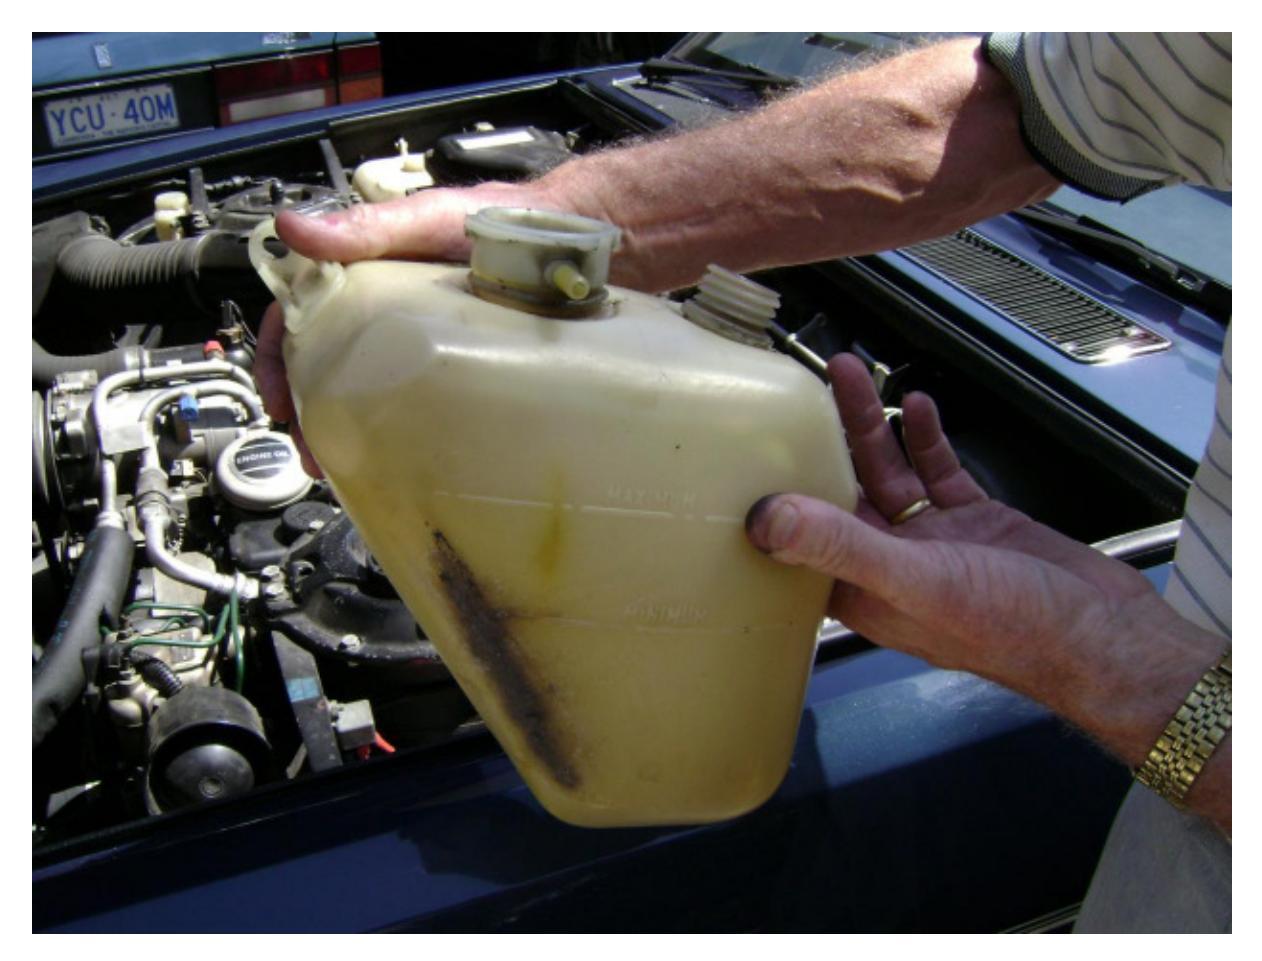
The bottle removed. The dirty mark was where the thing had sprung a leak. In fairness there had been some apparent abrasion from things unknown although there did appear to be moulding faults within the plastic. We did repair it with superglues and solid additives but given the hazard, a new one was later fitted.
