TEE ONE TOPICS

Number 19 November/December, 2002

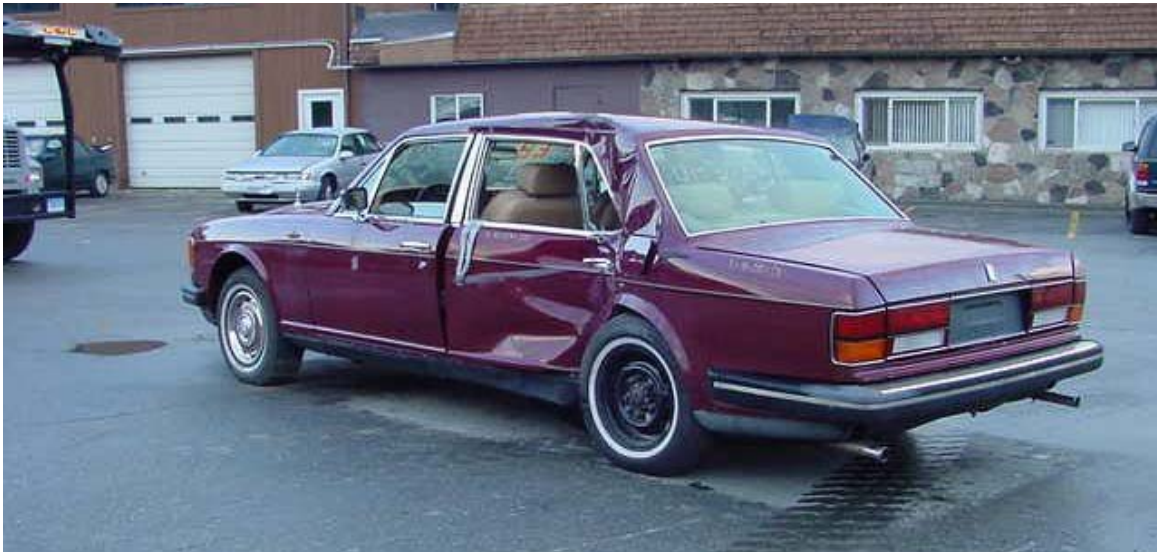
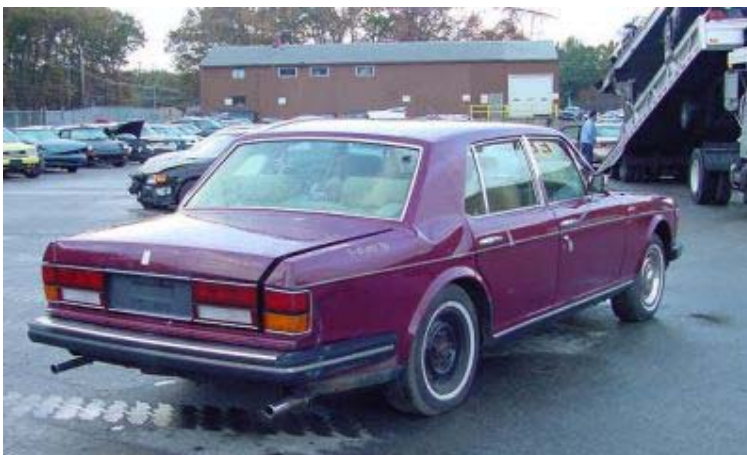
This poor specimen turned up on eBay. A left hand drive car apparently with a monumental smack in the left hand rear door. I thought it interesting to see the resistance the body put up to a side impact and the way the forces were transferred to the opposite side of the car. Presumably the occupants were able to exit the vehicle without difficulty – a credit to the design. Sadly, this vehicle is, as the Army says, BER (beyond

economical repair). There is a similar model in Queensland suffering a similar fate.

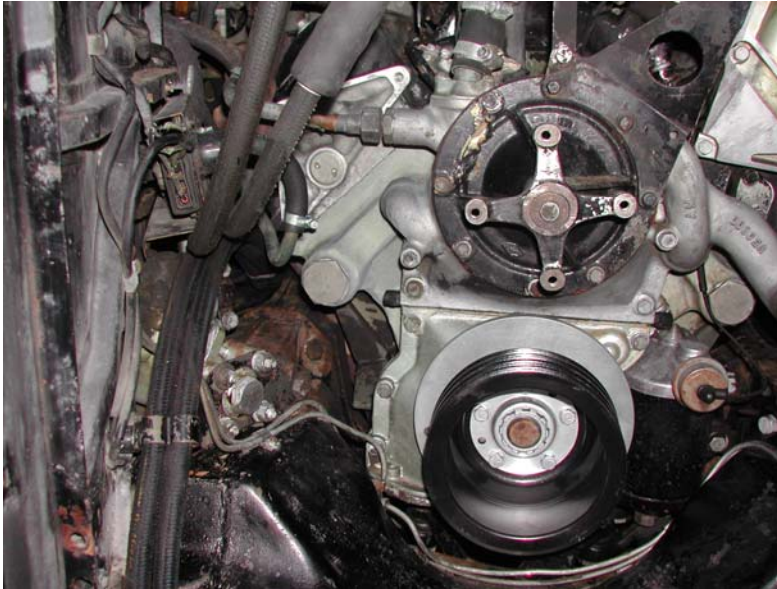
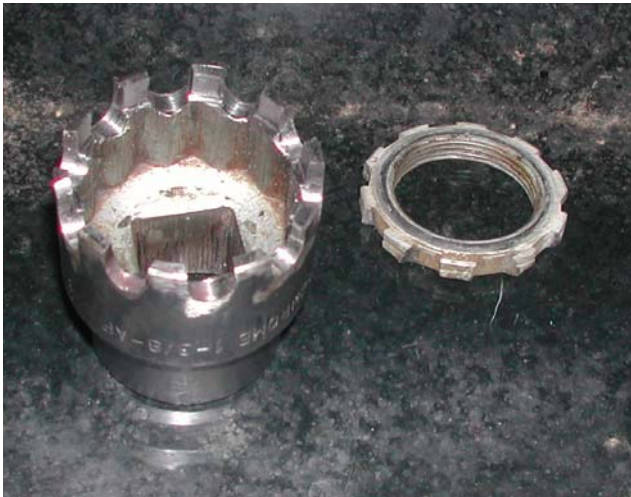
are required or extra precautions need to be taken to ensure that the things stay tight. The nut on the front of the vee eight crankshaft is a typical example. I had occasion to remove the radiator for repairs on this well-worn car and discovered that in fitting an extra pulley on the front to drive a strap on air-conditioner, the fitter had removed the lock plate shown below and jammed the additional pulley over the but in the hope that it would stop it turning. I suppose it did to some extent. The same gentleman must have

decided to give the nut a bit of an extra tighten judging by the belting presumably that the thing had suffered from a cold chisel. One

wonders which planet these people learnt their trade. Anyway the nut had worked loose comparatively. A close look at the picture and you will realise that the lock plate largely determines the tension in the nut since in the end the bolt holes for the pulley have to line up with the plate. The factory specifies 90 foot pounds torque on the nut but allows you to exceed that to get the plate lined up with a maximum torque loading of 150 foot pounds.

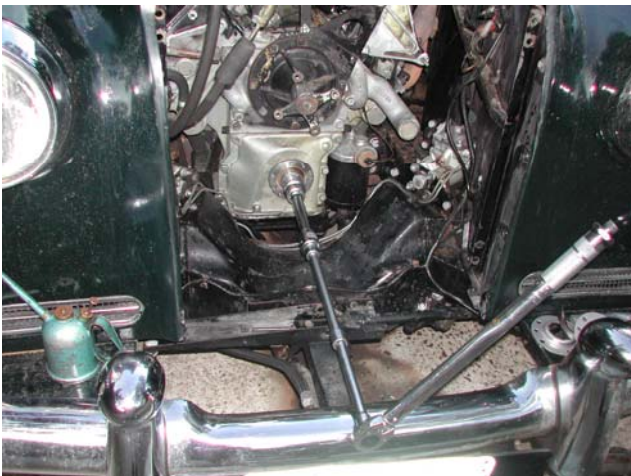
And here is the nut. Undoubtedly the factory provides a tool for the purpose which of course is not available to mere mortals. My solution is besides the nut in the picture. My fitter man George somewhat reluctantly depreciated one of his valuable milling tools to groove up a standard socket and the finished product worked very well. If it had been necessary to tighten the nut even further, the solution would be to rub down the back of the nut to reduce its dimension.

And finally this is the tightening in action. The other way to tighten/loosen these nuts is to use a 'C' spanner but then there is no way to measure the applied torque.

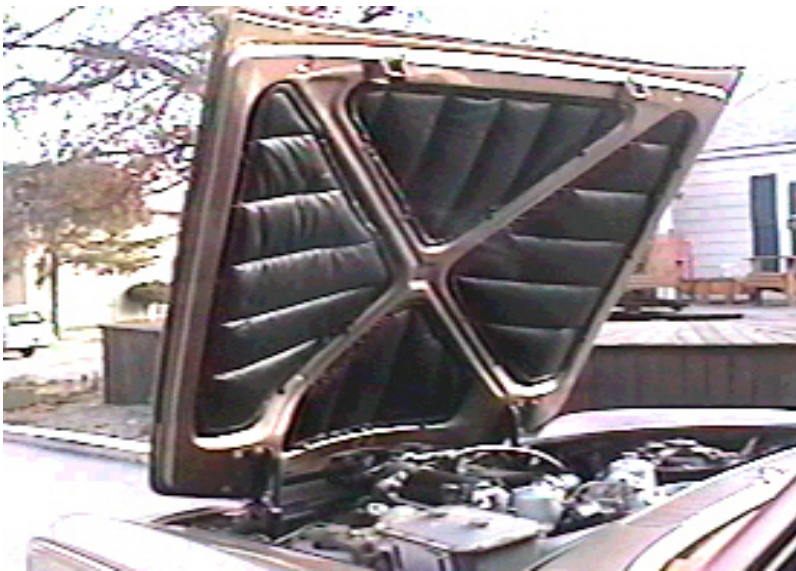
These pads are made very much like an original set only better, using the same style welded steel wire frame and attachment loops. Original under hood pads used fibreglass insulation similar to household insulation and were upholstered with canvas (Duck) fabric. These new style after-market pads have been upgraded using Tekfoil® insulation with a Dacron® wrap. The pads are upholstered (front & back) with # 9005 Black Arctic® Vinyl. Arctic® is a name brand top grade quality heavy weight expanded vinyl. Arctic® Vinyl meets Motor Vehicle Safety Standard #302, California Fire code bulletin #117 Sections E & F, rated at -30 degrees F. Cold Crack, rated @ 40 Ounces Per Linear Yard and has a 100% Polyester Knit Backing.

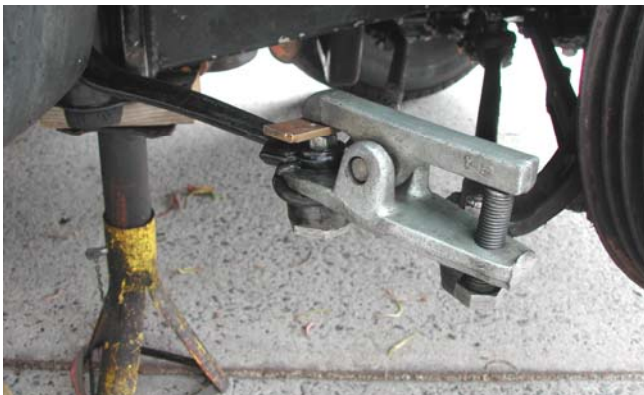
First up disconnect the steering lever from the pitman arm using a tie rod end splitter.

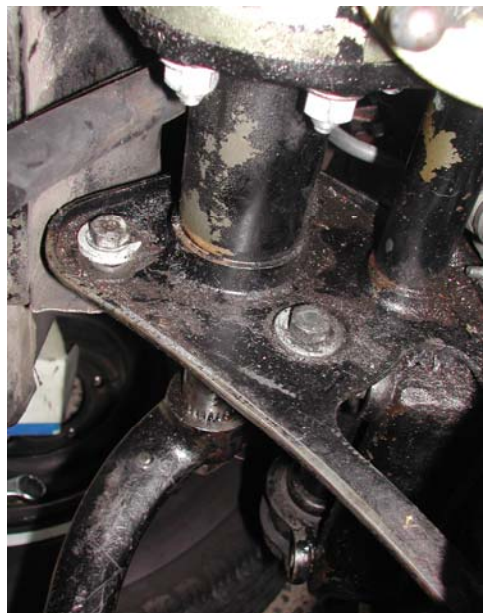
And two of the three bolts seen from above

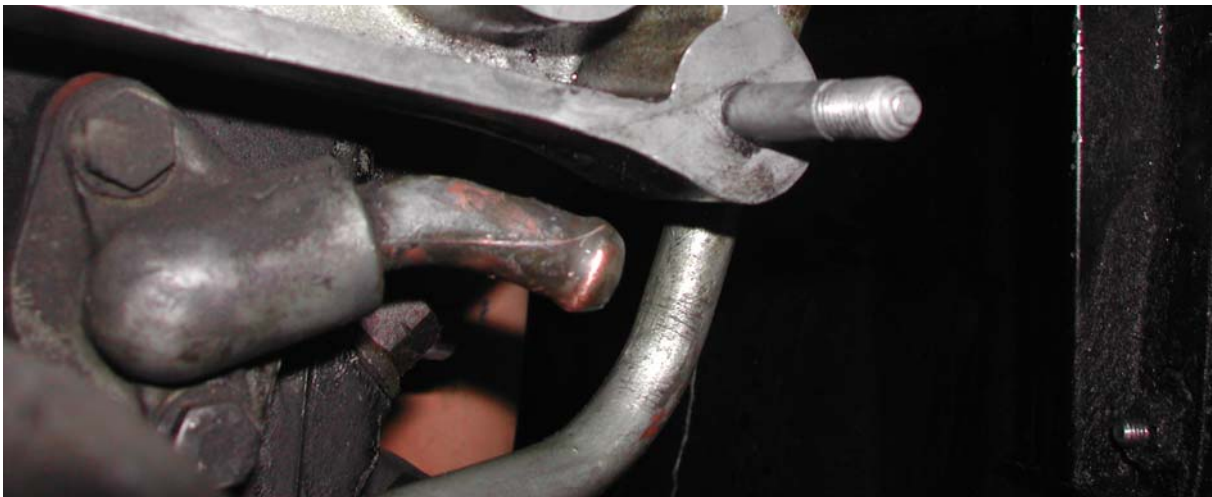
We all know that the main heating supply comes from the back of the 'A' bank (right hand) head. But the Cloud three needed a separate supply for its upper system and this is where it comes from. This little pipe is cunningly concealed under a projection at the front of the 'B' bank head right behind the power steering pump. The other pipe in the picture wanders across the engine under the water pump and with yet more rubber connections delivers water to the upper heat exchanger under the right hand mudguard.

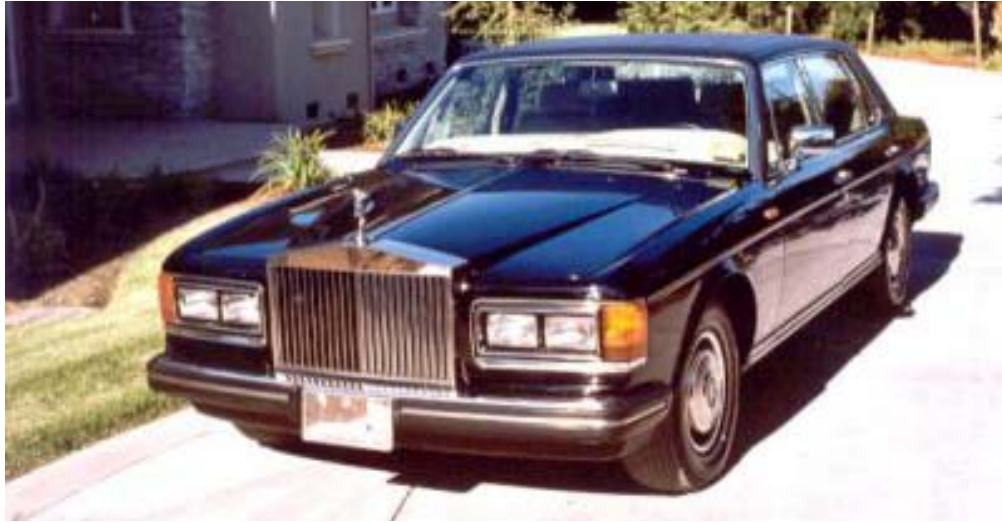
Nothing remarkable here other than a left hand drive version of the Silver Spirit. But why are the headlights different? This nonsense has been going on since before WWII. Even the hallowed P100's fitted to Silver Wraiths and Phantom IV's suffered the anomaly of having sealed beams shoved into them to meet American standards. Apparently it all dates back to the pre-War flapper days, Gatsby and all that when a popular sport was using externally mounted spot lights plus manoeuvrable headlights to blind oncoming drivers. Presumably the idea was to stop the oncoming fellow until you passed. Unfortunately many oncoming drivers tried to keep going and finished up very dead in the ditch. This was so serious that Congress actually passed Bills specifying the lighting allowed on vehicles and those restrictions apply to this day. The main requirement seems to be the requirement for sealed beams. Semi-sealed units of course allow the driver to slip larger globes into them.

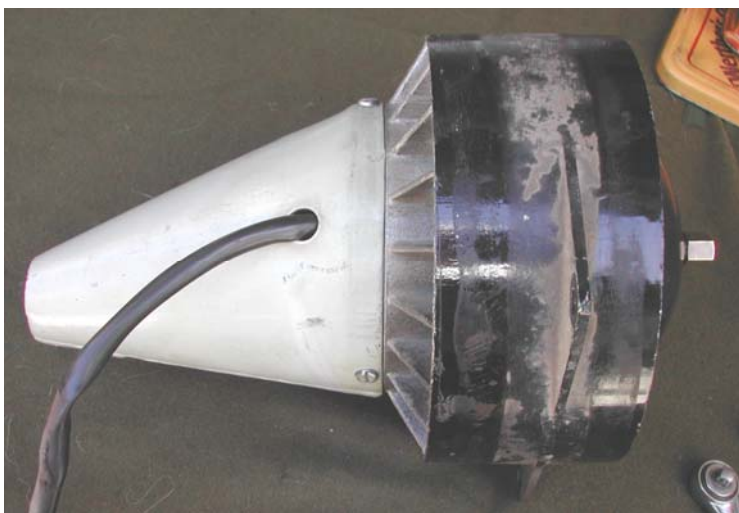
Here is an early picture of the S2 ducts and fan. The large vertical opening plugs into a hole under the right hand side of the driver's seat and sucks air out of the car pushes it through the heater/air conditioner matrices and into the big distribution tube that runs across the car behind the bulkhead.

system is switched to high speed the resultant noise emulates a 747 at idle! This must have driven the designers crazy to the point that they changed the exhaust arrangements for the fan with a cone – a design used I note on some jet engines. I imagine the theory is that the semi compressed air comes together gradually after the fan and as a result is quieter.
