TEE ONE TOPICS

Number 31 January 2004

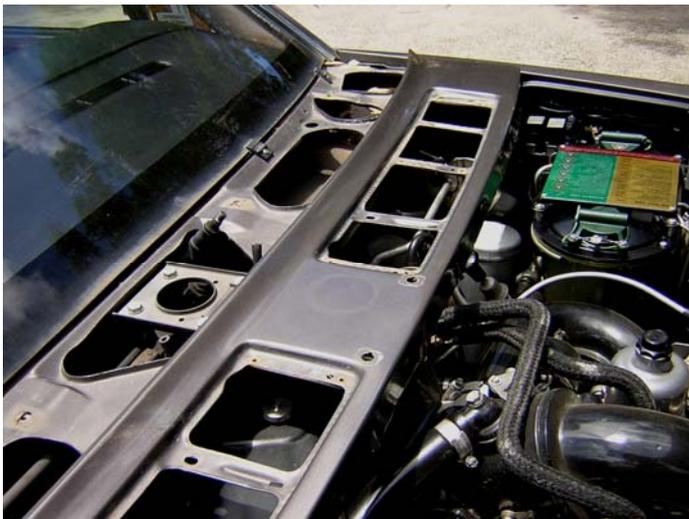
The scuttle panel unscrewed and unbolted and slid forward. Note the mysterious circle in the middle! Note also the holes for the windscreen washers. These plastic nozzles have nice little mounting gaskets under them which disintegrate on removal. Just under a hundred dollars for a pair of nozzles with gaskets - the latter can't be purchased separately. Seems the Toyota Cressida employs an almost identical fitting.

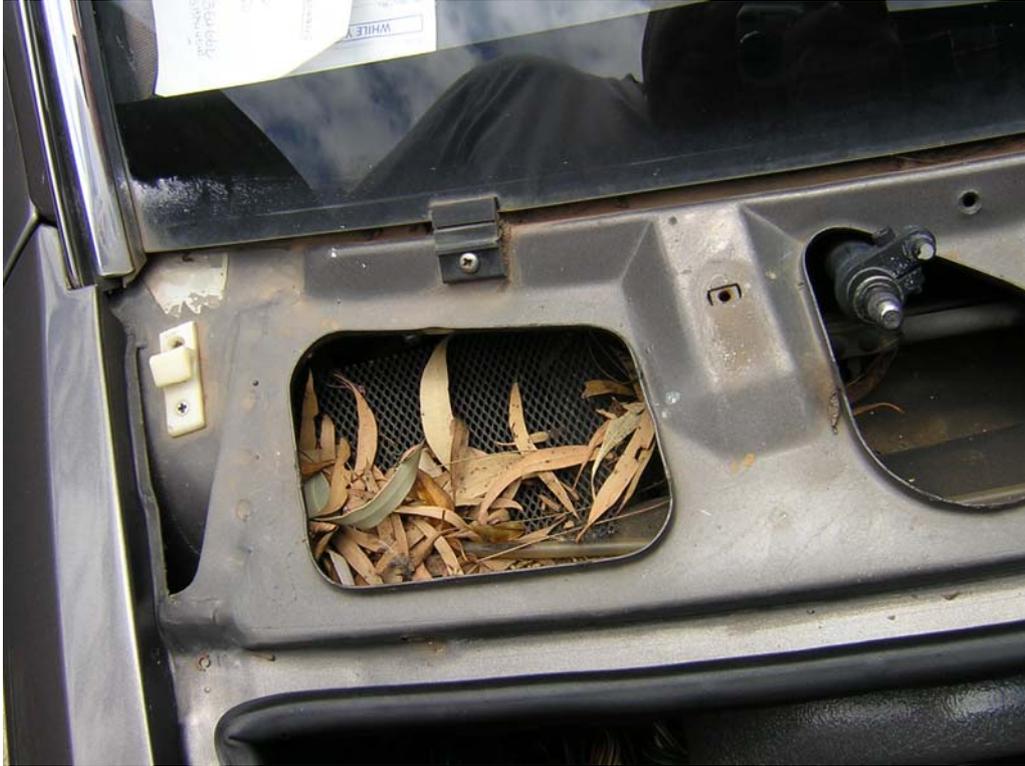
Giving up the investigation, I decided to remove the branded panel and prevail on the repair man to throw some paint over it when he is restoring the rest of the car. Off came the filters and retaining panels and then the wiper arms. On a Spirit they have to be actually removed with

a puller! No problem they popped off and then off came the panel. Quite a shock. The air for the ventilation system goes through the filter panel at the centre of the scuttle but then rushes out towards the outsides of the car and through yet another coarse mesh filter into the whirling fans. The pictures tell the story. This car arrived in Canberra with worn (?) filters but they were still there in some form and I replaced them on the spot. Since then they have been changed religiously. The point being it doesn't take long to crud up the system. It also points up the desirability of cleaning the area under the scuttle panel anyway to see what is there.! When you do remove it, be sure to collect the plastic spacers behind the fixing screws!

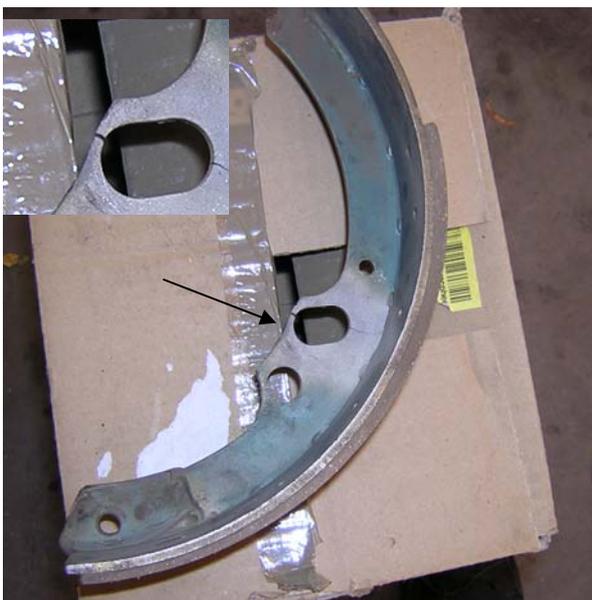
A Cloud III brake shoe with a fractured web (see inset). The friction device hovers around this elongated hole.

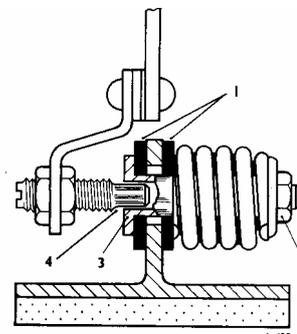
A simple arrangement. The washers (1) are squeezed either side of the shoe web by the pressure of the spring

efficient through lack of use and a build up of crud. The result was a brake shoe pressed very firmly on the drum and suddenly you have a mysterious scent of hot brake lining. The other extreme is for you to lubricate the devices thereby allowing the shoes to pull much further back. Given the capacity of the master cylinders, applying the brakes simply moved the shoes part of the way towards the drums and quite probably no contact was made at all.

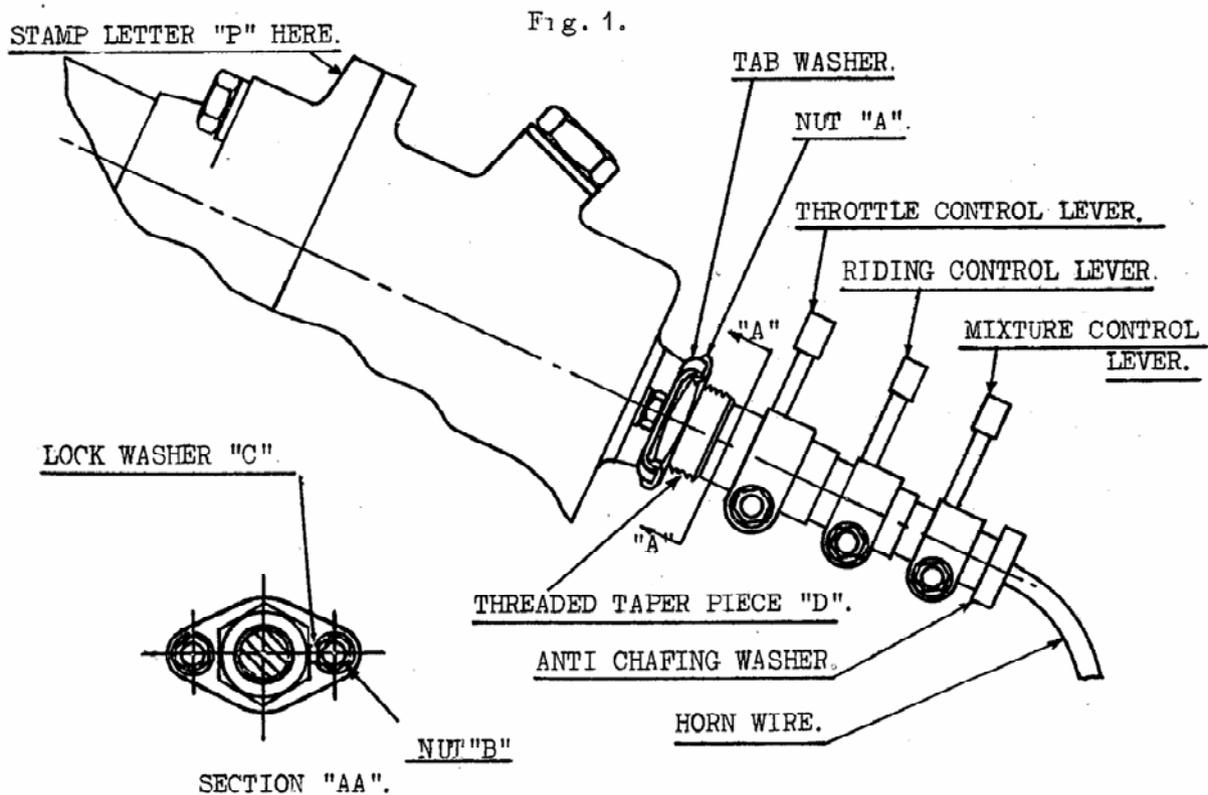
PROCEDURE .(Refer to diagram)

Loosen the tab washer and remove nut 'A' from the threaded taper piece 'D'.

Remove the near-side nut 'B' and its lock washer.

Temporarily fit the nut 'A' back onto the threaded taper piece three or four threads and give it a few sharp taps towards the steering box to loosen the threaded taper piece from its seating, after which the nut can be removed and slipped downwards over the tubes. A receptacle should be placed at the bottom of the steering box to catch the oil that will be lost during the next

The centre assembly of the steering wheel boss is now free to be pulled out of the steering column 11 to 2 inches, sufficient to allow removal of the three bolts from the underside and thus separate the horn push button and the cover from the lower half of the assembly. From the horn push button unit tap out the taper pin W and remove the contact nut 'J' and the brass washer 'G'. The push button and its contact pillar 'F' is now free to be removed from its cover.

Tap out the taper pin 'E' from the contact pillar and unscrew the pillar from the button. This contact pillar, with holes drilled through both its threaded portions, and the taper pin 'E' can be discarded.

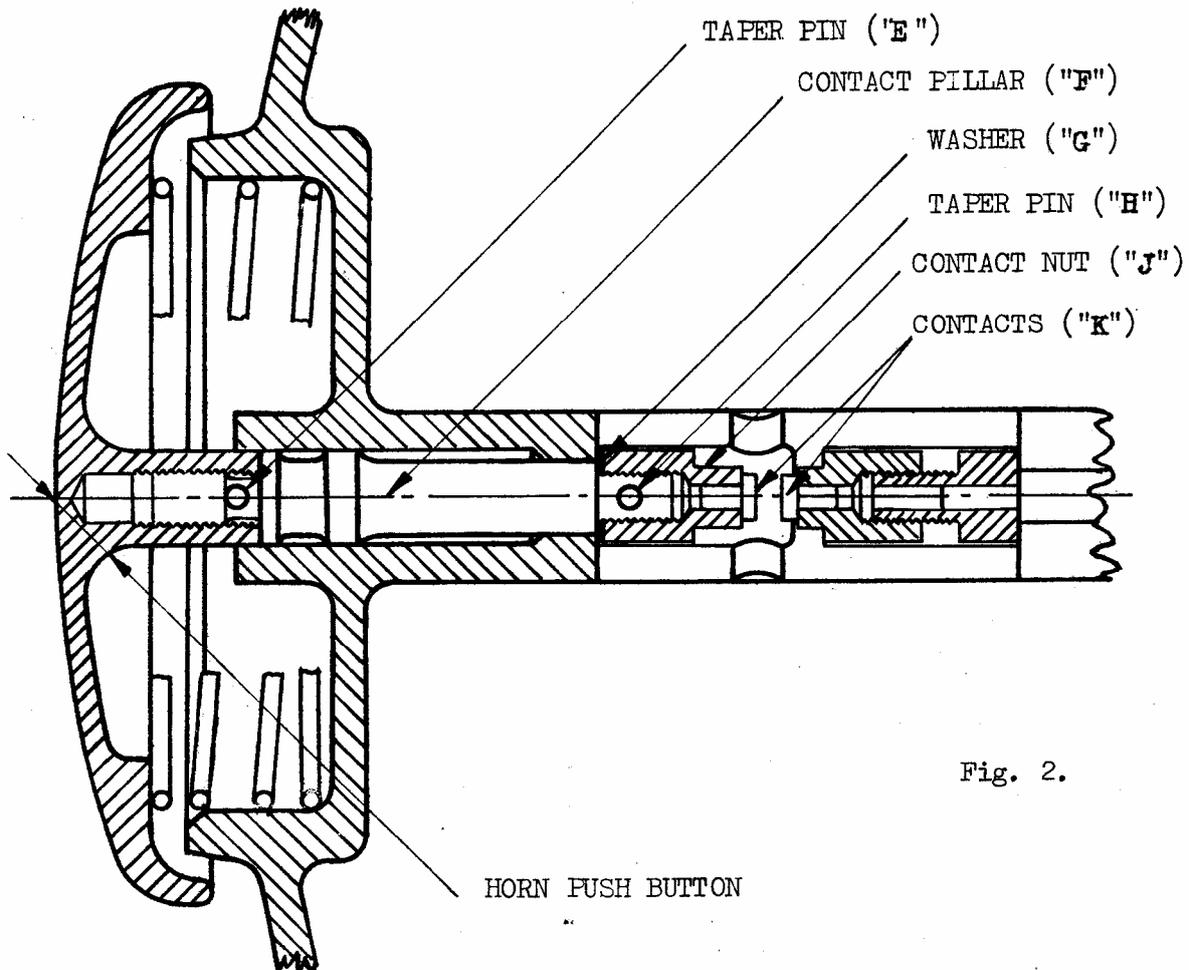
Fig. 2.

A new contact pillar, with its top threaded portion tinned with solder is screwed and sweated into the push button. (Note that this was the modification).

The amount of this travel is regulated by the thickness of the brass washer 'G', If the horn sounds before the button nips the feelers, the brass washer requires reducing in thickness, but if a greater travel than .04011 is obtained before the horn sounds, then a thicker washer is required.

When the correct amount of travel is obtained, the contact pillar is drilled through the existing holes of the contact nut 'J' and the taper pin 'H' fitted. The unit may now be finally refitted in the steering wheel hub.

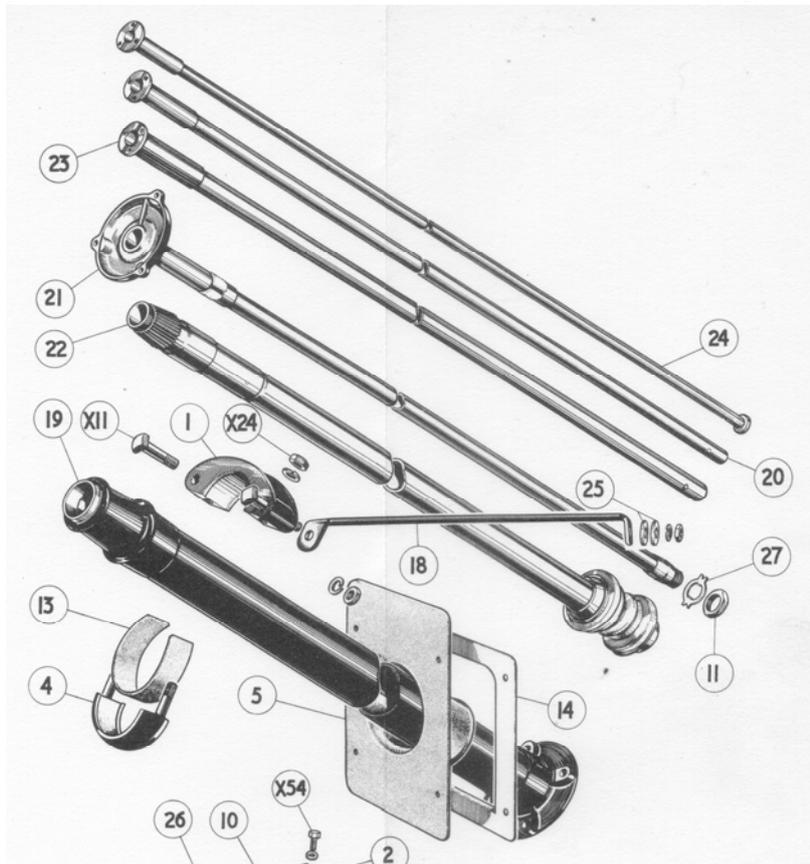
On the underside of the steering wheel you will find a large hole, turn the wheel around until this is at the top and with a pencil beam and possibly a mirror peer down the hole. You should be able to see the brass casting (Item 21 in the picture alongside) that is mounted on the outer stationary tube. On the periphery of the casting is a hole into which you can introduce your lubricant which all going to plan will work itself down between the three tubes. The controls should be light to turn; if not they are dry or gunked up.

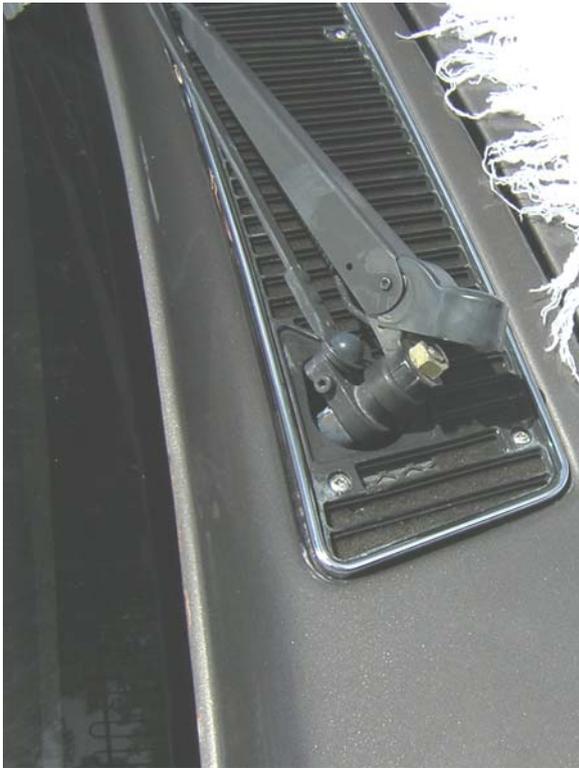
Although it is not necessary to remove the wiper arms to refit the scuttle vent elements, should you need to get the arms off this is step one – uncovering the securing nut. The plastic cover seen here pulled up and away from the driving

shaft, simply slides over the nut and into the base of the arm. The auxiliary arm simply clips off a domed peg. The main arm needs to be removed with a small puller seen in the lower photograph and readily procured in any decent tool shop.

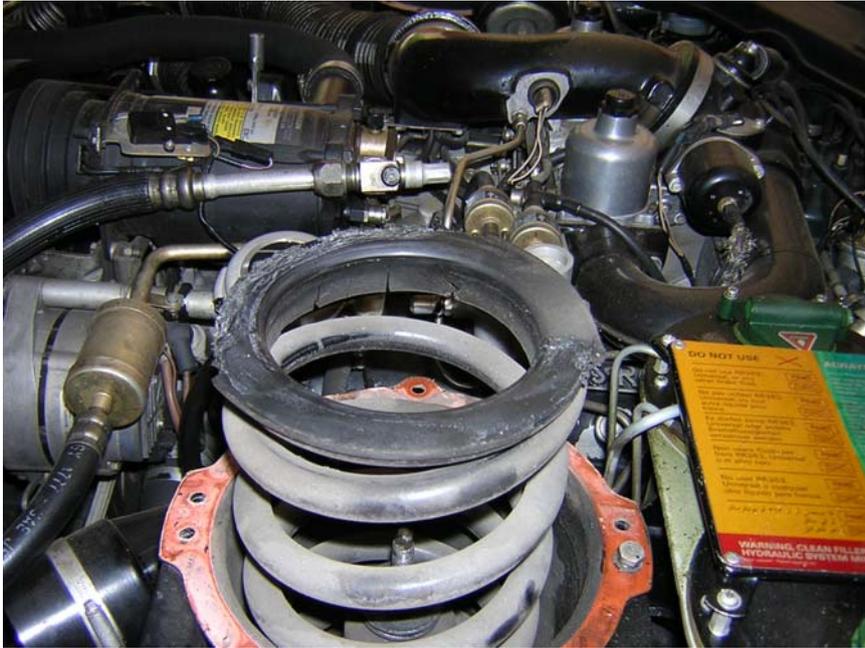
☞ The spring with the tower cap removed. Note the insulator on the top of the spring which along with its mates was badly chewed up. Note the shock absorber hiding down in the spring. Later and indeed current production shock absorbers have a very limited travel since they also perform the task of limiting downward travel of the suspension and avoiding smashing the sub frame. Note also the gasket on the top of the tower which provides

some noise insulation between the body and the upper spring seat.

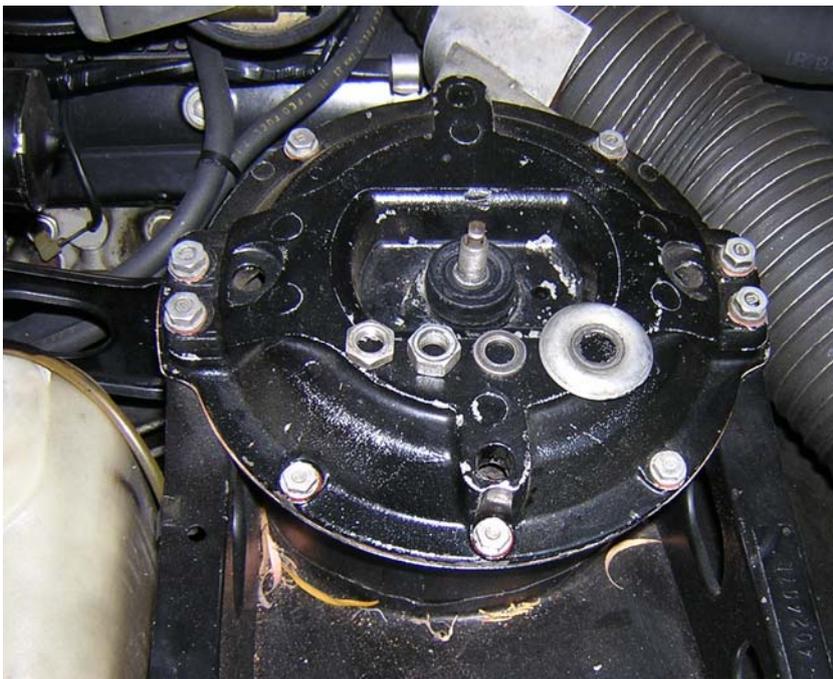
☞ Getting the tower ready for removal. Note the rubber mount around the shock absorber shaft and the spacer separating the top and bottom retaining washers. It was this rubber mount that expired and allowed the tower damage.

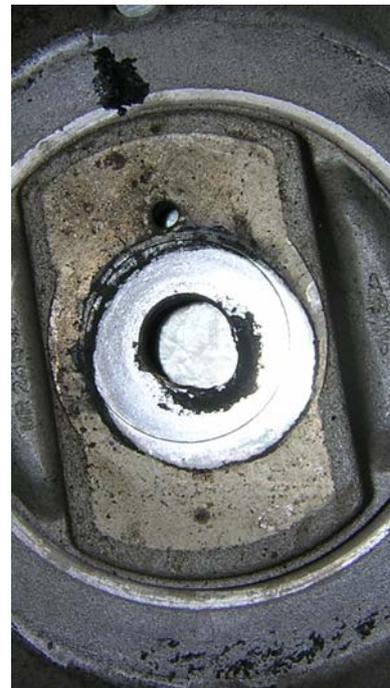
At right viewed from below is a view of the elongated tower hole. This is one problem you can check on safely and simply. **DO NOT OF COURSE ATTEMPT TO REMOVE THE TOP OF THE TOWER.** But you can undo the top nuts of the shock absorber and remove the washers. Place a close fitting piece of pipe or a tube spanner over the shock absorber shaft and try and wiggle it sideways. There should be little movement. If there is you should be able to gouge the top rubber free and replace it. The difficulty is keeping the shock absorber shaft vertical and central to the tower hole.

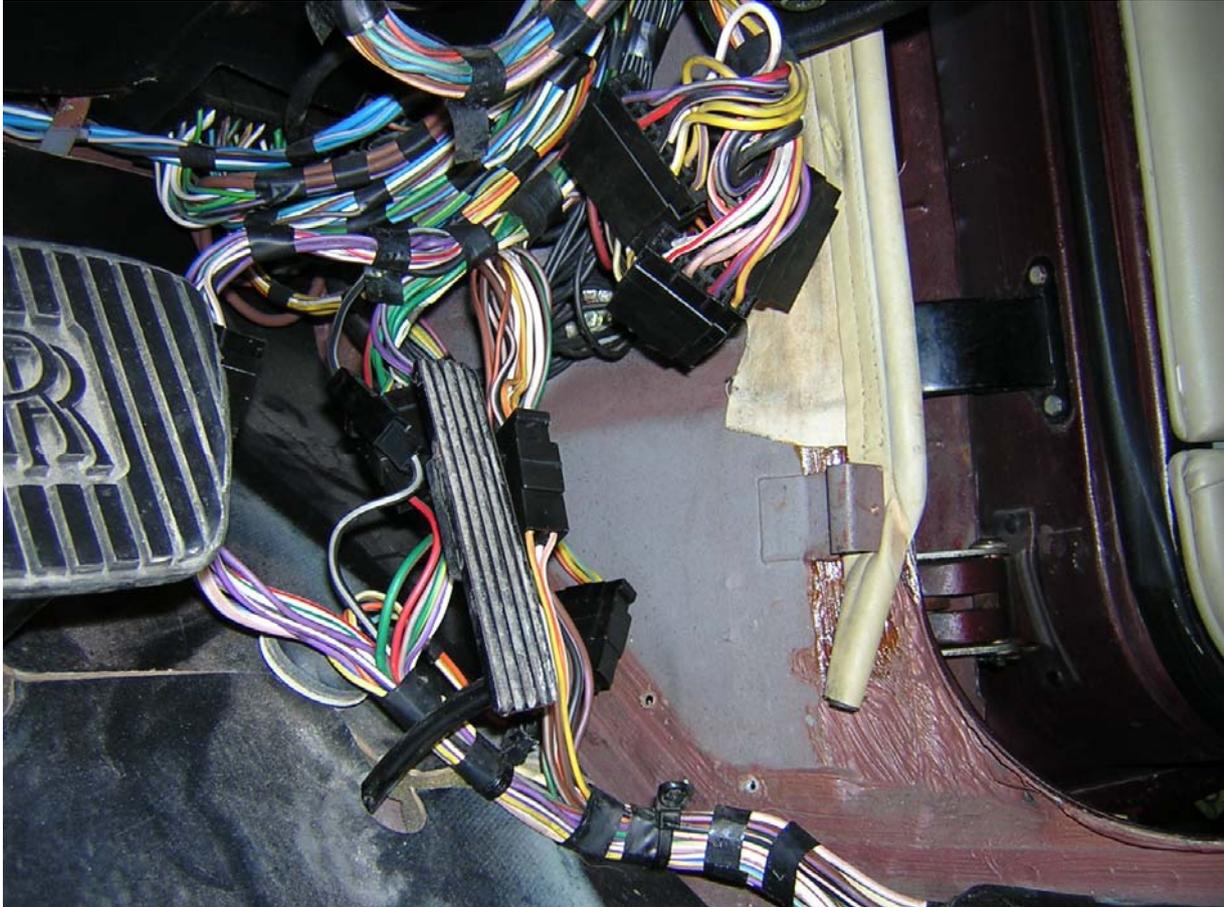
The little jigsaw puzzle below feeds the electrics down the right hand side of the car including the electric window lifts in both doors. The conduit carrying the wiring for the remote locking system and the window motors pokes into the 'A' pillar. The wires then emerge through a grommetted hole behind the wiring entanglement seen below. In chasing slow or inoperative windows cleaning the various loom plugs is a must as detailed in the previous issue.

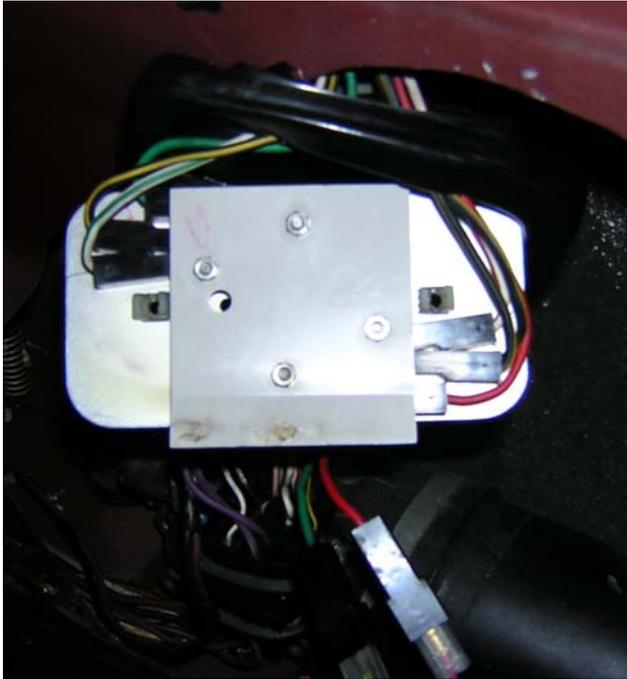
The drivers door switch at left uses eight micro switches partially interconnected by busbars. It should be protected at the rear by a rubber boot from water that inevitably gets inside the door through the windows.

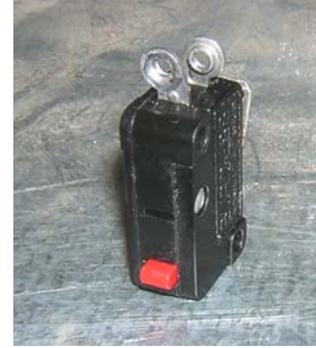
On the next page is one of the other door switches. Each has two micro switches which are readily available at electrical

wholesalers. The micro switch pictured however appear to be a Rolls-Royce special having screwed terminals rather than the standard push on Lucar fittings. These are used only in the

drivers door switch assembly. Both versions of switch are riveted shut. Switch faults can be quite elusive. The plunger seems to click in and out according to requirements but putting a multimeter across the terminals often shows that sometimes contact is made and sometimes not. Checking window function should start at the motor. The two wires entering the unit are both alive and movement is achieved by earthing one of them. This is the function of the switches. Most problems are dodgy switches or poor earths.

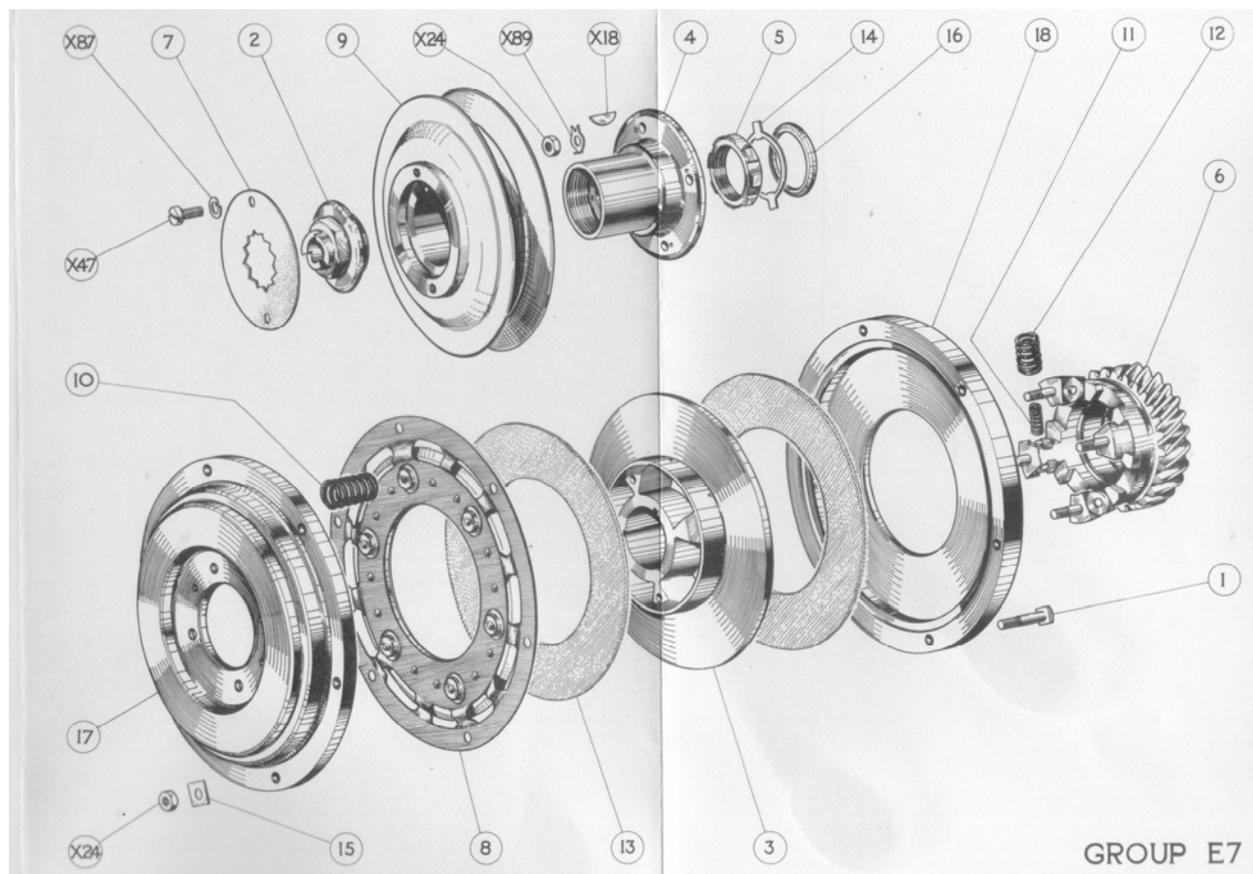
And for those of you who do not live and breath crankshaft dampers, here is an exploded view of the gadget. The infamous duck washers are shown here as item 13 – one either side of the driving plate – item 3.

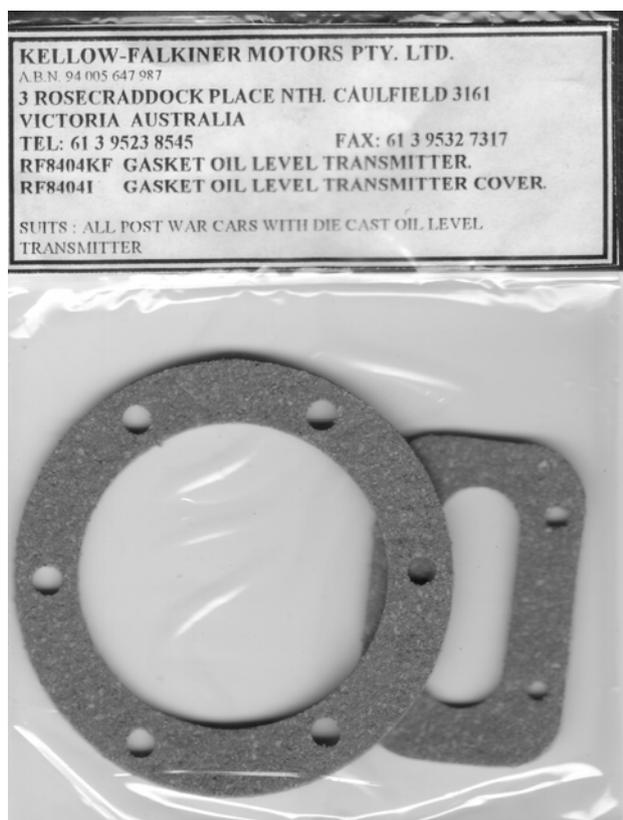
Last issue we were talking about sump level units and sealing the contents of the engine inside and not dribbling them outside. Peter Shellard of Kellow-Falkiner Motors sent me an anonymous pack pictured here. Eventually I got the message – he has the seal kit and here it is including the outer cover gasket which as far as I know is not available from the Factory.
