# TEE ONE TOPICS

Number 44 June, 2005

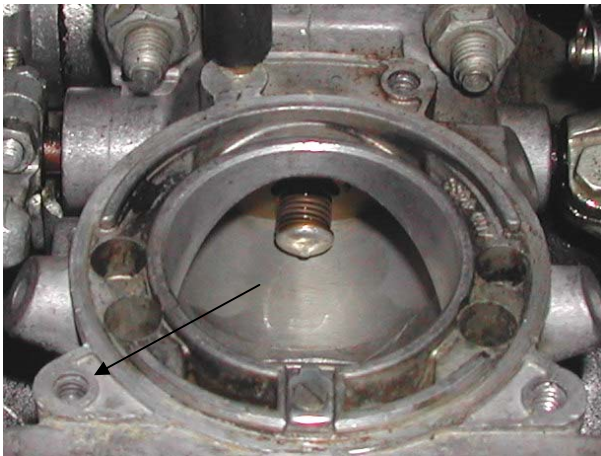
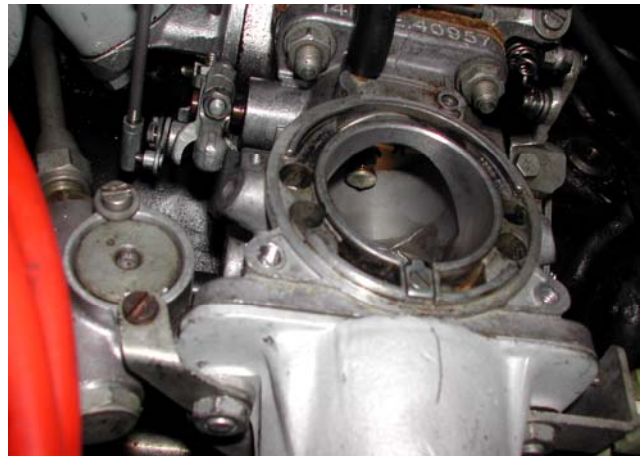
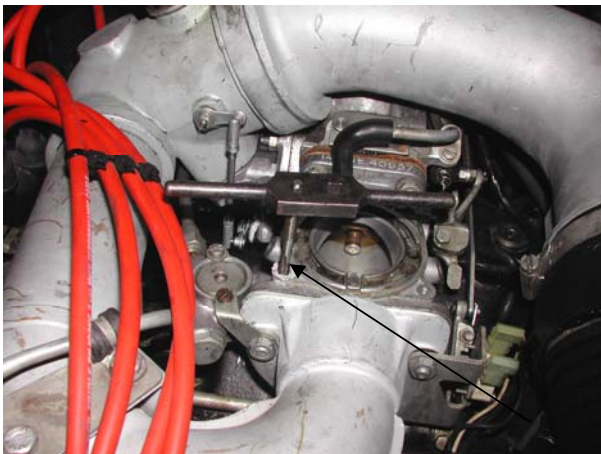
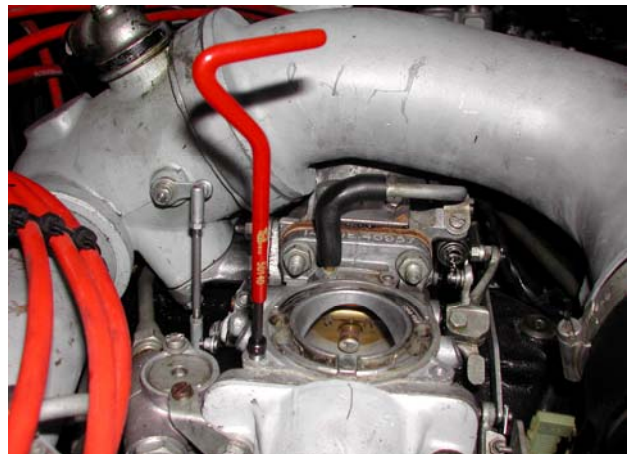
This is not an unusual story but when it happens to you it is momentarily the end of the world. The pictures below show one of the SU carburettors on a Bentley T2. As you always do you periodically pull off the dome bit and clean inside it and the piston and the bit that it slides in. Then you carefully reassemble the whole lot absolutely clean and dry and do up the screws. But in this case the screw in the third hole went in and screwed and screwed and screwed. Bugger as the ad says. The previous operator determined that a nuclear explosion was going to blow the top off the carburetter and tightened it accordingly. Perhaps he was trying to see how tight he could actually make it and bingo most of the thread was dragged off that fairly soft composition metal these assemblies are cast in.

So here on the upper left we have the casualty hole at lower left of the photograph. The pic below it shows how to run a special tap which is provided with the kit from Helicoil in order to screw in the replacement thread! Bottom right is the tool with the new thread coil being screwed in and above that the finished product.

Get a new carburettor! Not bloody likely, the manufacturers sadly are running down apparently because not many cars run SU's these days. The Factory has stocks no doubt but at the cost of some 3 arms and a left foot. Best you fix the thread eh! The first thing to do is find out what thread it is. For many of us, this is like trying to find the IQ of the third girl (or lad) at the first checkout counter at the local supermarket. The model of the car (as in year) will help but otherwise take the screw or bolt to your nearest machinist, fitter and turner or bolts and nuts shop and ask them to tell you. Then you will find for instance in the SU problem that it is a 3/16" Whitworth thread. So again to a suitable store in your location and buy a thread form kit. In Australia this is manufactured as Helicoil and used in every aluminium blocked engine ever made by Rolls-Royce!

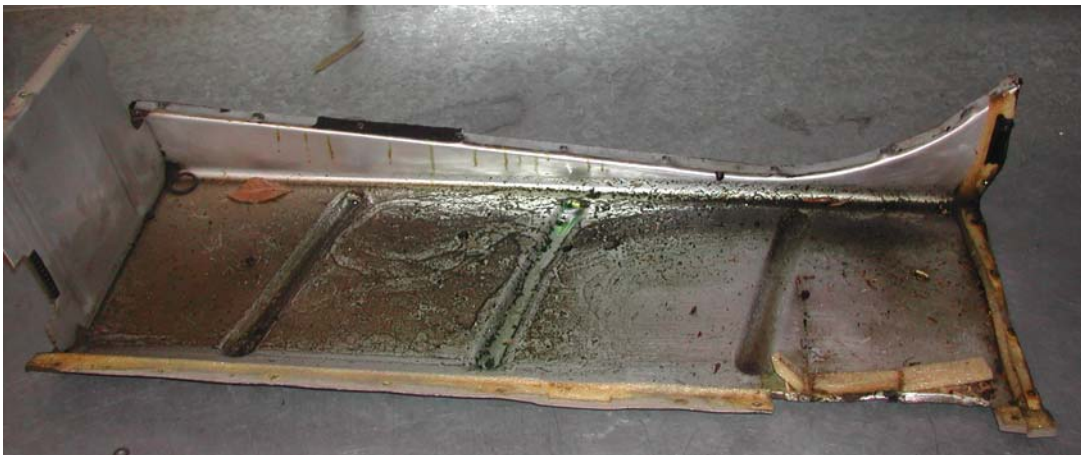
Pressed in aluminium and sealed around the edges with simple draft proof adhesive sponge foam tape, the cover is seldom a problem but it does get dirty. The valves which actually apply the brakes do not have seals on them and always drop a minute bit of fluid which collects on the tray. Cleaning is not essential but it does cut down one of the sources of 'old car' smell from the vehicle. And the same approach should be applied to pre-Shadow cars with their under trays for the same reason.

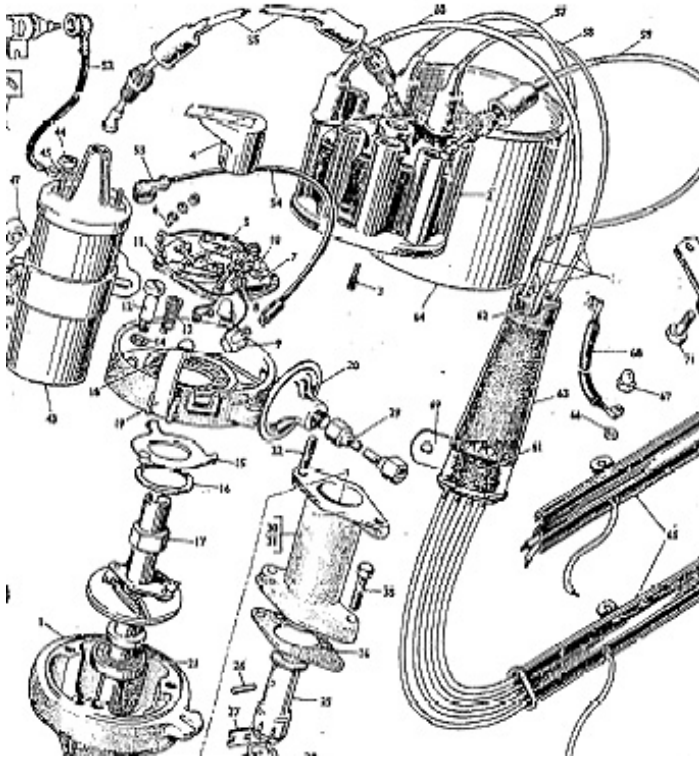
It is very easy to ignore the condition of these leads in any car. They are of course vital to the running of the engine. In the good old days they were made of a heavy copper core in good heavy insulation. These unfortunately tended to radiate some electronic emissions that other components and passing gadgets did not appreciate. And so it is actually illegal to use this stuff anymore. The newer material is apparently a vast improvement in function and causes no problems. It does however require a special terminating tool which if you were only doing your own car would be difficult to amortize. The suggested approach is to remove the leads from the distributor cap, unbolt the two brackets from the rear of the cylinder heads that hold the 'funnels' that carry them around the back of the engine and unbolt the carriers that run across the top of the tappet covers. Pull the leads

The carriers across the tappet covers when turned over will reveal their secret as to how the wires are threaded. The cylinder head holding brackets can be removed. What you have left you send to an appropriate tuning shop and they will make up new leads properly threaded through the 'funnels'.

Note that the 'funnels' consist of three mouldings items 61, 62 and 63 in the spares drawing and all of these are available. Understand that these are not decorative but very functional in that they stop chafing and cross-inductance. When you give them to your man insist that he put numbered collars on the leads (A1 B1 A2 B2 etc) above the funnels since they need to be seen over the distributor cap. You might also consider giving your car a present of a new distributor cap and rotor.

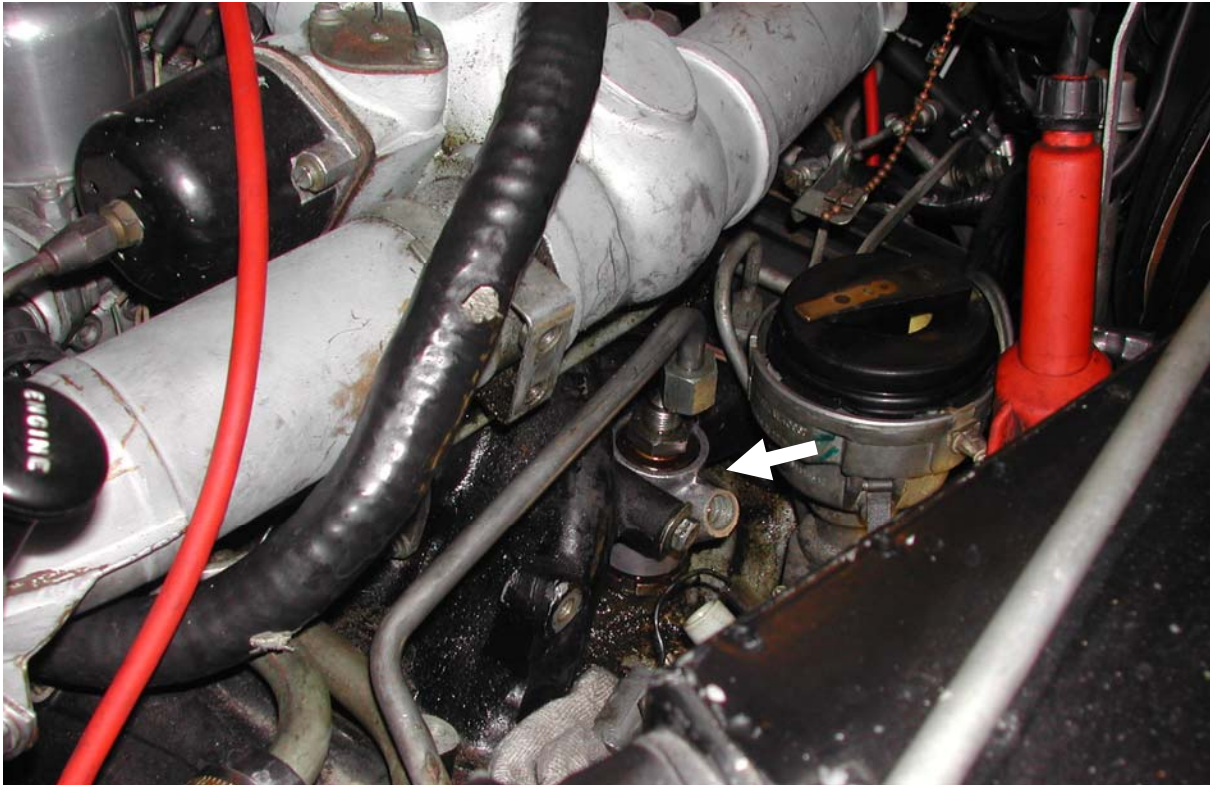
We hear them clicking away but pay them little attention. As you can see by the above they are fairly well hidden. Fed by gravity from the hydraulic reservoir they are capable of pushing the accumulators up to at least 2800 psi and then some. They are 'pushed' by an exclusive cam on the camshaft are beautifully machined, only stop working when the engine is switched off and apart from the occasional external leak and being crudded up rarely give any trouble.

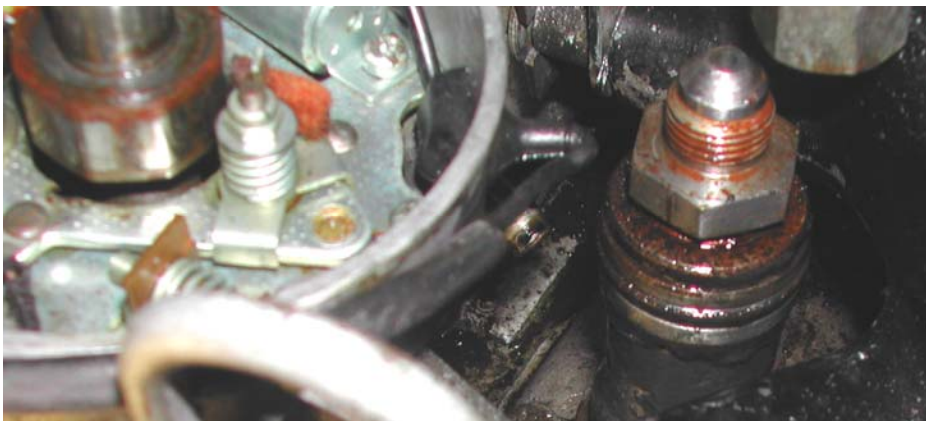
At the picture above you are looking down to the rear of the engine of a T2 engine. To the left of the distributor is the pump (arrowed). The angled pipe above it is the line, here disconnected, to the accumulators down the side of the

engine. The threaded hole on the side of the pump is the entry point for brake fluid from the reservoir. The large black pipe sweeping from left to the top is the engine breather.

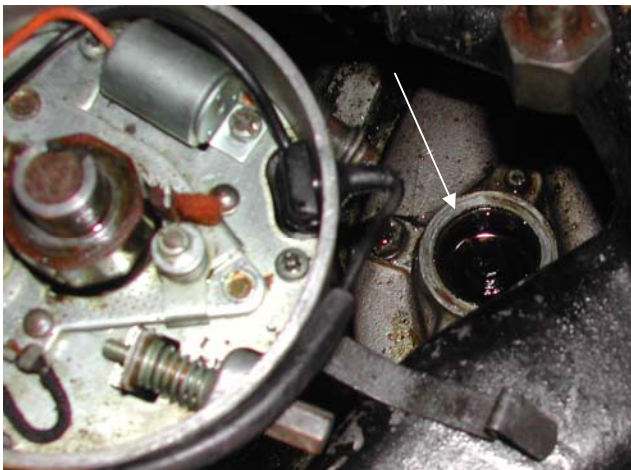
A good view of the gunk on the pump now removed and the 'O' rings (arrowed) that contain the brake fluid in the outer casing of the pump. This stuff is thought to be generated by mixing RR363 with conventional brake fluid. The two 'O' rings contain the fluid around the pump and seal the outer casing. These definitely fail and it is usually the rear pump that has the most problem since that is subjected to

the most heat. Apart from the mysterious loss of brake fluid from one reservoir the clue to a leaking pump is a nice puddle of oil below the rear of the engine.

Changing the 'O' rings is really quite simple, the only special tool needed is a pair of circlip pliers to undo the top. First clamp off the respective low pressure feed pipe to the pump and exhaust the accumulators by pumping the brake pedal until the lights come on then some. The high pressure pipe on the adapter outlet at the top of the pump is released as with the low pressure feed pipe that angles into the side of the pump casing. Off with the circlip and the casing can be prised upwards and lifted off the pump body.

Remove the lower 'O' ring first and roll it off the pump then the upper one. Clean every thing and using some fresh brake fluid fit the top 'O' ring followed by the bottom one. Before you slide the lubricated body back on replace the small 'O' ring in the feed aperture. Put it all back together and when you have just started the thread on the low pressure nipple, release the clamp on the feed line. You should have a good healthy drip around the pump while you screw the supply line back on. This overcomes an oft occurring problem of the line getting an air block in it.

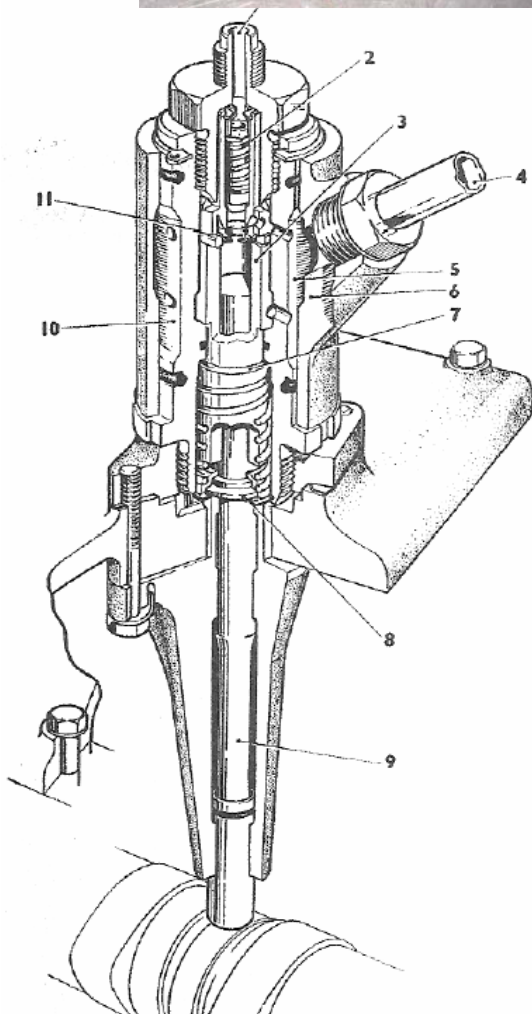
Here we have a general sectioned view of the pump installed on the engine. The drawing is actually of a very early setup as the 'guide' for the push rod and cam follower was changed in the early seventies to a much more open fitting allowing the general climate of oil to get at the working bits unlike the design shown here.

| 1 Adaptor and outlet port | 6 Pump housing—outer |
| 2 Non-return valve and spring | 7 Plunger spring |
| 3 Pump barrel | 8 Plunger |
| 4 Adaptor and inlet port | 9 Push rod |
| 5 Inlet annulus | 10 Pump housing—inner |
| | 11 Inlet valve |

One problem that occasionally occurs is that the cam lobe that operates one or both pumps wears prematurely and loses its case hardening. The exposed non-hardened cam then proceeds to wear very quickly indeed and as a result the push rod lifts a lot less and pump becomes eventually inoperative.

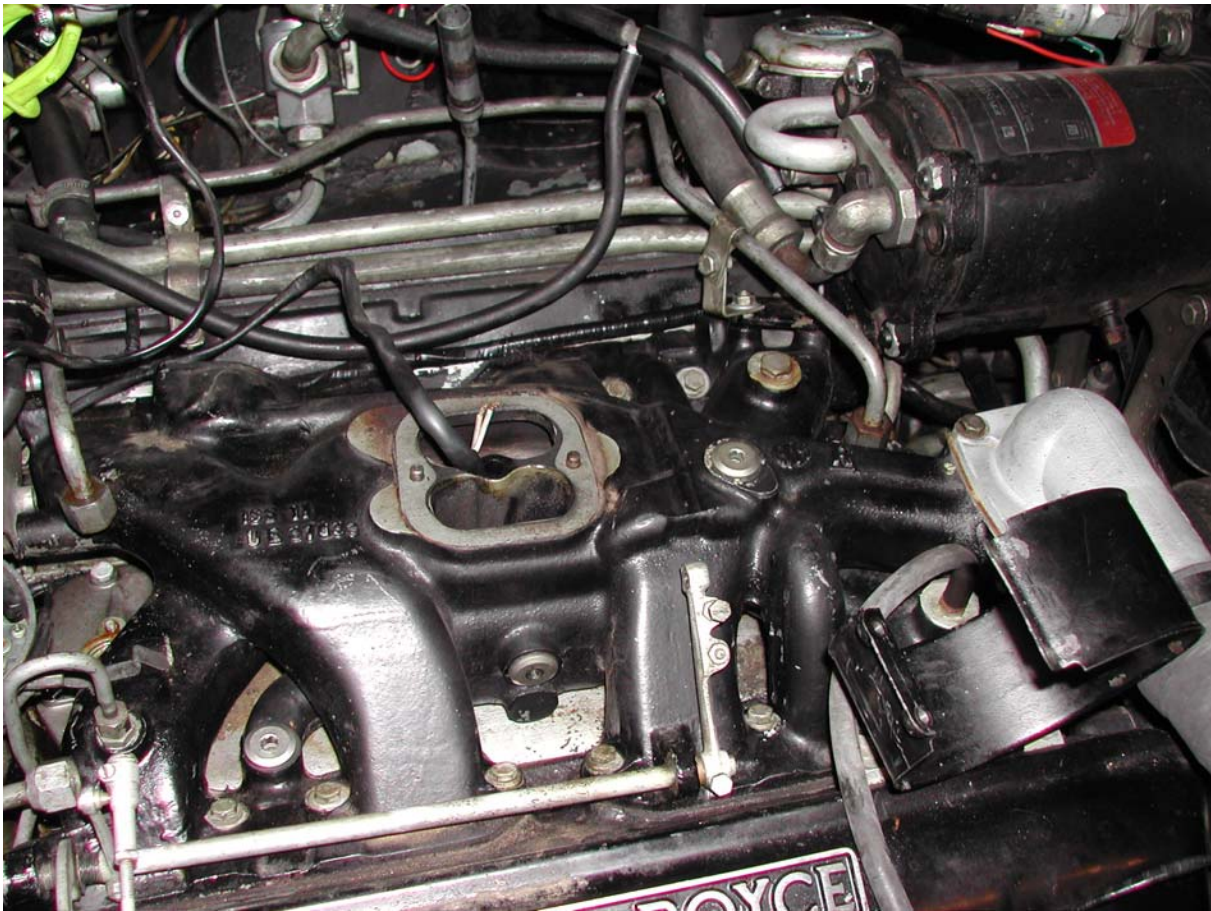
Below is a picture of the engine after the induction system has been removed. This is not as horrendous as it might appear. There is a central bolt in the induction system which when removed allows the whole assembly of carburetters induction horns and sundry other bits to be lifted off in one assembly.

Take a note of where the various rubber tubes connect some are obvious by size but others are not. Mostly they are vacuum connections although in later cars fuel is piped in in rubber rather than steel to reduce the conductance of heat and attendant vapourisation. And while you have this complex off is a good time to replace leaking carburettor diaphragms and cracked tubing anyway!! Note also from this picture, the ease with which the front pump can be removed.

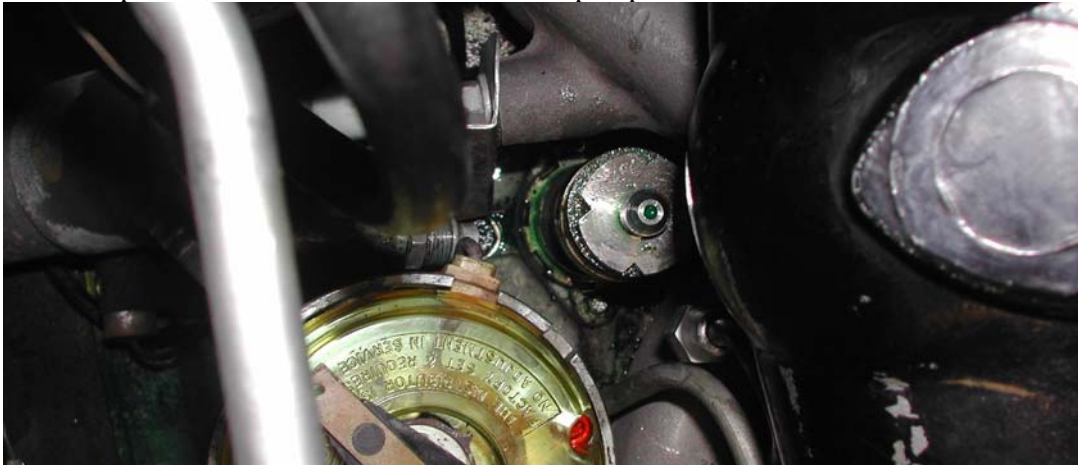
Unlike the other pump pictured this pump on a T2 Bentley is the later 'staked' type identified by the notched disc adapter seen here with the pump outer cover removed. Note that even with the correct serrated tube spanner it is still necessary to move the induction system forward for access to the rear pump.

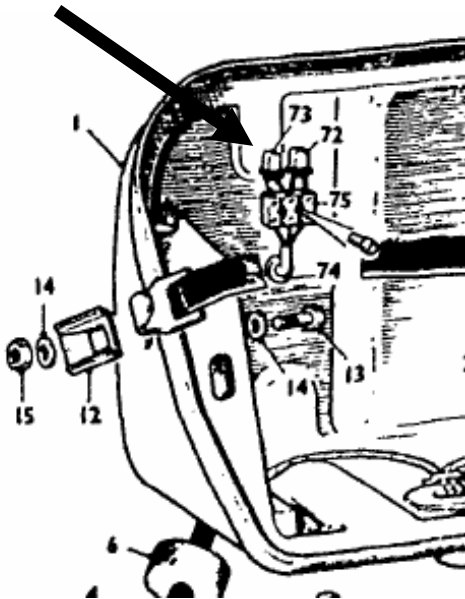
This is for the benefit of all Shadow II and T2 owners who are about to throw away perfectly good CAV alternators. There is a temp sensor in the battery box behind the battery that is supposed to switch the voltage regulator to a lower charge rate in extreme temperature conditions (I think from memory below 0 c and above 35c). The problem is it can fail in the low setting. Move the battery out of the way and reapply power with some jumper cables. With the engine running check the battery voltage with a multimeter. If it is around 13V the device has probably failed. If you disconnect the center (earth) of the sensor, the voltage should jump to above 14v. The device is located in the top left hand corner of the battery box (arrowed) of RHD cars. (The layout may be slightly different in LHD cars). This sensor was only used in the Shadow II era.

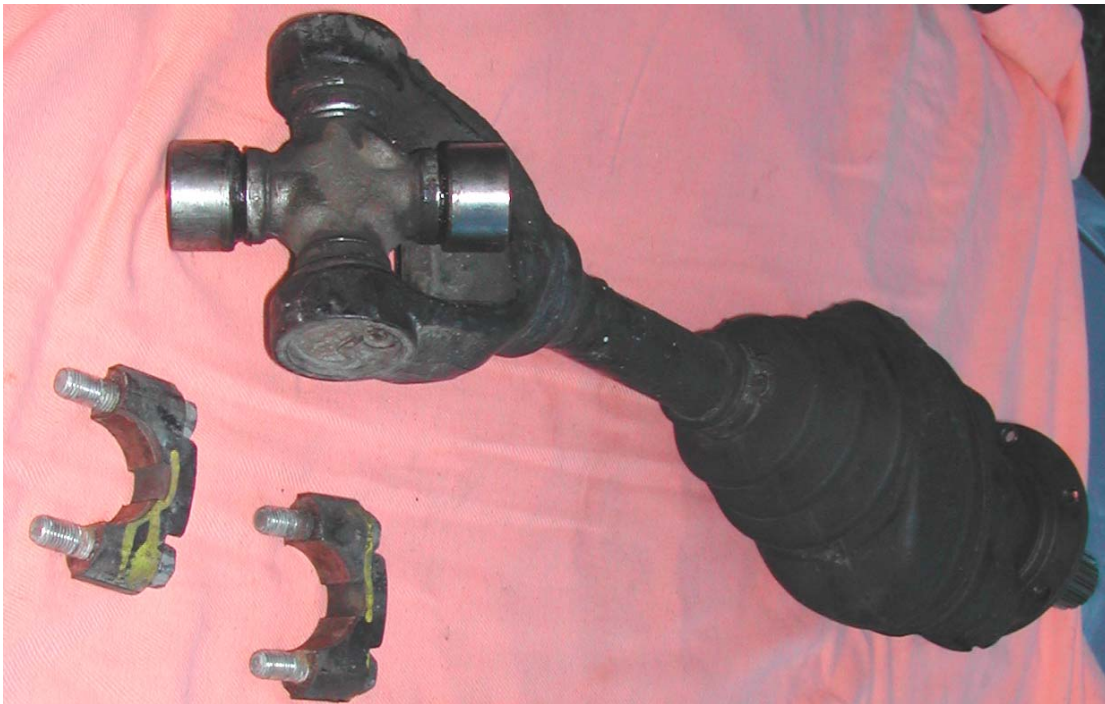
The poor old rear axles one of which is pictured here are often quite neglected. They should have grease nipples in the universal joints (Item 3 in the drawing) and a filler plug (17) for the trunnion joints on the inner end. Removal is very simple involving undoing the two saddles and the half dozen nuts securing the inner bearing flange (37) to the rear axle casing.

As with any other joint they wear and vibrate and on a Shadow this is often felt on acceleration. One quick cure is to reverse the axles which are identical. While doing so have a very good look at the boots ((7) to ensure they are not about to puncture and consider replacing the universal joints. They are not expensive and can be the cause of a pronounced 'clunk' when engine power is applied.

And seeing that you have the axles out why not pull out the inner bearings (38) and replace the oil seals (35)?

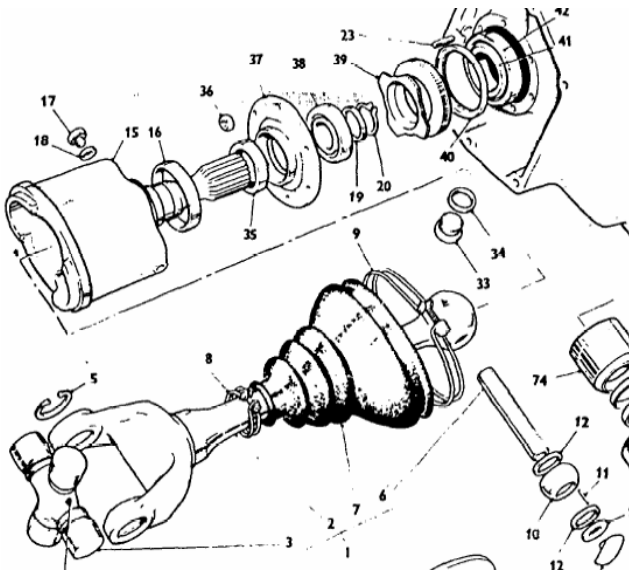
The inner trunnion joint was as you know copied from Buick immediately after the last World War. The joint was used on the front end of the propeller shaft on all the Silver Clouds and Phantoms V and VI and also the very early Shadows. They are very expensive to produce are fiddley to service and the rubber sealing boots are very difficult to replace. They were discontinued on the propeller shaft shortly after the start of Shadow production but continued to be used on rear axles until the Spirit line got established.

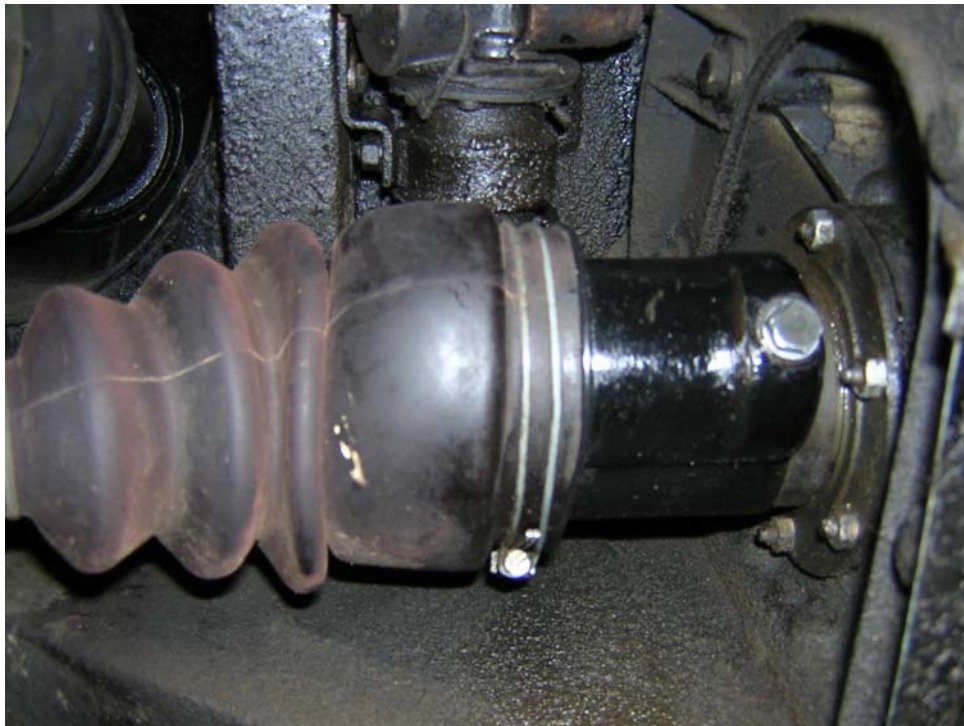
When did you last have a look at these dear old things stuck either side of your differential (read final drive). They have quite a job to do are very expensive to replace yet the number I find utterly empty of oil. If you haven't been there get the car up into the air clean around the filler plug and remove it preferably when the plug is at 3.00 o'clock. Ideally oil should just start to dribble out. If not turn the trunnion down until it does dribble which will give you an idea of how much is there. You may as well let the lot out and start again.

The required oil is the same as that you put in the diff of 90 viscosity and the quantity is 150 millilitres. That is about ½ a coffee mug, the amount is not really critical. The easiest way I find to get it in is to use a medical syringe available from most chemists. The most common size available is 50ml. Buy three, fill them all and take them under the car with you. Pull the plunger out fill it with oil pop the plunger back poke it in the hole and squeeze. The more clever among you will

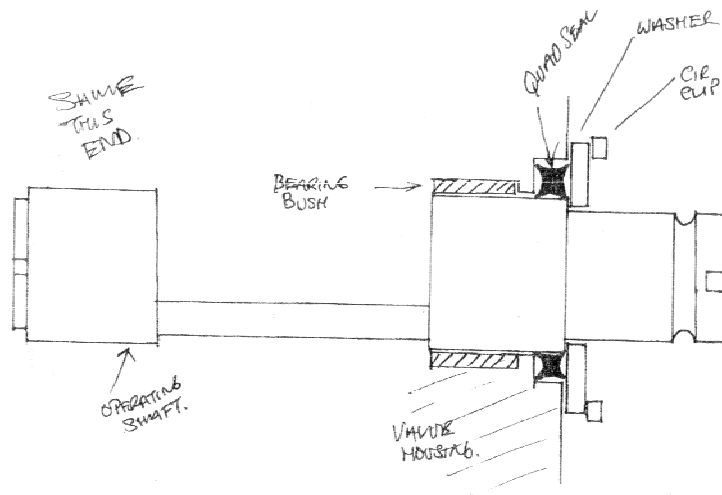
The end of the shaft away from that where the operating arm is fastened has a slot in it that allows the shaft to be held while the operating arm is unclenched and moved to a new position. Road grime can easily penetrate this area which not only provides an abrasive to cut the seal but also corrodes the shaft surfaces where the seal runs. Clearly a perfect setup to destroy the seal and precipitate a significant leak. The other end is similarly placed for

More and more of these valves are starting to leak for the third and fourth time with the overhaul period becoming shorter and shorter. All the forgoing is to alert you the owner to have a good look at the operating shaft surfaces and if there is the slightest sign of corrosion or damage replace them. I understand RA Chapman is now making these shafts and they are readily available.
